**STRUCTURAL REPORT**

**26A FERNCROFT AVENUE  
LONDON  
NW3 7PH**

**PROJECT NO: P5641**

**JULY 2023**

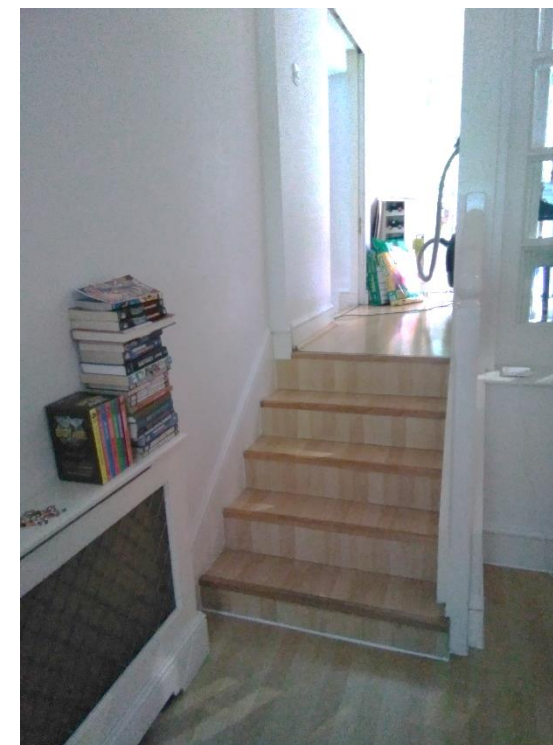
**Photo 3.12**

- 3.11 The ground floor is of generally solid construction, with the exception of the rear reception room, which has a timber suspended floor. The tiling to the hallway shows extensive crazing/cracking. Refer **photo 3.11**
- 3.12 The ground floor is on three different levels. To the rear, there are steps up to a living area, and a further set of steps up to the kitchen. Refer **photo 3.12**

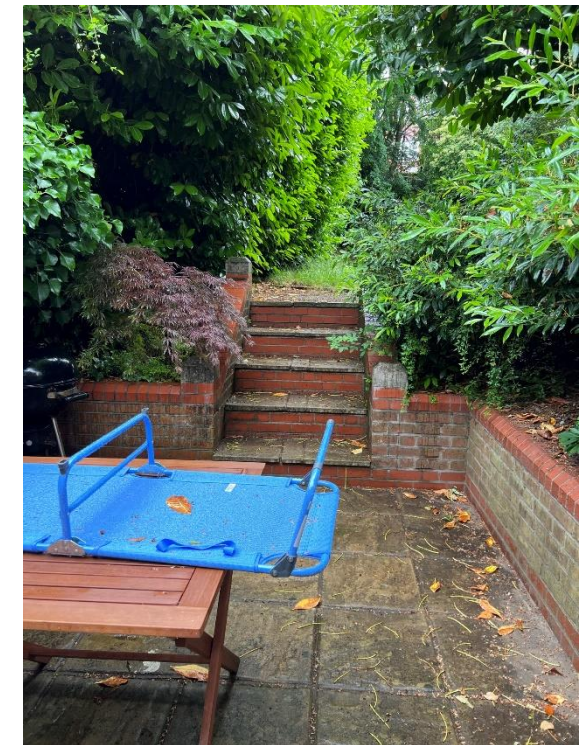
Photo 3.22

- 3.21 The rear garden contains a large tree, immediately adjacent to the rear of the house. Refer **photo 3.21**.
- 3.22 There are short retaining walls around the patio, with steps up, to allow access between the area immediately behind the house, which is paved, to the main garden level at the rear. Refer photo **3.22**
