**Tree Report**  
**Picus Testing – 258 Camden Road, London, NW1 9AB.**

**1.1 Inspection date:** 15<sup>th</sup> June 2023 by Mr. Kim Gifford, undertaken in the area of test and at the time of inspection.

**1.6 London Plane (*Platanus x hispanica*)/ @ level: 150cms ground level approximately from ground level. Test point 1 at south orientation. Height 19m Crown 10m dbh 100cm, very mature. Rear garden by wall and fence.**

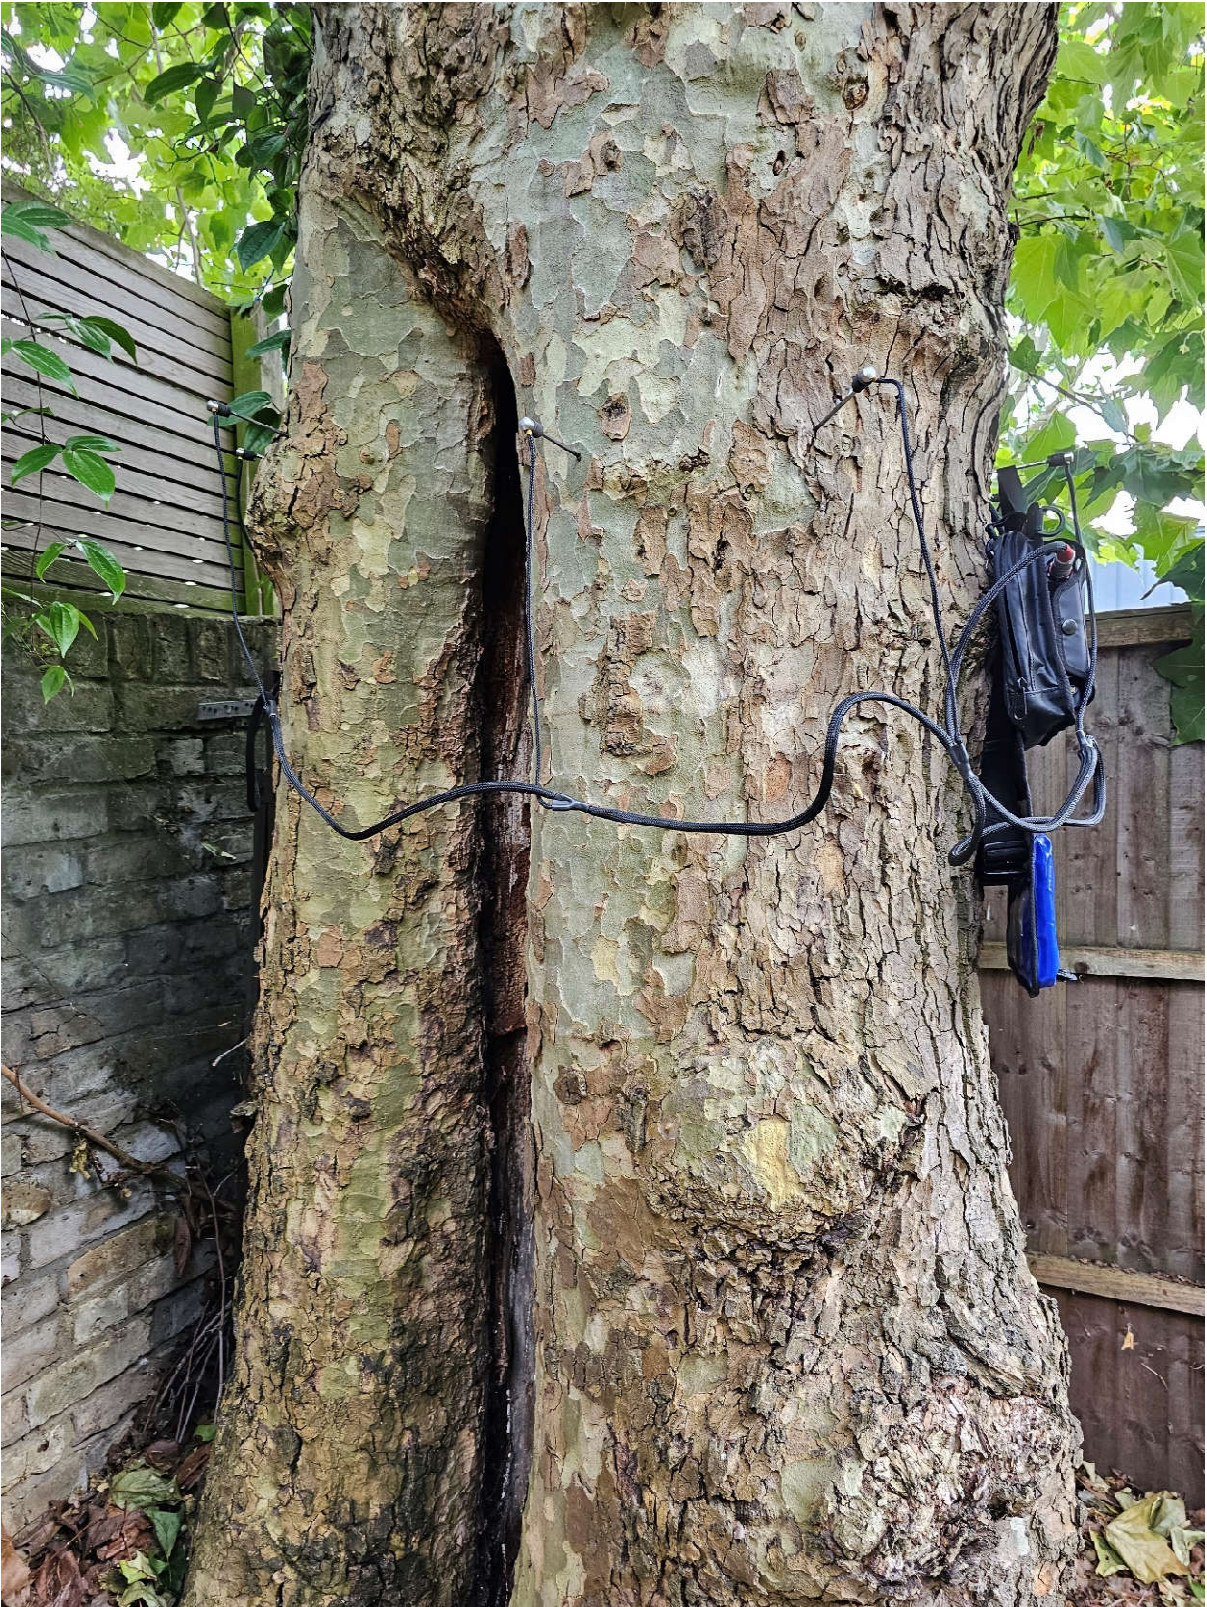
**Figure 5 – Picus testing**

The results show extensive decayed timber in the area of test. Major cavity on east side of trunk 30cms x 2m visual evidence of hole into root plate.

It would now be appropriate to recommend that consideration be given to the complete removal of this specimen on the grounds of further damage and health & safety in this location.

**Within 6 months.**
