# **LONDON BOROUGH OF CAMDEN**

## **ARBORICULTURAL REPORT**

Address of Property: **170 Maygrove Road, NW6 2EP**  
Department/s responsible for tree/s: **LBC – Highways**  
Date of inspection and Officer: **Liam Vincent inspected on 23/3/2023**

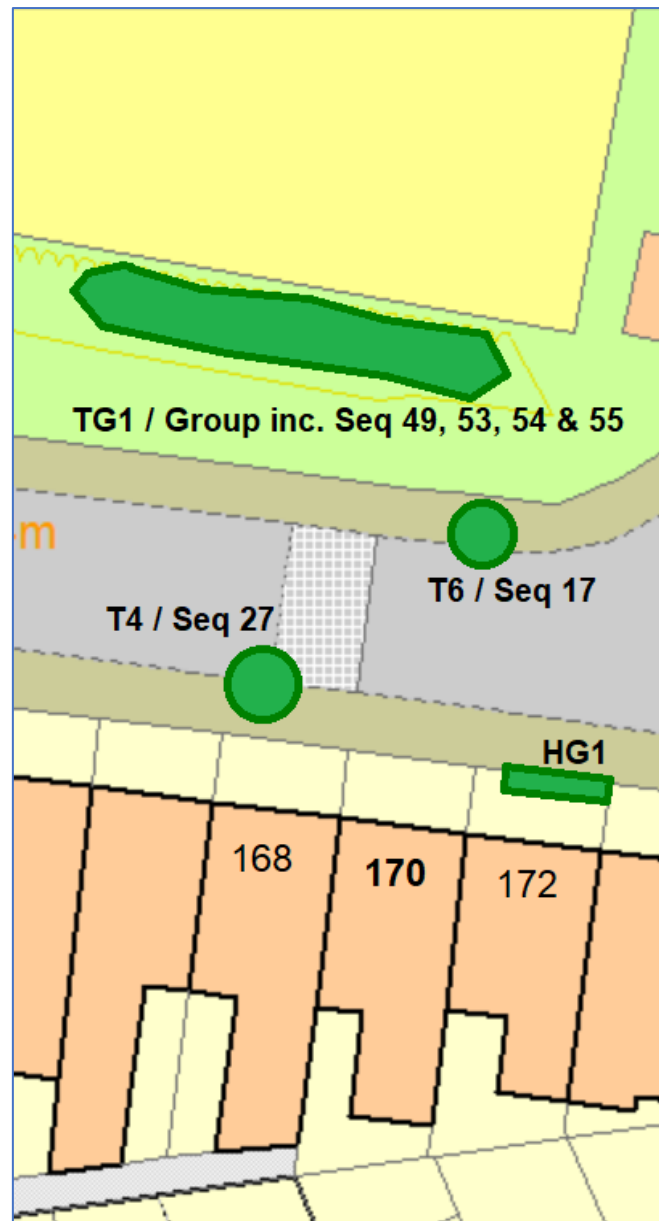
Fig. 1: Location of 170 Maygrove Road and LBC and third-party vegetation implicated

- The trees inspected for this investigation within Highway to the front of the claim address and the Public Open Space (POS) opposite the claim address on the other side of the highway are a semi-mature Cockspur Thorn (Seq 27, photo 1) and four mature Aspen trees (Seq 49, 53, 54 & 55, photo 2). See Fig.1.
