# Site Investigation Report

| Job Information | |
|---|---|
| Client | Crawford & Co |
| Visit date | 18/03/2022 |

| Overview | |
|---|---|
| Brief | Auger were commissioned by Crawford & Co to undertake a site investigation and CCTV inspection of the underground drainage within the area of concern (AOC) at the property. |

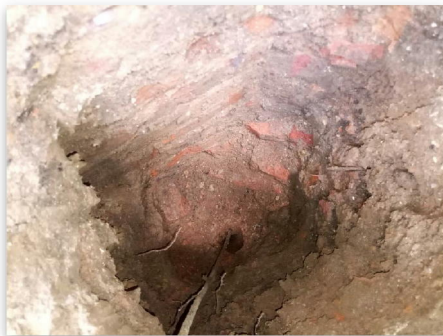
Fig 1.3: Trial Hole 1

| Overview | |
|---|---|
| Trial Hole Findings | <p>Within TH1, we also took footing measurements from the projection of the front elevation. These measurements are shown in Trial Hole Log 1b below. The footings exposed during TH1 were brick step outs on top of loose concrete.</p> <p>During the excavation to expose the footing of the two storey addition we encountered a broken drain pipe, however as this was outside the AOC we did not further investigate this drain, should this be required then a cost and scope for this can be completed on request</p> |
