# ARBORICULTURAL ASSESSMENT REPORT

50 Priory Road, London, NW6 3RE

Survey Date: 19/12/2022

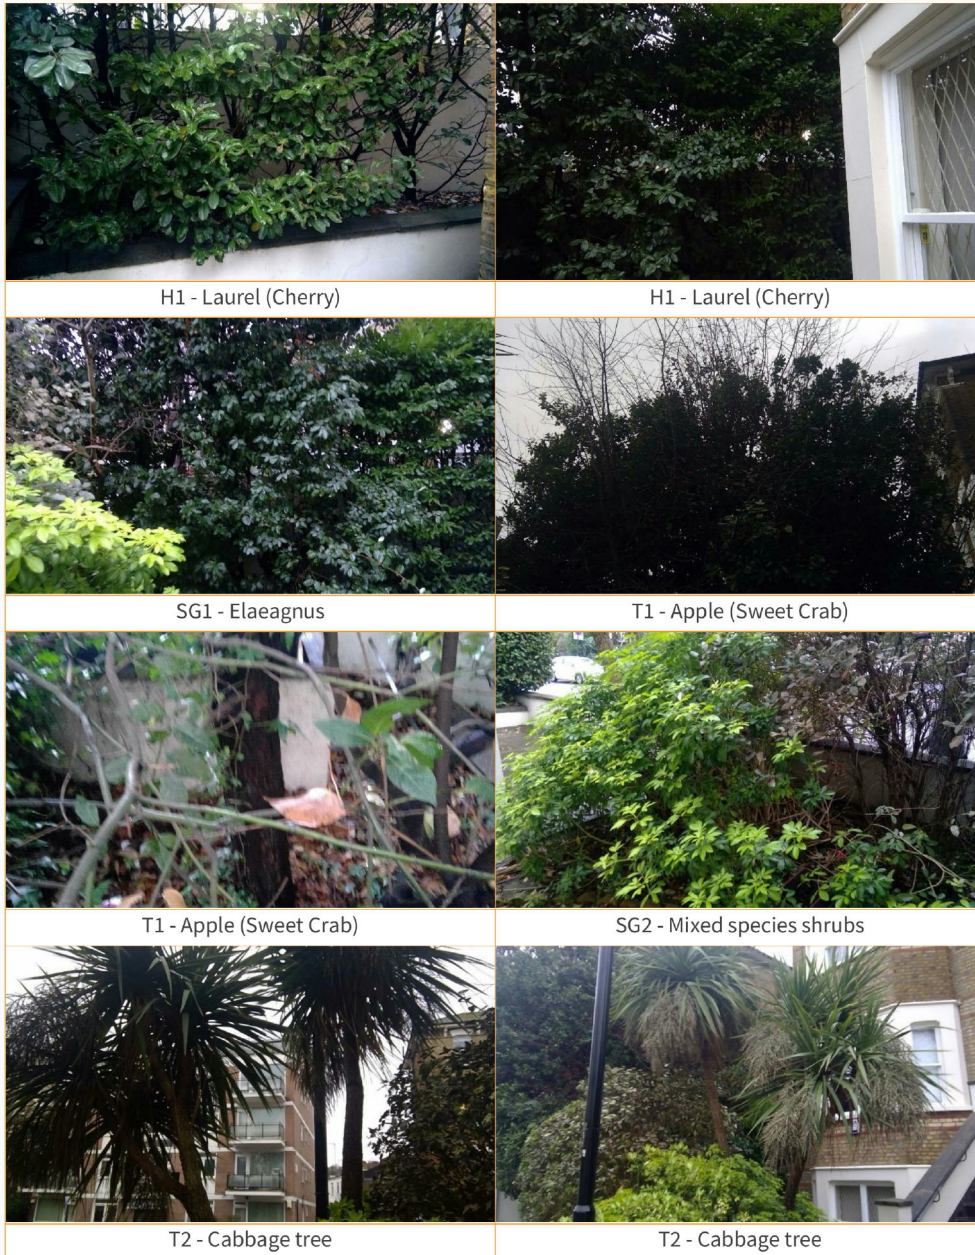
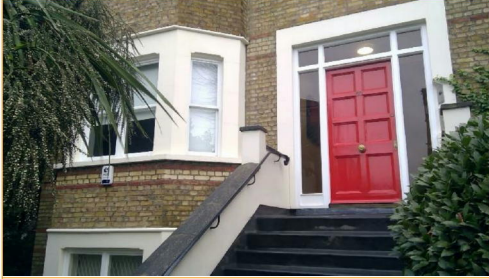
Photo

Tree No	Common Name	Age Class	Condition	Height (m)	Crown Spread (m)	Stem diam. (mm)	Dist to bldg. (m)	Roots Implicated	Pruning history	Recommendation	Tree work constraints	Notes	Owner address	Owner
H1	Laurel (Cherry)	Mature	Good	4	2	80	2.1	N	Subject to past management.	No work required.			50 Priory Road London NW6 3RE	PH
SG1	Mixed species shrubs	Mature	Good	6	4	100	2.5	N	Subject to past management.	Fell and treat stump with eco plugs (broadleaved).	Adjacent to highway - traffic management required. Pre cone/signage/ barriers action required - footpaths/public access.	Bay Laurel and Elaeagnus.	50 Priory Road London NW6 3RE	PH
SG2	Mixed species shrubs	Mature	Good	3	2	20	3.5	N	Subject to past management.	No work required.		Viburnum and Choisya.	50 Priory Road London NW6 3RE	PH
T1	Apple (Sweet Crab)	Mature	Good	10	6	300*	3	N	Subject to past management.	Fell and treat stump with eco plugs (broadleaved).			50 Priory Road London NW6 3RE	PH
