Site Investigation Report

Job Information	
Client	Crawford & Co
Client ref	[Redacted]
Visit date	28/10/2022
Report date	07/11/2022

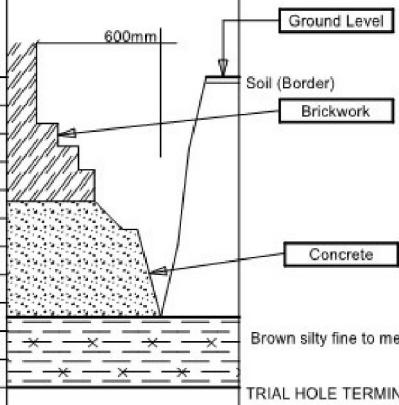
Location: Rear of bay

Ground Level Soil (Border) Brickwork Concrete				
0.5						
1.0		Brown silty fine to medium gravelly CLAY TRIAL HOLE TERMINATED	140kpa		Soil Sample @ 0.85m	Root Sample @ 0.85m
1.5						
2.0						
2.5						
3.0
