## 3.0 EXISTING BUILDING

101 Bayham Street is a handsome Art Moderne building. The facade has a strong horizontal emphasis and a highly symmetrical facade bookended by vertical bays at either end.

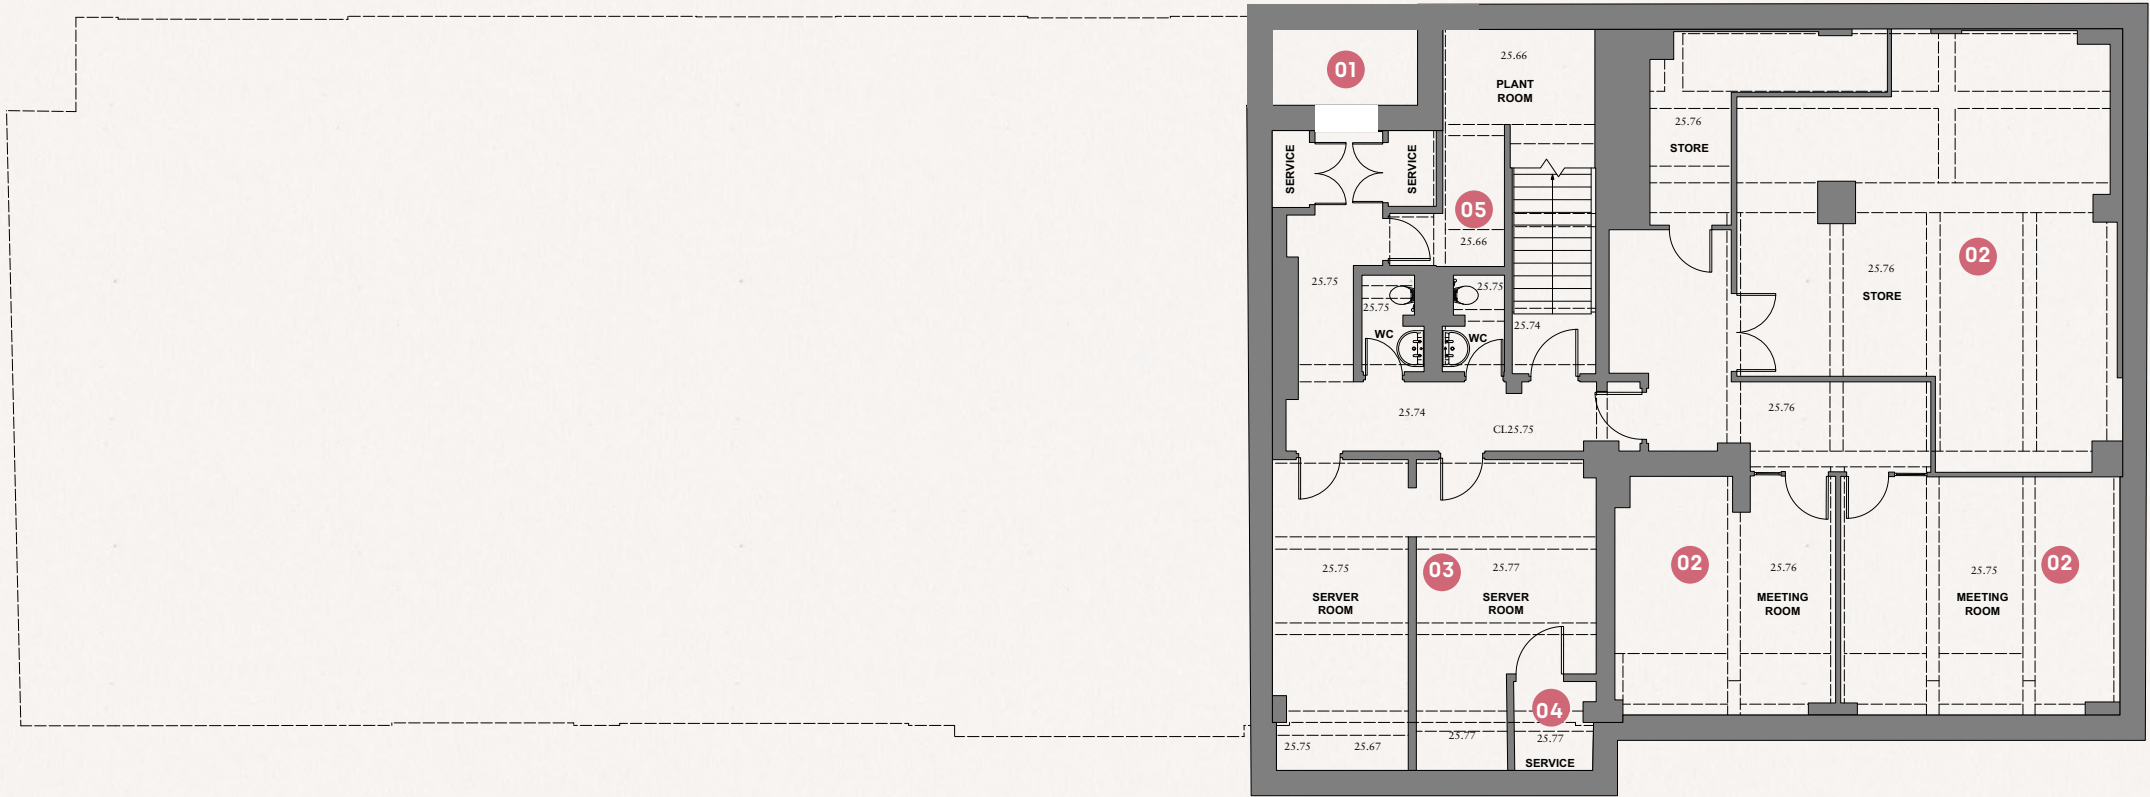
The basement has previously been used for meeting rooms and there is a room for data racks and incoming services. However there is very limited daylight to this floor apart from via a small lightwell in the incoming services and server room. The ceiling height is also relatively low at between 2135 and 2355mm meaning the office areas are of poor qualitative value.

- 01 Primary lift to floors above
- 02 Office Spaces / Meeting Rooms
- 03 Server room
- 04 Location of Incoming Services
- 05 Storage area under stairs

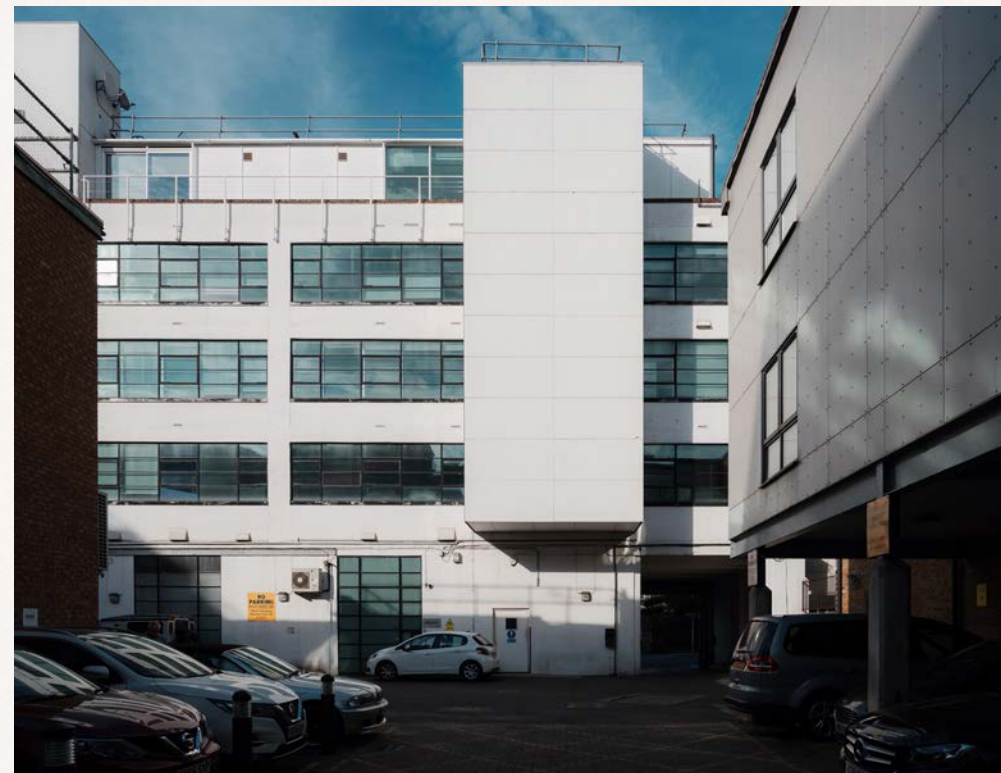
- The rear facade is practical in its composition and is not visible from wider townscape views.
