No 2 Bedford Square Works to Railings

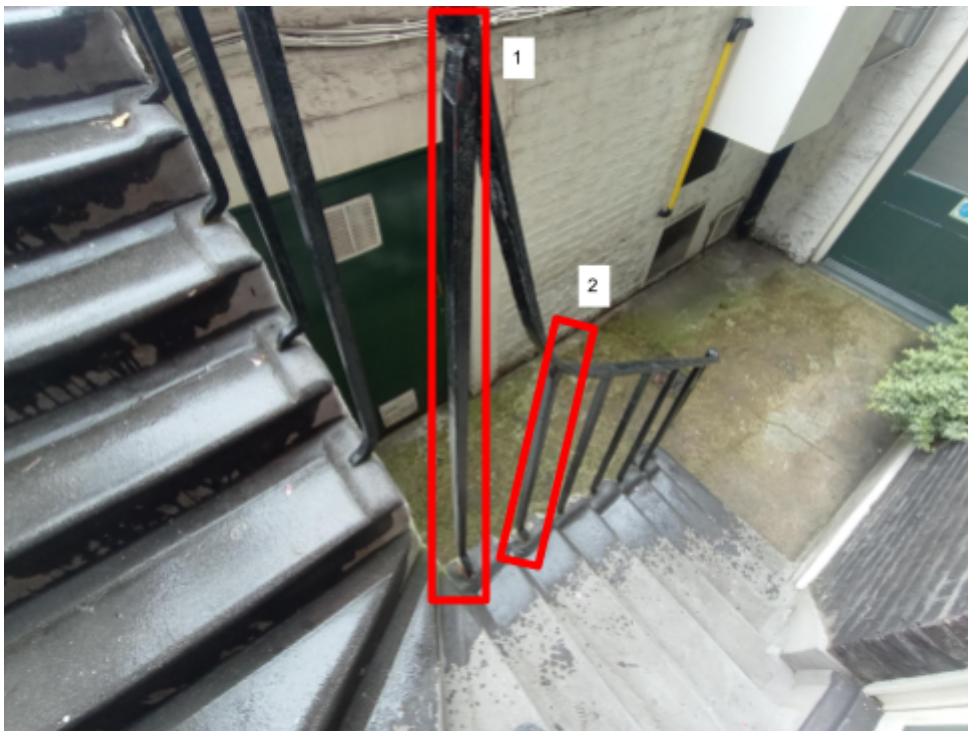
The balusters which require replacing/repairing are located on these steps, as highlighted.

There are two railings which have decayed where they meet the steps. The intention is to remove the lead fill to the socket into the steps and remove the damaged section of the iron balustrading.

A new section of balustrading would be welded to the existing baluster, although depending on the quality of the iron, this may not be possible. If it is not possible then new wrought iron balusters will be manufactured and installed. The lead surround would then be reinstalled.
