PRELIMINARY ARBORICULTURAL REPORT

31 Daleham Gardens, NW3 5BU

DATE: September 2021

OUR REF: SHA 1198

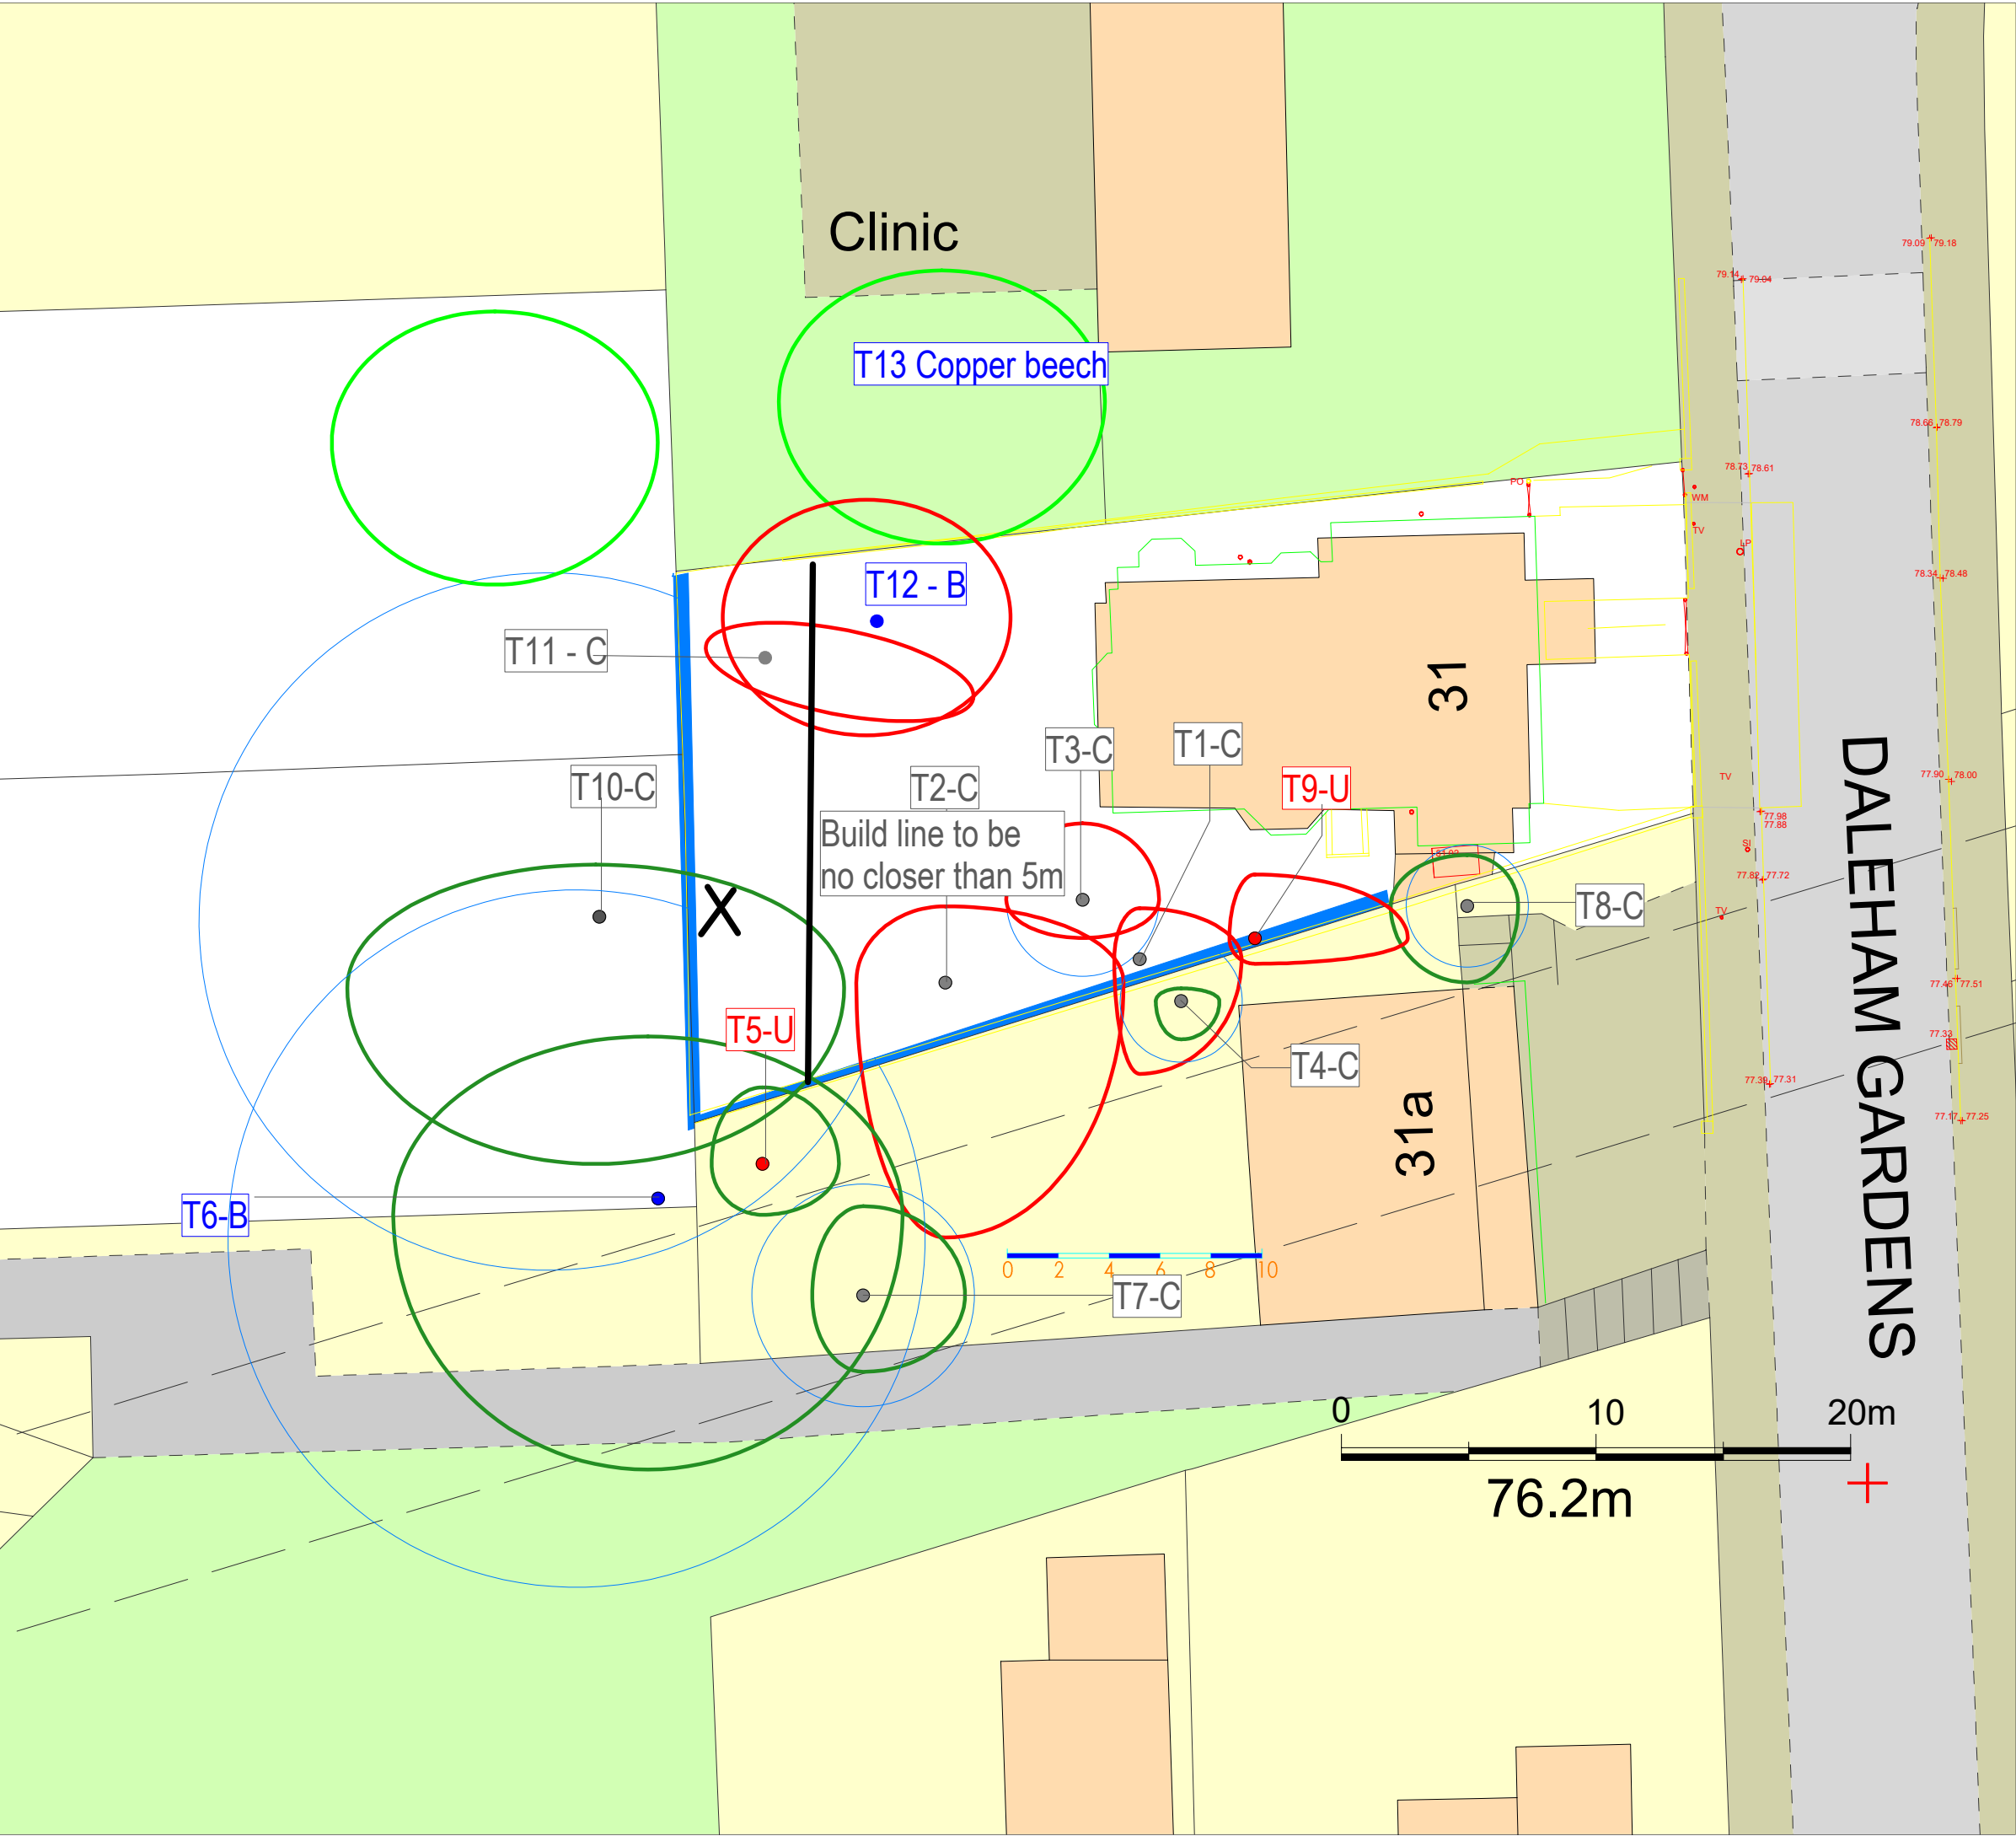
Tree information plan SHA 1198 TIP

A trial pit was dug with the arboriculturist present next to the wall (see X on the plan SHA 1198 TSP and TOP). This found that the wall had a 750mm deep foundations with no roots just below. It is reasonable to assume that the wall is acting as a root barrier to this tree. As
