/ 8 GUILFORD STREET ROOM SCHEDULE

6569

REV 01

26/09/2023

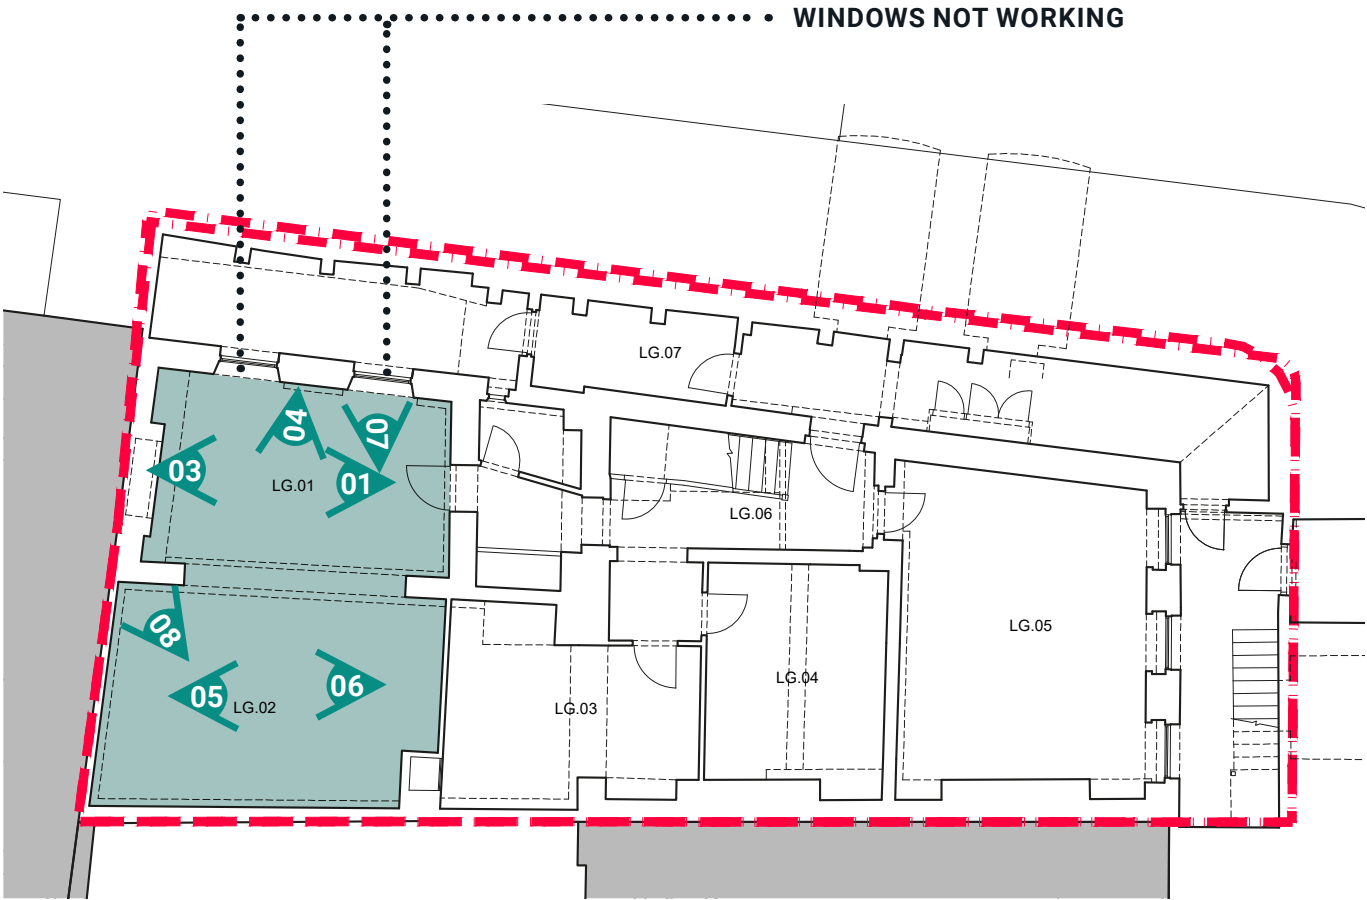
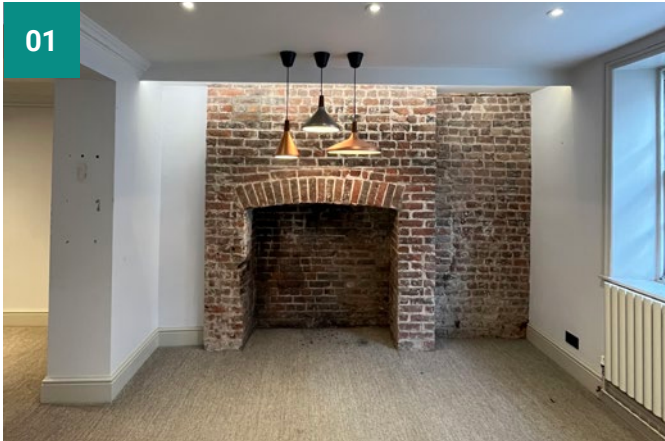
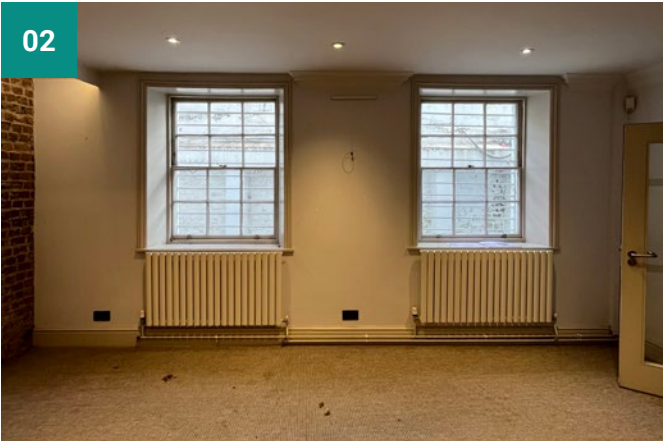
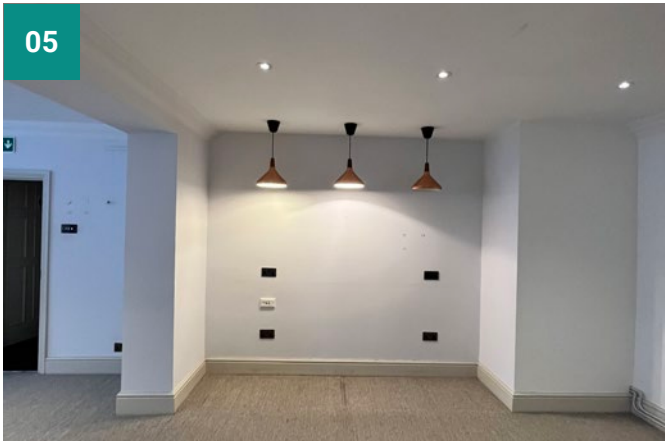
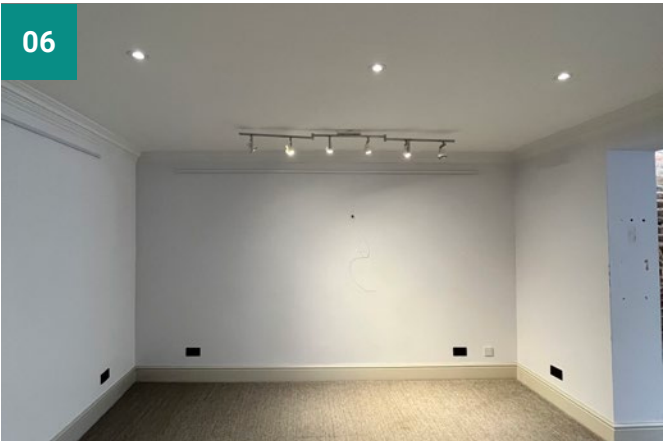
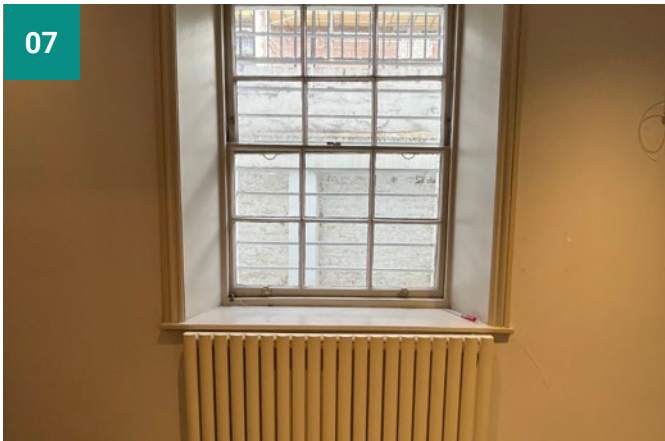
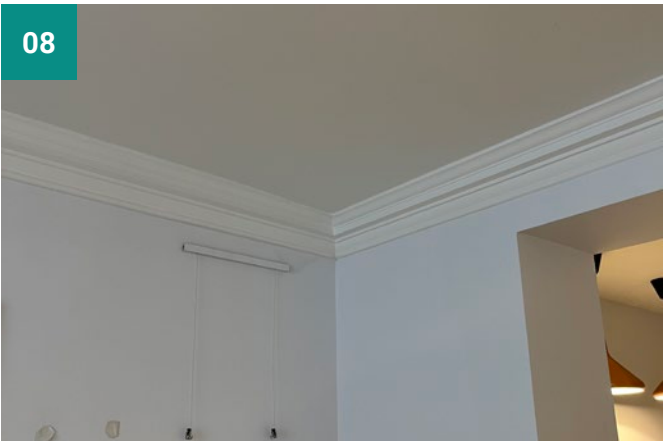
FIGURE 01 ROOM LG.01/02

LOCATION	DESCRIPTION	CONDITION / SCOPE OF REPAIR	COMMENTS
LG.01 / LG.02	Ceiling / Cornice	<ul style="list-style-type: none">Modern suspended ceiling with recessed spotlightsModern cornice only partially present,	<ul style="list-style-type: none">All to be adapted to suit layout of conversion to residential use
LG.01 / LG.02	Floor	Carpet covering poor condition concrete slab	<ul style="list-style-type: none">All to be adapted to suit layout of conversion to residential use
LG.01 / LG.02	Walls / Skirting	<ul style="list-style-type: none">Good conditionModern skirting, architraves and fixture & fittings	<ul style="list-style-type: none">All to be adapted to suit layout of conversion to residential useWalls to be repaintedSkirting to be replaced
LG.01 / LG.02	Windows	<ul style="list-style-type: none">Existing timber sliding Sash windows, single glazed to be retained and refurbished.Windows do not work and present several layers of paint	<ul style="list-style-type: none">Windows to be kept and secondary glazing to be installedExternal metal bars to be removed

LG.01 / LG.02	Internal Doors	Modern door with vision panel and architrave	All to be adapted to suit layout of conversion to residential use
LG.01 / LG.02	Fireplace	Exposed bricks fireplace, no insert	Clean the bricks and possibly reinstate an original reclaimed Victorian fireplace insert
LG.01 / LG.02	Radiators	Modern water filled radiators and surface mounted pipework	All to be adapted to suit layout of conversion to residential use

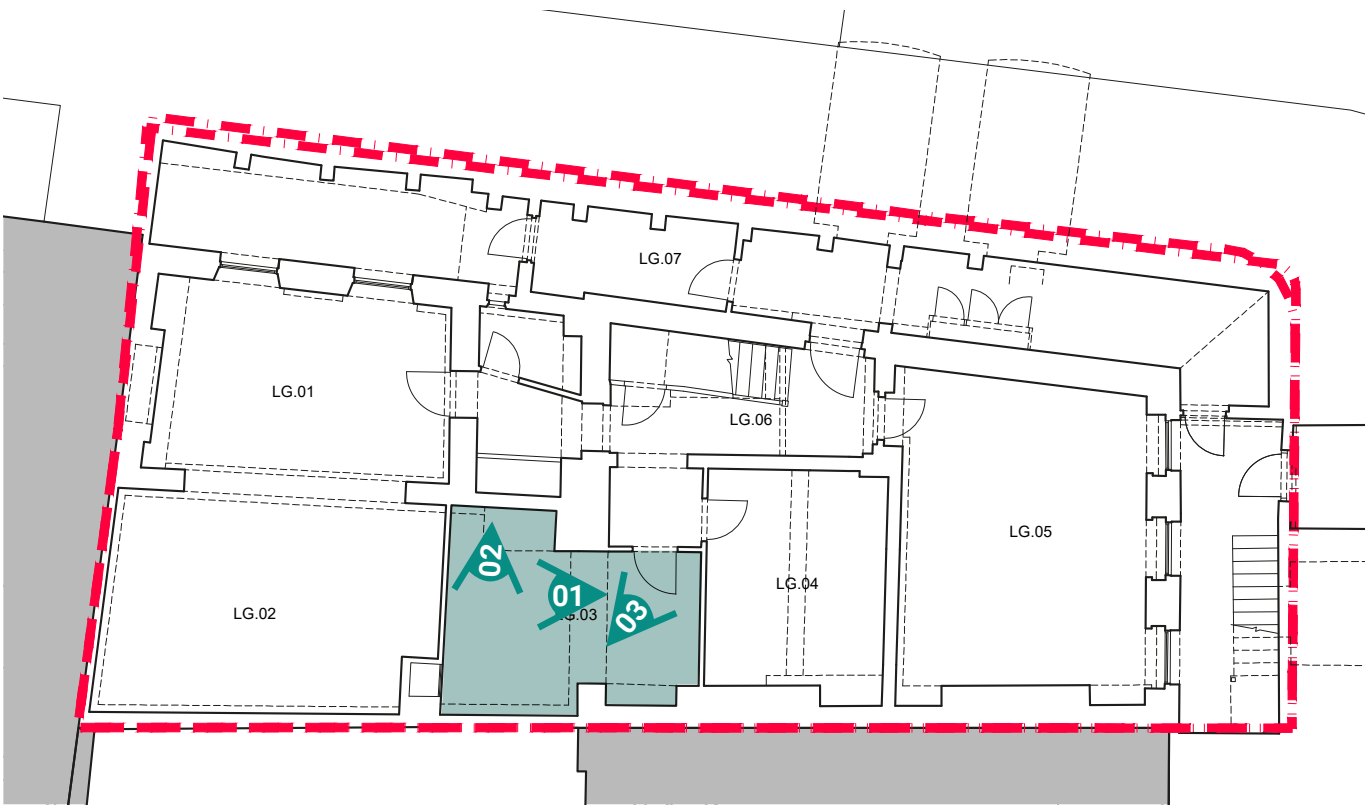
FIGURE 02 ROOM LG.03

LOCATION	DESCRIPTION	CONDITION / SCOPE OF REPAIR	COMMENTS
LG.03	Ceiling	Modern plasterboard ceiling, poor condition with various bulkheads	All to be adapted to suit layout of conversion to residential use
LG.03	Floor	Modern vinyl floor, covering concrete slab	All to be adapted to suit layout of conversion to residential use
LG.03	Walls / Skirting	<ul style="list-style-type: none">• Modern plasterboard• Modern skirting, poor condition	All to be adapted to suit layout of conversion to residential use
LG.03	Internal Doors	Modern doors and fittings	All to be adapted to suit layout of conversion to residential use

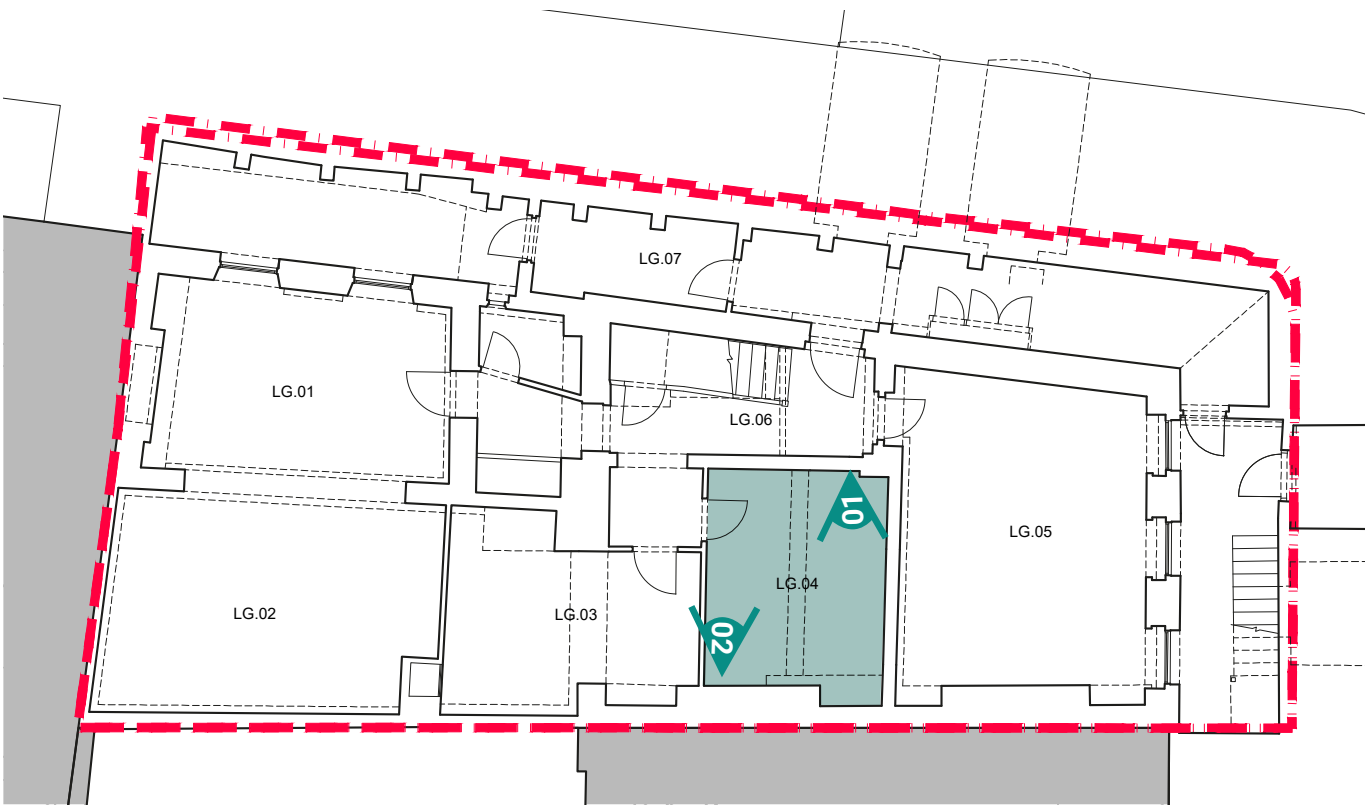
FIGURE 03 ROOM LG.04

LOCATION	DESCRIPTION	CONDITION / SCOPE OF REPAIR	COMMENTS
LG.04	Ceiling	Modern ceiling in bad condition with cracks and black spots in corners. A bulkhead spans from North wall to the chimney breast (now closed up with modern vent louvre)	Restore the ceiling plaster, repaint, check option of creating a suspended ceiling to conceal bulkhead (subject to bulkhead height)
LG.04	Floor	Poor condition modern carpet, covering concrete slab	Carpet to be removed, new floor to be installed above existing concrete.
LG.04	Walls / Skirting	<ul style="list-style-type: none">Shelving & Fixings to be removedModern skirting, poor condition	<ul style="list-style-type: none">Walls to be made good and repainted where keptSkirting to be replacedSince LG03 and LG04 are to be connected, option to reinstate fireplace
LG.04	Internal Doors	Modern door and ironmongery	Door to be removed
LG.04	Radiators	Modern panel radiators with surface mounted pipework	To be removed

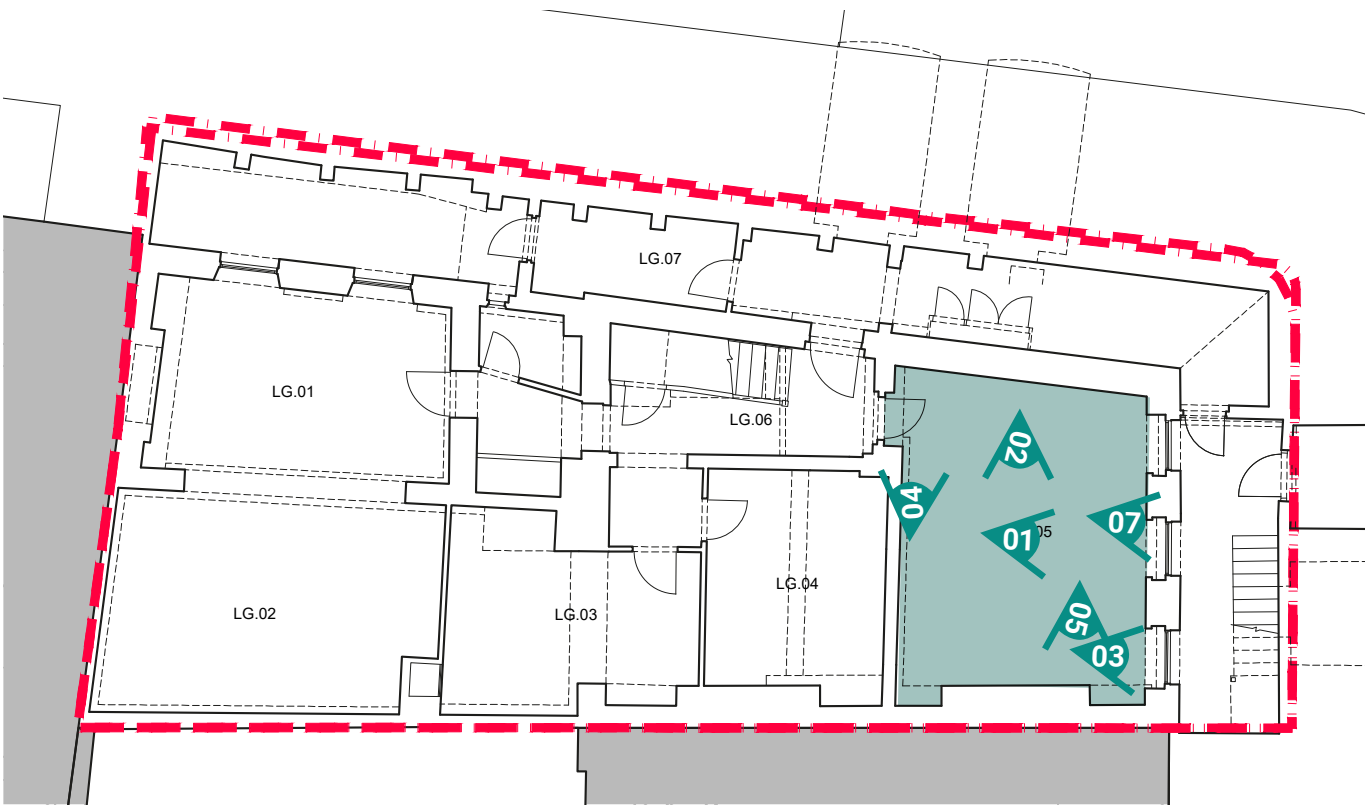
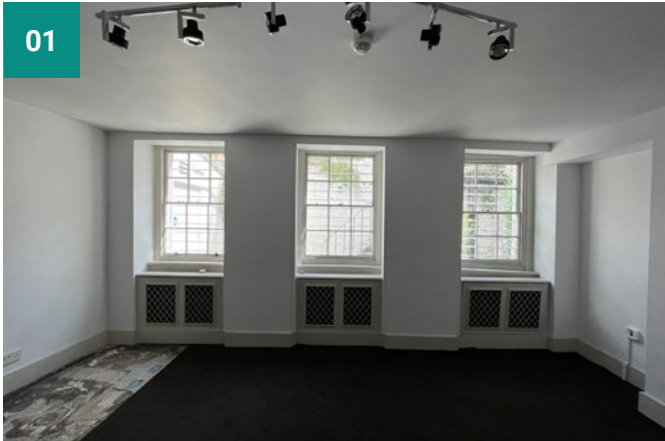
FIGURE 04 ROOM LG.05

LOCATION	DESCRIPTION	CONDITION / SCOPE OF REPAIR	COMMENTS
LG.05	Ceiling / Cornice	<ul style="list-style-type: none">• Modern plasterboard ceiling with modern fittings• Bulkheads running around room perimeter to conceal services	Ceiling to be renewed
LG.05	Floor	Poor condition modern carpet, covering concrete slab	Carpet to be removed, new floor to be installed above existing concrete.
LG.05	Internal Door	Existing door to be retained	modern fixtures and fittings to be removed and replaced
LG.05	Walls / Skirting	<ul style="list-style-type: none">• White painted walls• Modern skirting	<ul style="list-style-type: none">• Where walls are to be kept, make good and repaint• Option to reinstate fireplace• Skirting to be retained and redecorated
LG.05	Windows	<ul style="list-style-type: none">• Existing timber sliding sash windows to be retained• Windows do not work and present several layers of paint	<ul style="list-style-type: none">• Windows to be kept and secondary glazing to be installed.• External metal bars to be removed

LG.05	Radiators and covers	Modern radiators and covers are located beneath each window	to be removed and replaced

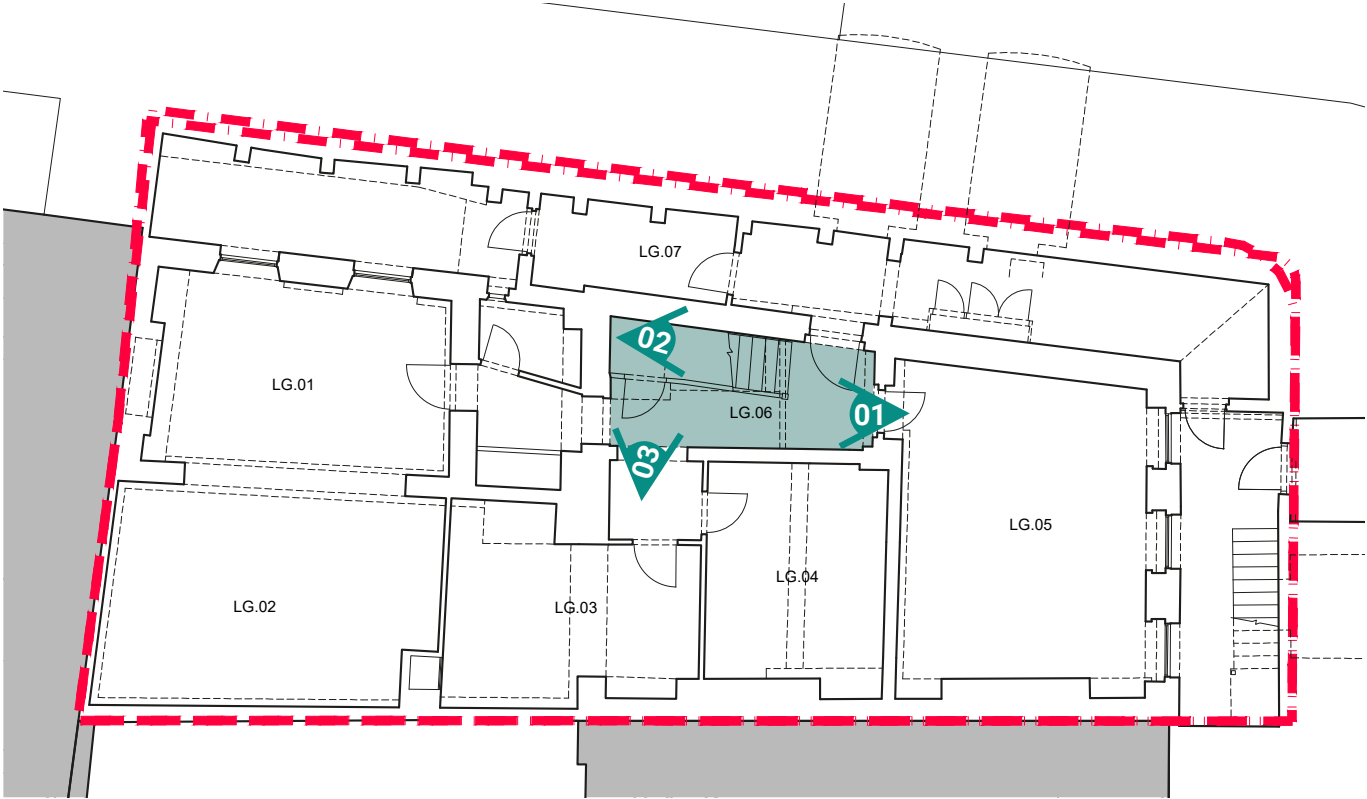
FIGURE 05 ROOM LG.06

LOCATION	DESCRIPTION	CONDITION / SCOPE OF REPAIR	COMMENTS
LG.06	Stairs	Steps covered by modern carpet	Carpet to be removed and stairs to be repaired and redecorated
LG.06	Hand rails, newel posts and balusters	All to be retained	All to be repaired and redecorated
LG.06	Floor	Modern carpet, covering concrete slab	Carpet to be removed, new floor to be installed above existing concrete.
LG.06	Walls	White painted walls	To be made good and repainted
LG.06	Internal door to services cupboard	Existing door to be retained	To be repaired and redecorated with new ironmongery & fittings

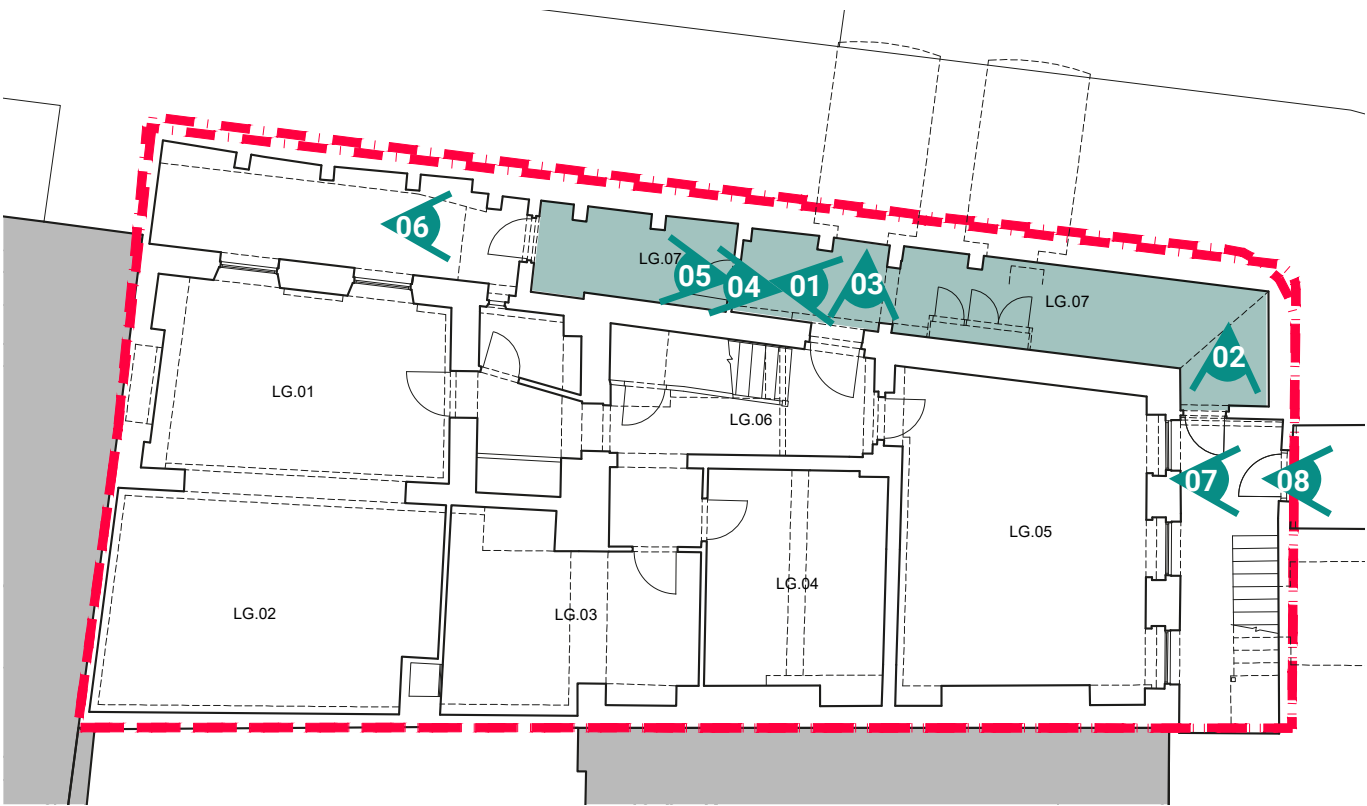
FIGURE 06 ROOM LG.07

LOCATION	DESCRIPTION	CONDITION / SCOPE OF REPAIR	COMMENTS
LG.07	Ceiling	Vaulted ceiling with partially exposed bricks and partially concealed by a plaster layer	All to be repaired and redecorated
LG.07	Floor	Modern terracotta tiles and exposed concrete slab in boiler room	Tiles to be stripped out and all the floor to be repaved
LG.07	Walls	Modern wall tiles and painted brickworks	Tiles to be removed and walls to be repaired and repainted
LG.07	Internal Door	Door beween LG06 & LG07 to be retained	<ul style="list-style-type: none">Doors to be retained, replaced and redecoratedNew ironmongery to be installed
LG.07	External Doors	All modern doors to be removed and renewed	To be removed and replaced
LG.07	Kitchen	Poor quality modern kitchen and shelving	All removed and replaced

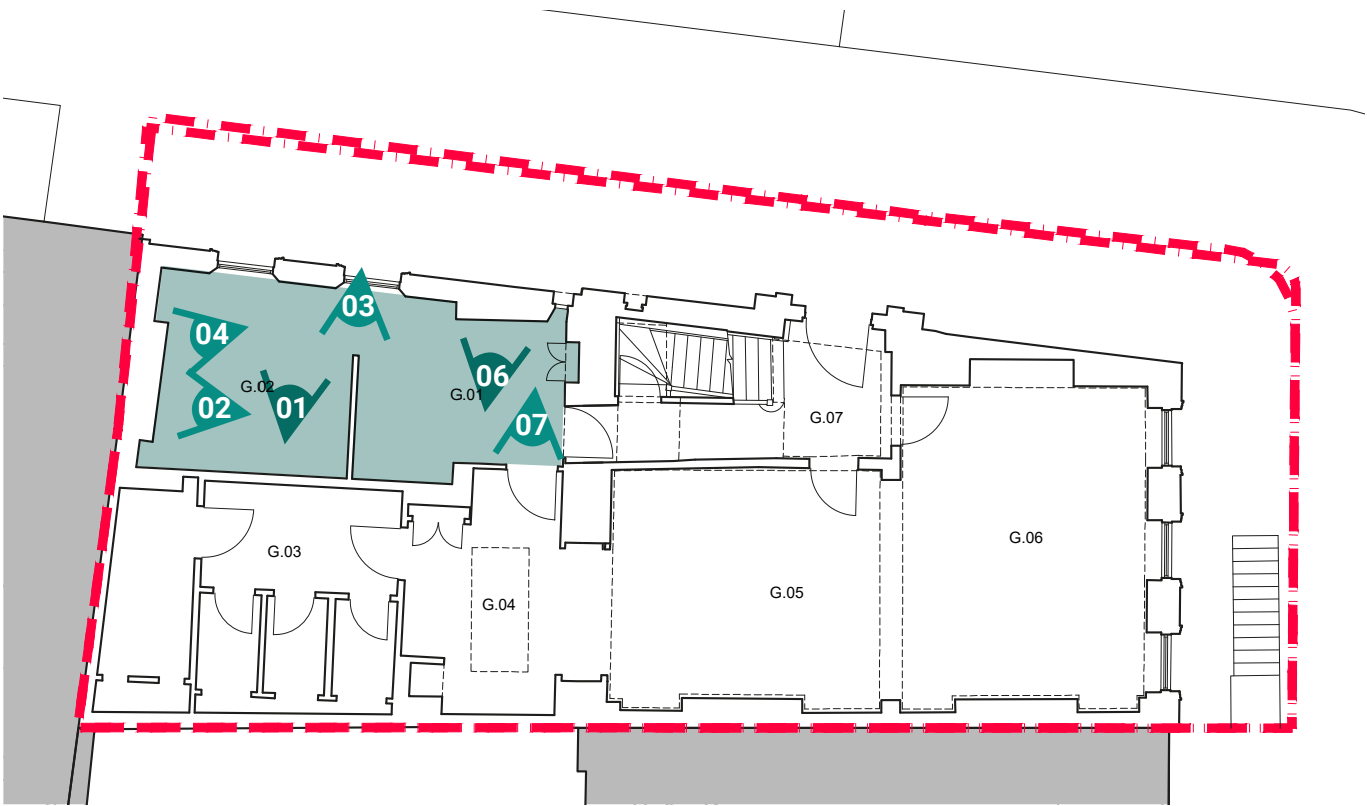
FIGURE 07 ROOM G.01 / G.02

LOCATION	DESCRIPTION	CONDITION / SCOPE OF REPAIR	COMMENTS
G.01 / G.02	Ceiling / Cornice	<ul style="list-style-type: none">• High ceiling, no spotlights except for bulkhead• No cornice	All to be adapted to suit layout of conversion to residential use
G.01 / G.02	Floor	Part carpet, part vinyl covering concrete slab	All to be adapted to suit layout of conversion to residential use
G.01 / G.02	Walls / Skirting	<ul style="list-style-type: none">• Good condition• Mostly modern skirting with plastic electrical conduits• Skirting below indows appers to be original	<ul style="list-style-type: none">• All to be adapted to suit layout of conversion to residential use• Original skirting to be retained
G.01 / G.02	Windows	Timber sliding sash windows, single glazed. Windows do not open and present several layers of paint.	Existing windows to be retained and refurbished with secondary glazing added
G.01 / G.02	Internal Doors	New door with vision panel, good condition - non original	All to be adapted to suit layout of conversion to residential use

G.01 / G.02	Fireplace	Chimney breast present, no fireplace insert	Option to reinstate a reclaimed fireplace
G.01 / G.02	Radiators	Modern double panel radiators located beneath windows, with concealed pipework	All to be adapted to suit layout of conversion to residential use

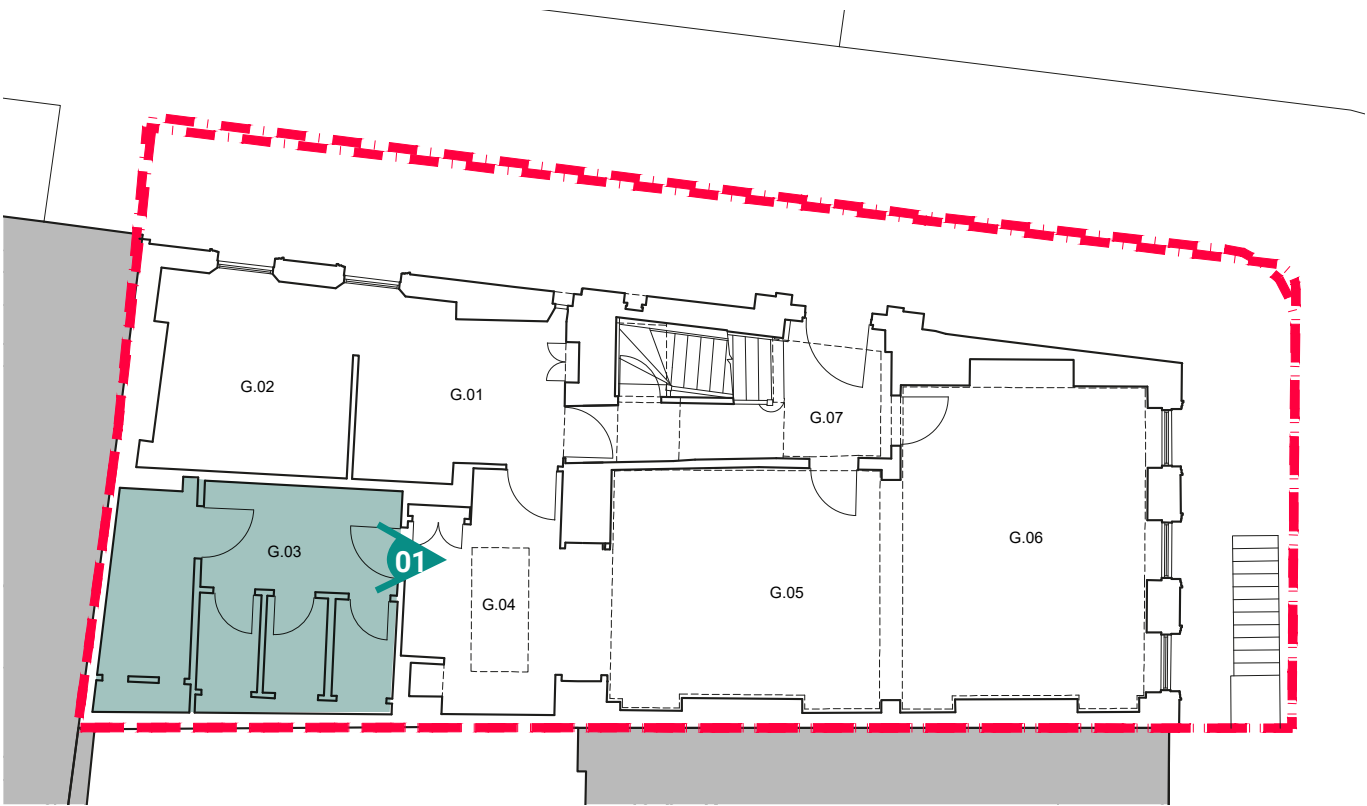
FIGURE 08 ROOM G.03

LOCATION	DESCRIPTION	CONDITION / SCOPE OF REPAIR	COMMENTS
G.03	Ceiling / Cornice	Modern suspended ceiling	All to be adapted to suit layout of conversion to residential use
G.03	Floor	Modern vinyl covering concrete slab	All to be adapted to suit layout of conversion to residential use
G.03	Walls / Skirting	Modern partitions	All to be adapted to suit layout of conversion to residential use
G.03	Internal Doors	All are plain modern doors	All to be adapted to suit layout of conversion to residential use

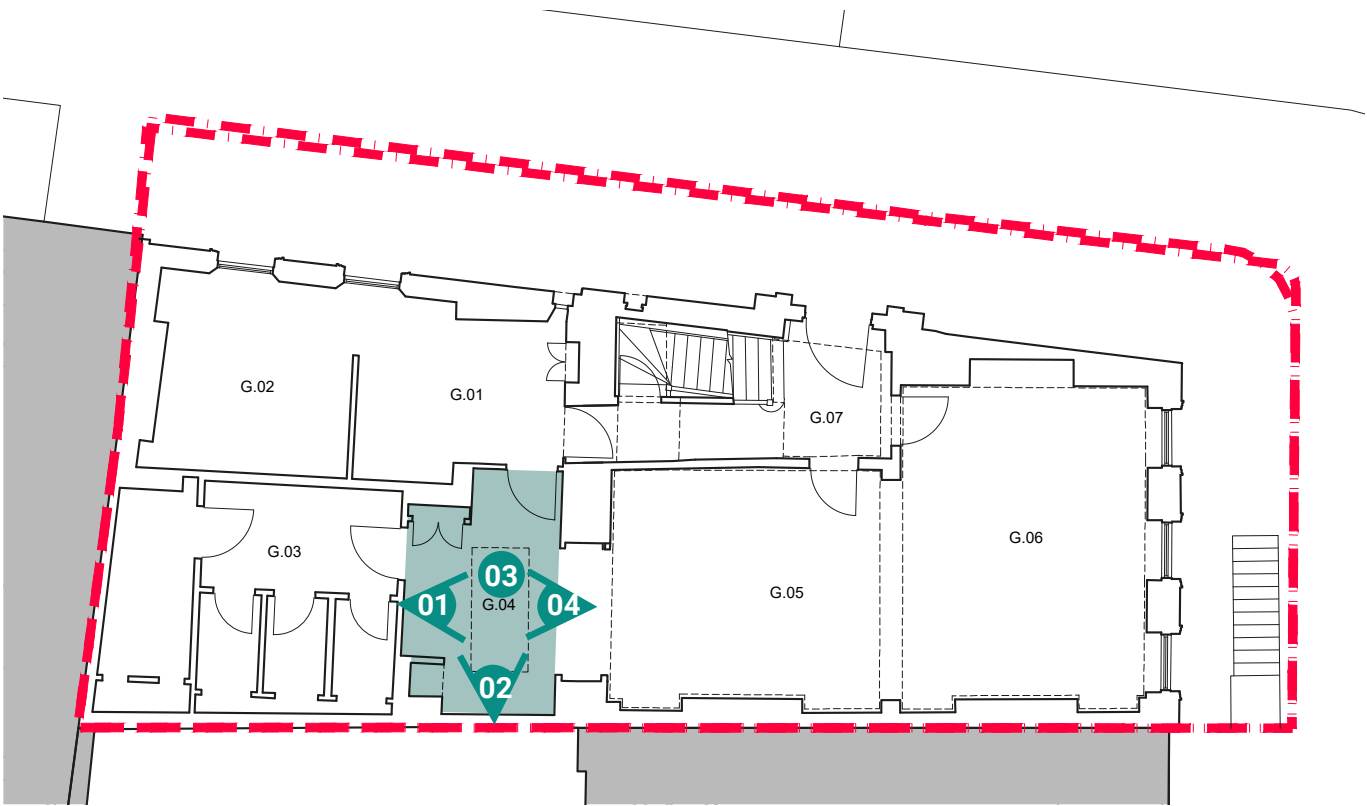
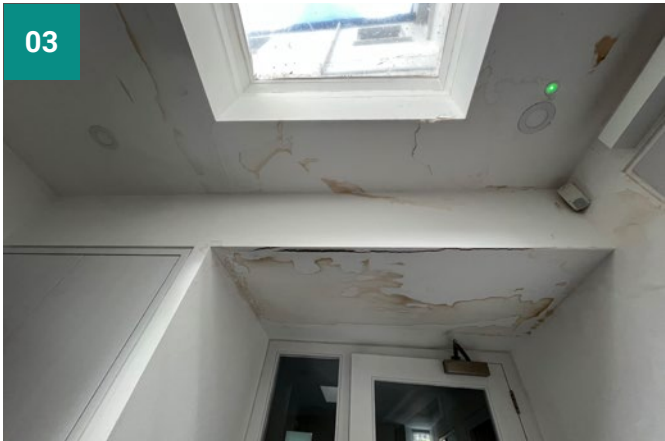
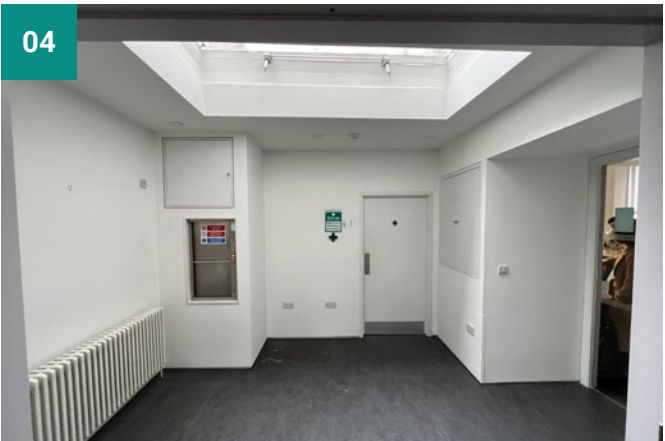
FIGURE 09 ROOM G.04

LOCATION	DESCRIPTION	CONDITION / SCOPE OF REPAIR	COMMENTS
G.04	Ceiling / Cornice	<ul style="list-style-type: none">• Modern Suspended ceiling• No cornice• Modern plastic rooflight	All to be adapted to suit layout of conversion to residential use
G.04	Floor	Part carpet, part vinyl covering concrete slab	All to be adapted to suit layout of conversion to residential use
G.04	Walls / Skirting	<ul style="list-style-type: none">• Modern plasterboard• Modern skirting and panels	All to be adapted to suit layout of conversion to residential use
G.04	Windows	N/A	N/A
G.04	Internal Doors	Modern door with vision panel	All to be adapted to suit layout of conversion to residential use
G.04	Fireplace	Chimney breast present, no fireplace insert	All to be adapted to suit layout of conversion to residential use
G.04	Radiators	Tubular Radiators	All to be adapted to suit layout of conversion to residential use

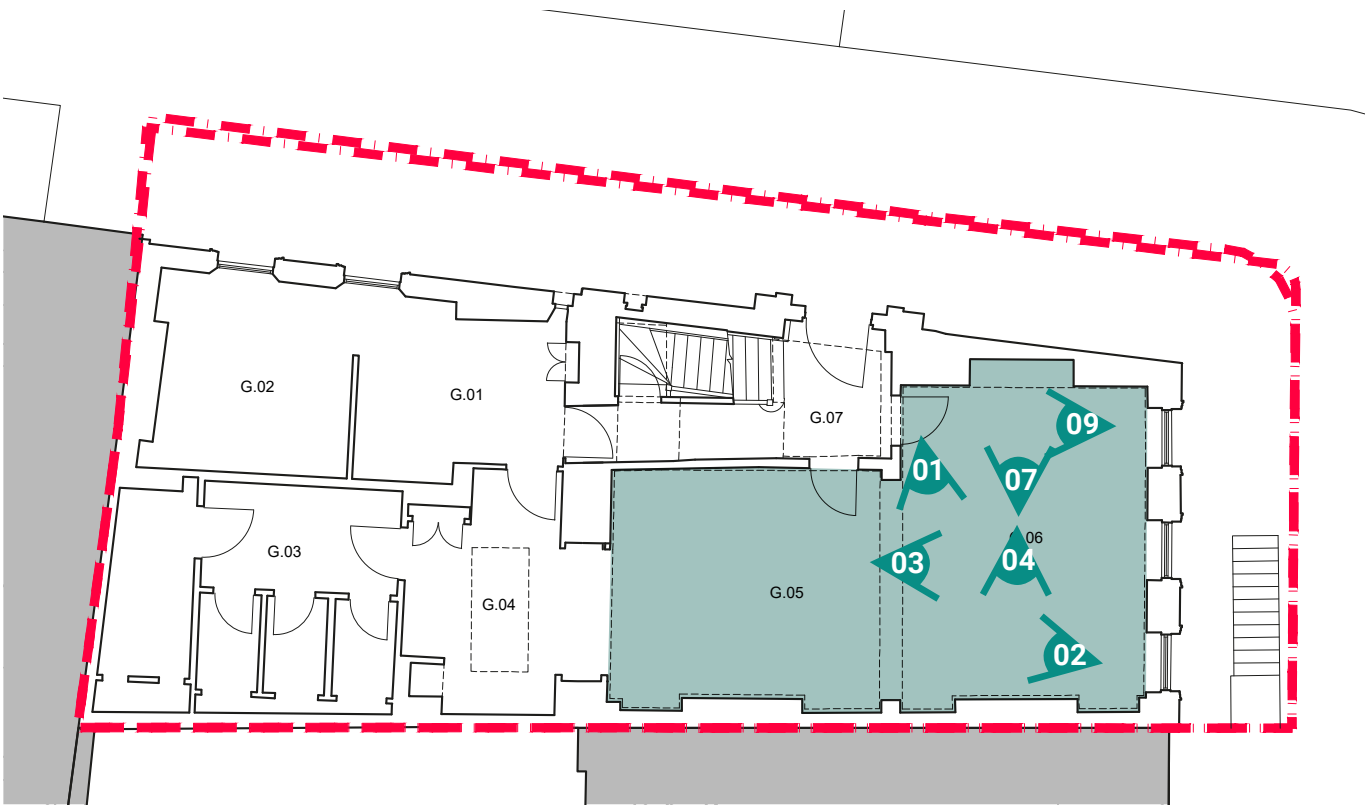
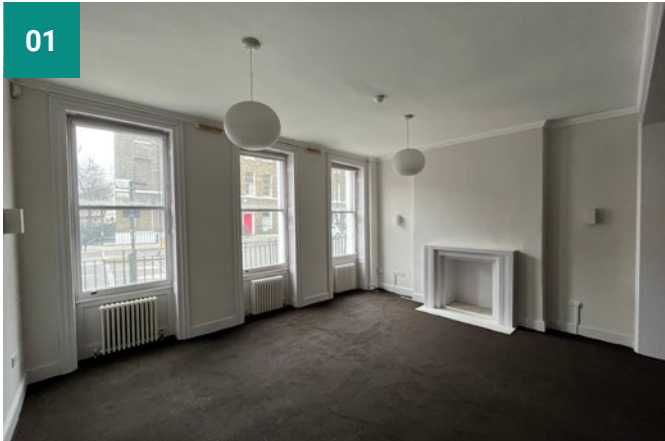
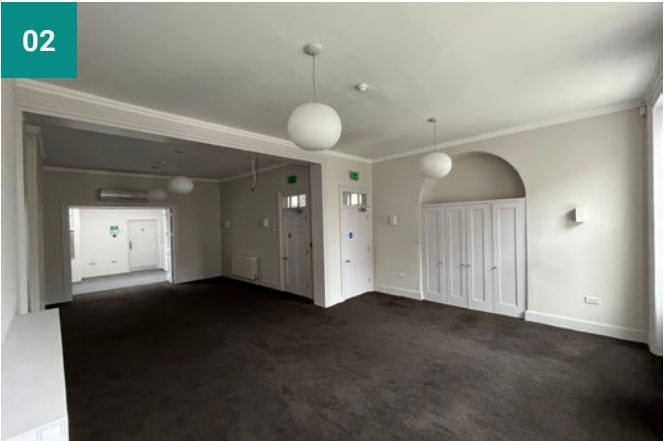
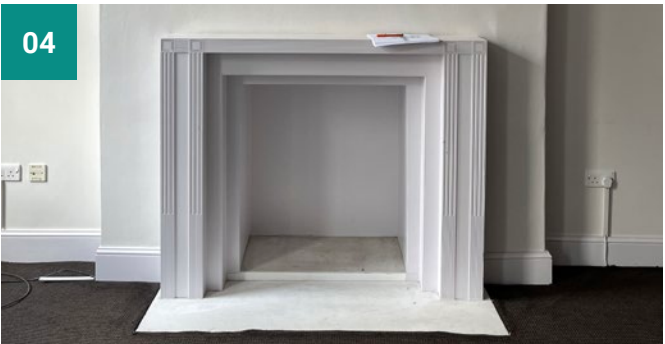
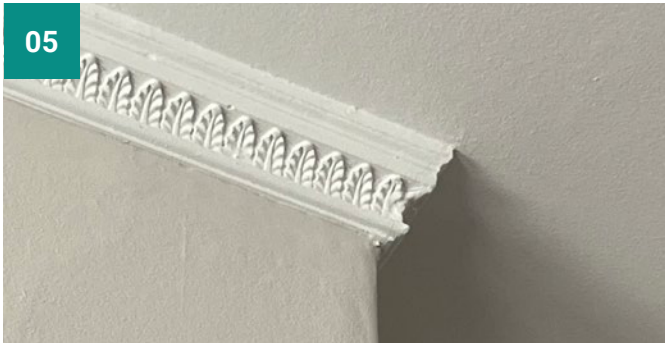
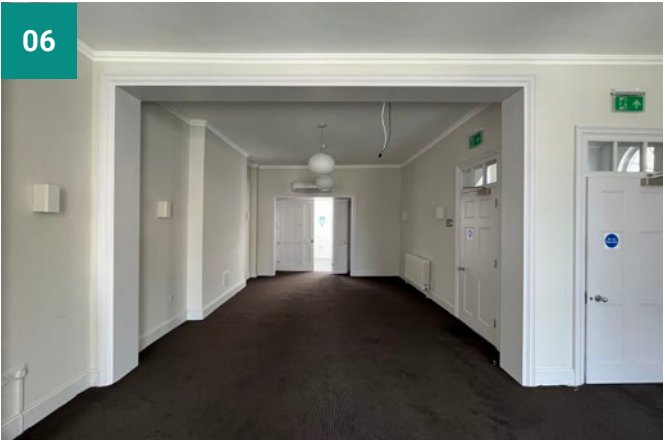
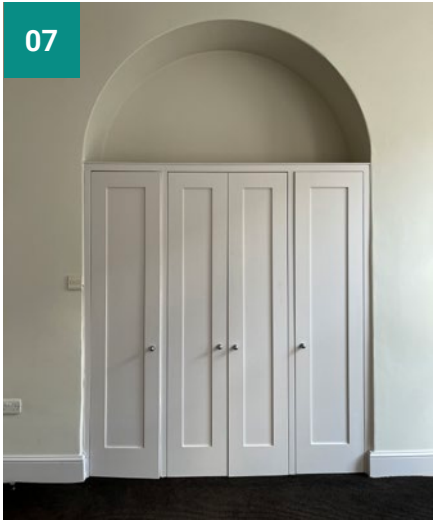
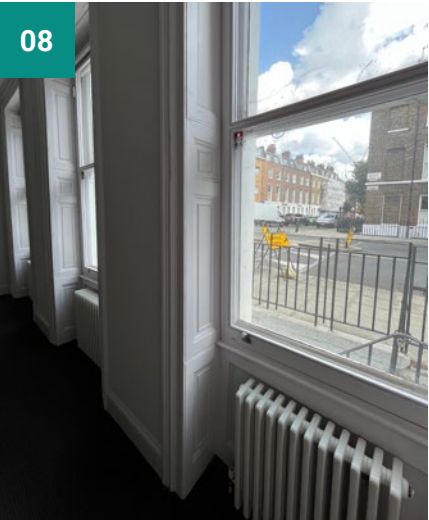
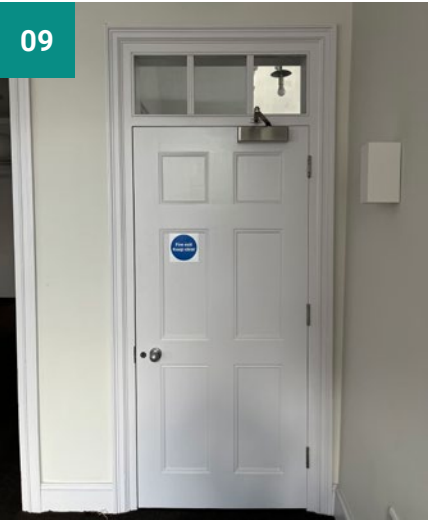
FIGURE 10 ROOM G.05 / G.06

LOCATION	DESCRIPTION	CONDITION / SCOPE OF REPAIR	COMMENTS
G.05 / G.06	Ceiling / Cornice	<ul style="list-style-type: none">Plasterboard ceilingCornice with floral pattern	<ul style="list-style-type: none">Ceiling and cornice to be repaired and redecorated
G.05 / G.06	Floor	Modern Carpet	Carpet to be stripped out renewed
G.05 / G.06	Walls / Skirting	<ul style="list-style-type: none">Plaster wallModern skirtingFrame to opening non original	Walls and skirting to be repaired and repainted
G.05 / G.06	Windows	Existing timber sash windows, single glazed and secondary glazing to be retained	Existing windows and secondary glazing repaired and redecorated, including architrves, cills, panelled reveals and panels below windows
G.05 / G.06	Internal Doors	Existing doors to stair/lobby retained Modern cupboard doors and screens to be removed	Existing doors to the stair lobby to be retained and refurbished including the fanlight above

G.05 / G.06	Fireplace	<ul style="list-style-type: none">G.06: Fireplace retainedG.05: Chimney breast present, no fireplace insert	G.05: Option to reinstate a reclaimed fireplace
G.05 / G.06	Radiators	Modern radiators beneath windows	Radiarors to be replaced

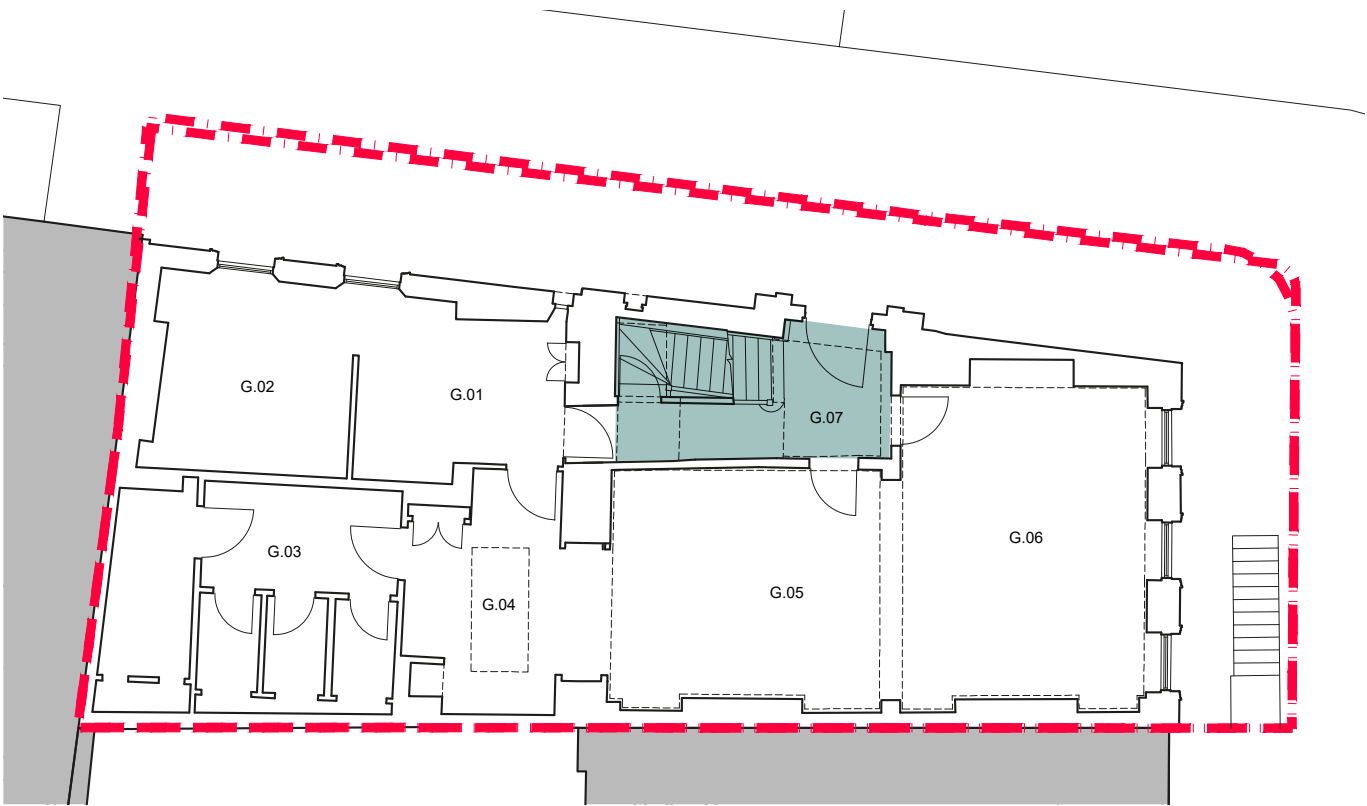
FIGURE 11 ROOM G.07

LOCATION	DESCRIPTION	CONDITION / SCOPE OF REPAIR	COMMENTS
G.07	Stairs	Modern balusters, but newel post & baluster handrail appears to be original components	<ul style="list-style-type: none">• Carpet removed and replaced• All joinery renovated
G.07	Floor	Chequer tile floor to be retained	Tiled floor to be repaired where needed and retained
G.07	Walls	White painted walls	To be made good and repainted
G.07	Ceiling	Modern plasterboard ceiling Cornice with floral pattern	Ceiling and cornice to be redecorated and retained

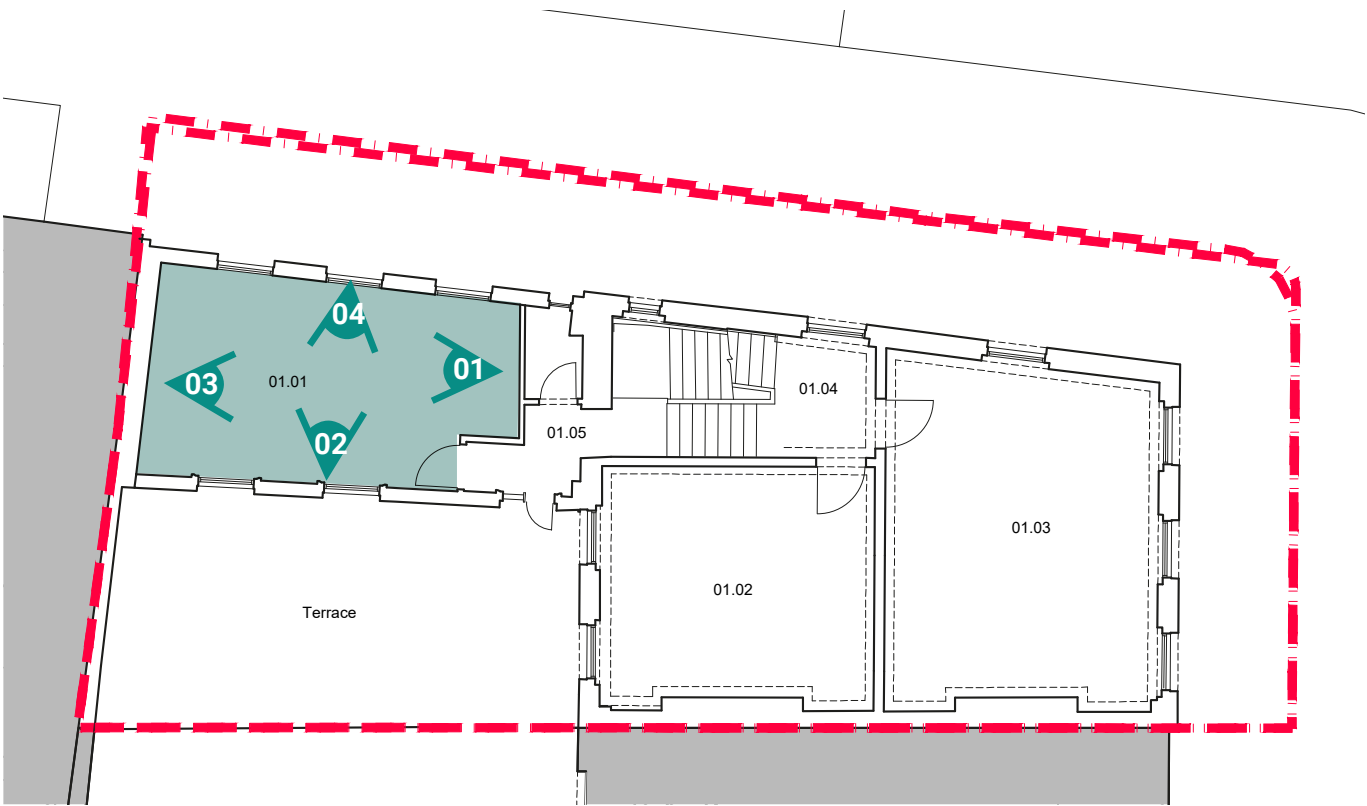
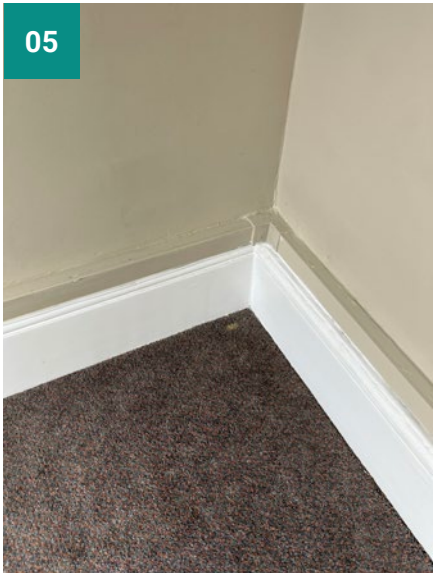
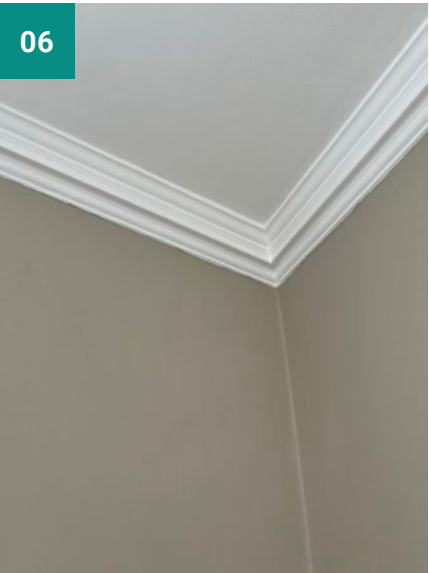
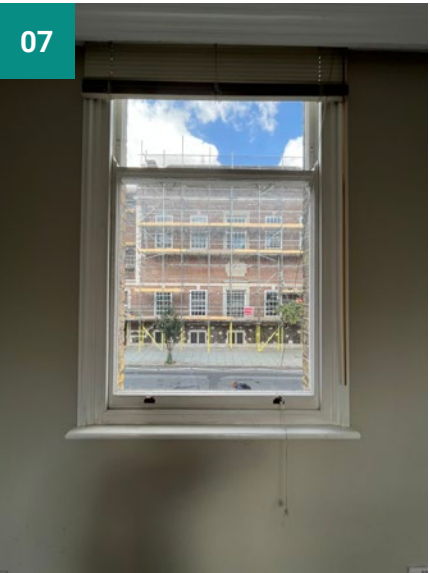
FIGURE 12 ROOM 01.01

LOCATION	DESCRIPTION	CONDITION / SCOPE OF REPAIR	COMMENTS
01.01	Ceiling / Cornice	<ul style="list-style-type: none">• Modern plasterboard ceiling and cornice• Ceiling bulkhead covering part of existing window	All to be adapted to suit layout of conversion to residential use

01.01	Floor	Modern carpet covering timber floor	All to be adapted to suit layout of conversion to residential use
01.01	Walls / Skirting	<ul style="list-style-type: none">• Plasterboard walls• Modern skirting• Electrical plastic conduit running above skirting	All to be adapted to suit layout of conversion to residential use

01.01	Windows	Surface mounted slideing timber sash windows, single glazed to be retained	<ul style="list-style-type: none">• Windws to be refurbished and redecorated with new secondary glazing installed• Windows to the rear to be replaced to enable extension

01.01	Internal Doors	Modern doors to be retaned for possible reuse	Doors to be retained, refurbished for possible reuse
01.01	Radiators	Modern double panel radiators	Radiators to be removed and replaced
