/ 8 GUILFORD STREET ROOM SCHEDULE

6569

REV 01

26/09/2023

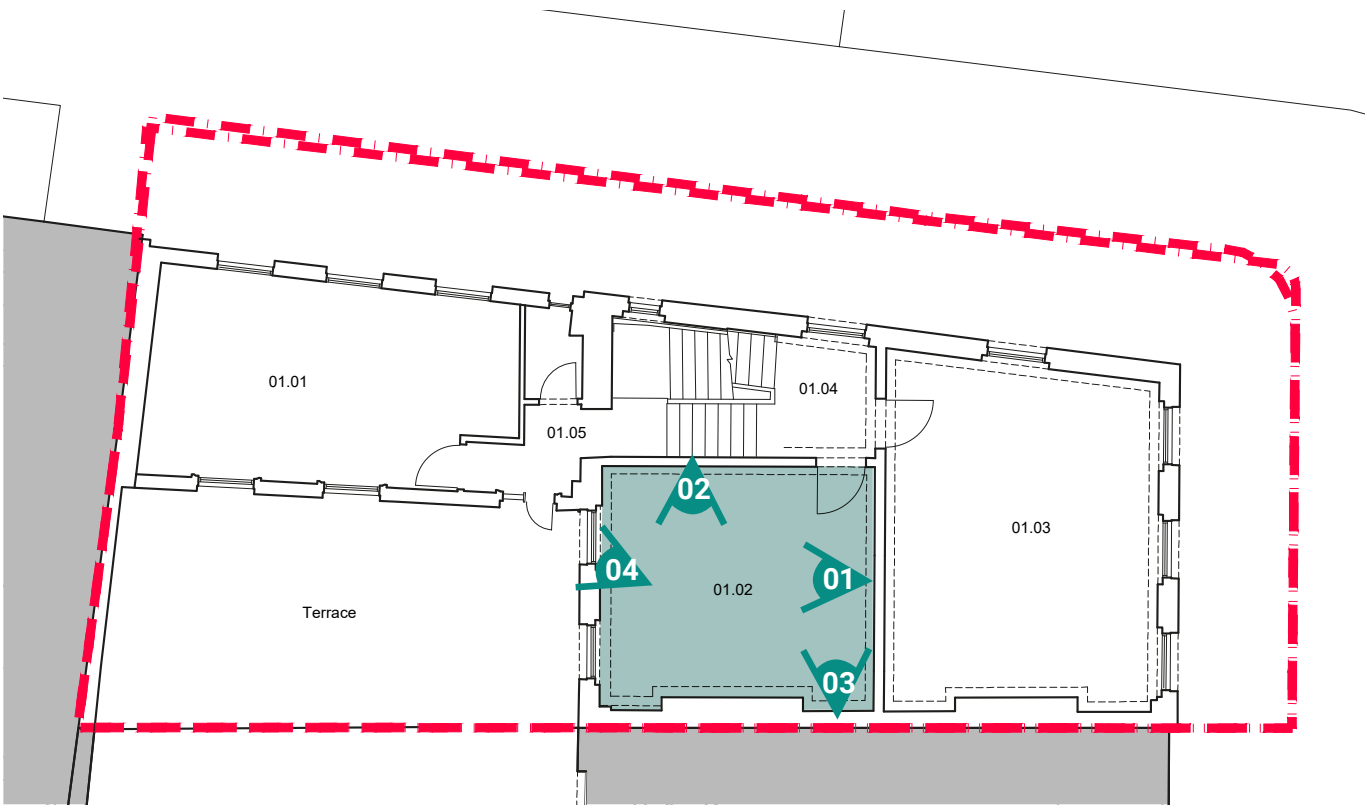
FIGURE 13 ROOM 01.02

The finishes to the walls and ceiling in this room are all in poor condition.

LOCATION	DESCRIPTION	CONDITION / SCOPE OF REPAIR	COMMENTS
01.02	Ceiling / Cornice	Ceiling and cornice in poor condition	All to be retained (where possible), refurbished and redecorated

01.02	Floor	Modern carpet covering floor - to be inspected to confirm condition	Depending on floor quality either sand and stain or replace floor with new boards. joists to be inspected

01.02	Walls / Skirting	<ul style="list-style-type: none">• Poor condition• Skirting to be retained	<ul style="list-style-type: none">• All to be retained (where possible), refurbished and redecorated• All surface mounted fixtures, fixings and services to be removed

01.02	Windows	<ul style="list-style-type: none">• Traditional timber sash windows, single glazed to be retained.• Extremely poor condition, stuck and covered in several layers of painting. Most timber forming the bars seems to be rotten and beyond repairable state	Repair where possible, and replace components beyond repair

01.02	Internal Doors	Six panel door to stair retained	Retained and refurbished, ironmongery to be replaced
01.02	Radiators	Double panel metal radiato beneath windows	Replaced and renewed

All will be retained (where possible), refurbished and redecorated

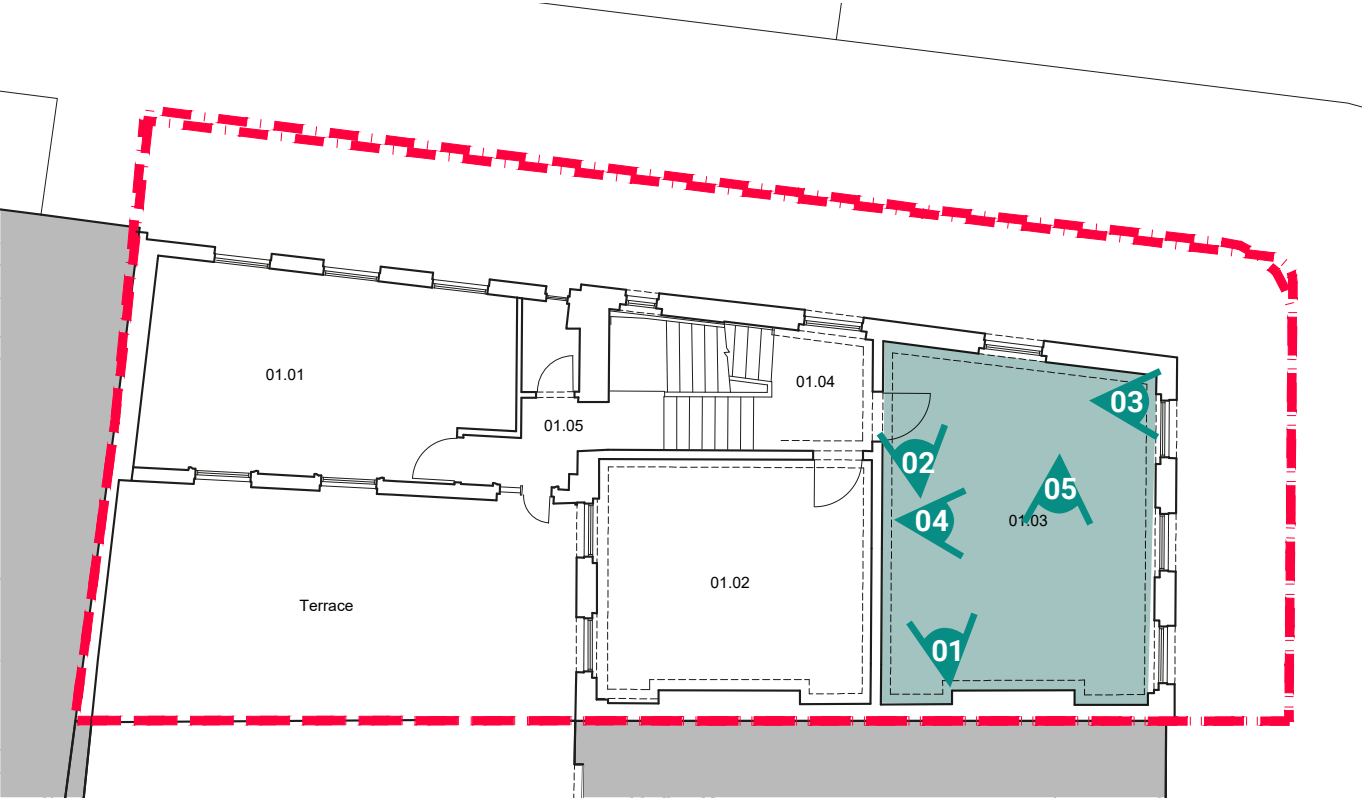
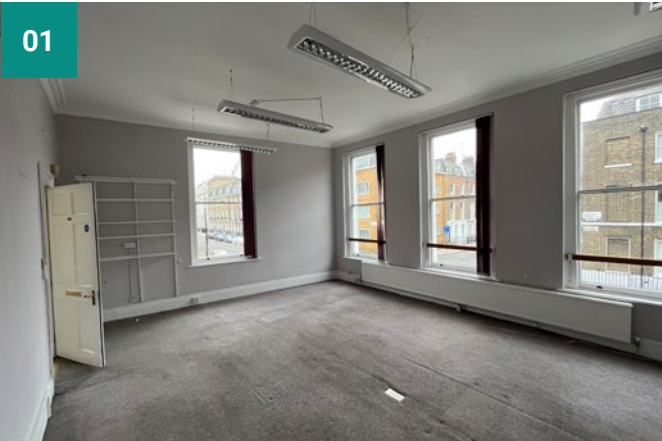
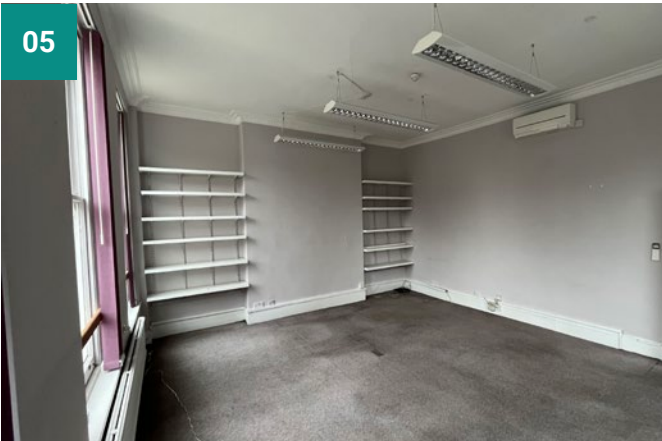
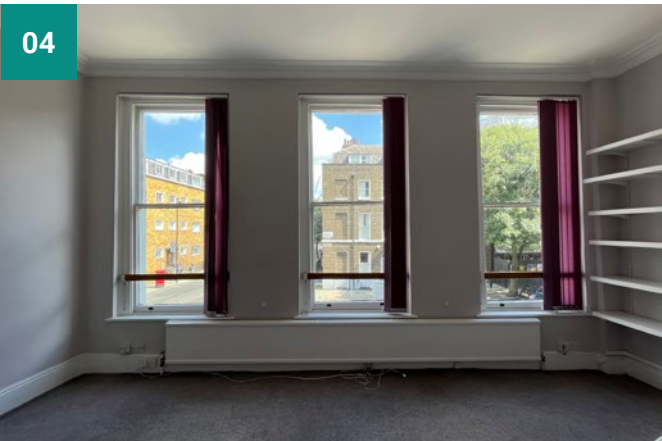
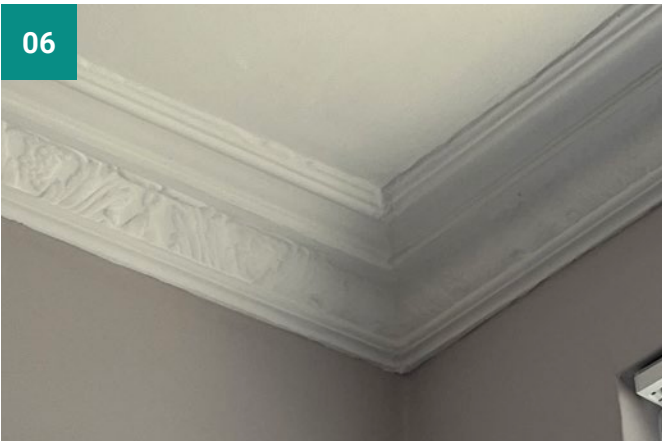
FIGURE 14 ROOM 01.03

LOCATION	DESCRIPTION	CONDITION / SCOPE OF REPAIR	COMMENTS
01.03	Ceiling / Cornice	Plaster ceiling and cornice retained	<ul style="list-style-type: none">All to be repaired and redecorated

01.03	Floor	<ul style="list-style-type: none">Modern carpetfloor to be inspected to confirm condition below carpet	Renew floor finishes
01.03	Walls / Skirting	<ul style="list-style-type: none">Plaster wall and skirting retainedElectrical plastic conduit running above skirting	<ul style="list-style-type: none">Walls to be repaired and redecoratedConduit to be stripped outAll wiring to de concealed under floor/ceiling/walls

01.03	Windows	<ul style="list-style-type: none">Existing sliding sash windows, single glazed retained. Windows are covered in several layers of painting.	<ul style="list-style-type: none">To be refurbished and redecorated (where possible)Secondary glazing to be installed

01.03	Internal Doors	Existing timber door retained	To be retained and redecorated with new ironmongery
01.03	Radiators	Double panel metal radiator	Radiators to be removed and replaced

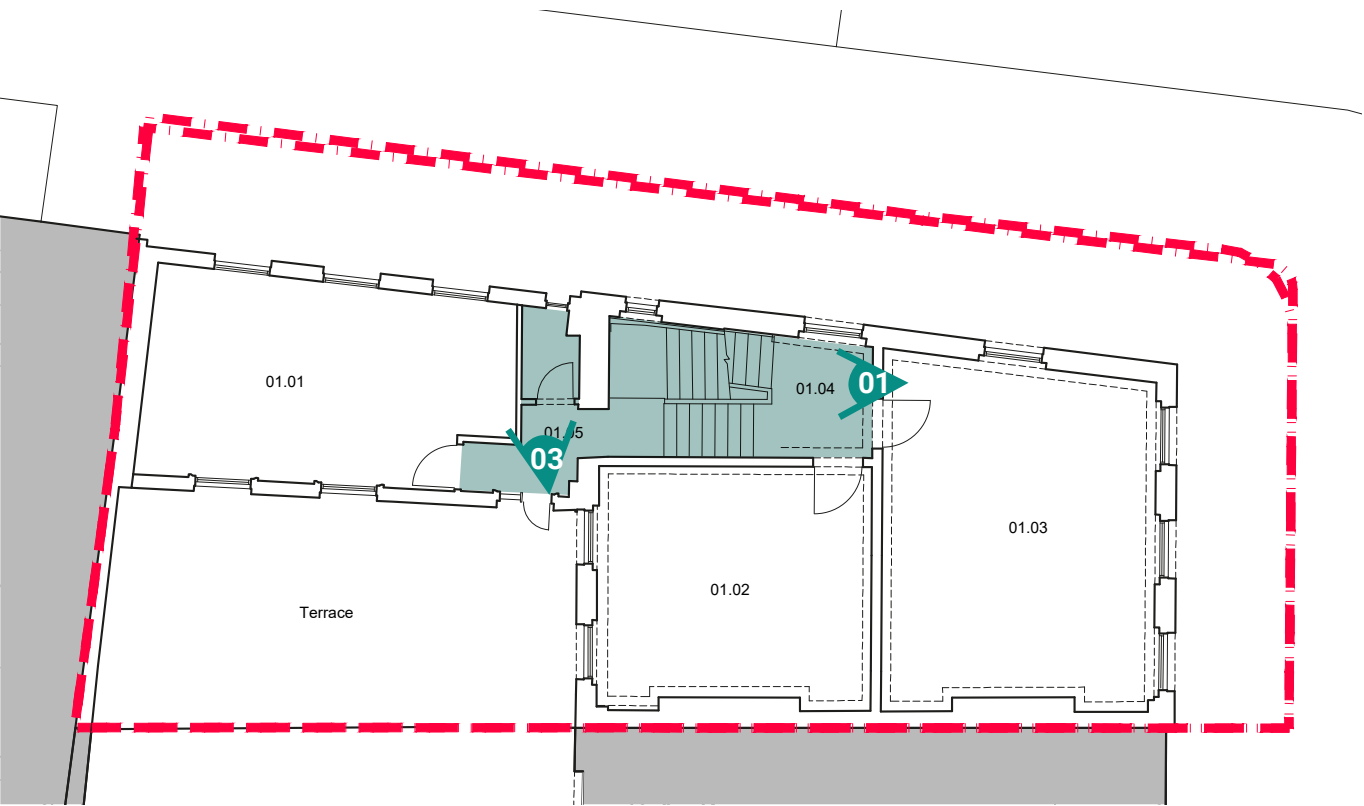
FIGURE 15 ROOM 01.04 - 01.05

Room 01.05: This modern toilet fitout will be removed entirely to suit new residential layout

LOCATION	DESCRIPTION	CONDITION / SCOPE OF REPAIR	COMMENTS
01.04	Stairs	Steps covered with modern new carpet	Carpet to be removed and replaced
01.04	Railings	Handrail to baluster and newel posts appear to be original elements, but the balusters appear to be modern	All to be retained and refurbished
01.04	Floor	Modern carpet	Carpet to be removed and replaced
01.04	Walls	Painted plaster walls	To be made good and repainted
01.05	Toilet		To be removed

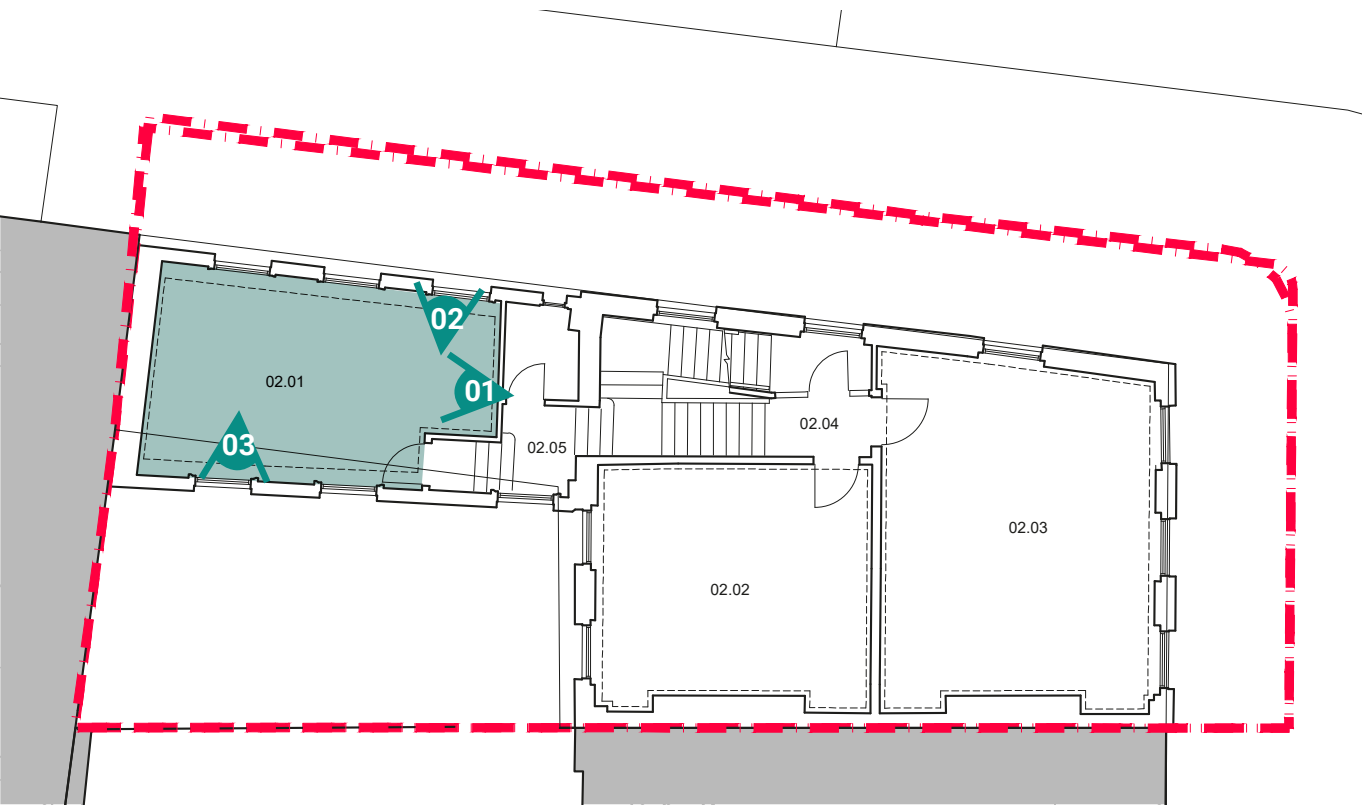
FIGURE 16 ROOM 02.01

LOCATION	DESCRIPTION	CONDITION / SCOPE OF REPAIR	COMMENTS
02.01	Ceiling / Cornice	<ul style="list-style-type: none">• Modern plasterboard ceiling and cornice• Ceiling bulkhead covering part of existing window	All to be adapted to suit layout of conversion to residential use

02.01	Internal Doors	Modern doors to be retaned for possible reuse	Doors to be retained, refurbished for possible reuse
02.01	Radiators	Modern double panel radiators	Radiators to be removed and replaced

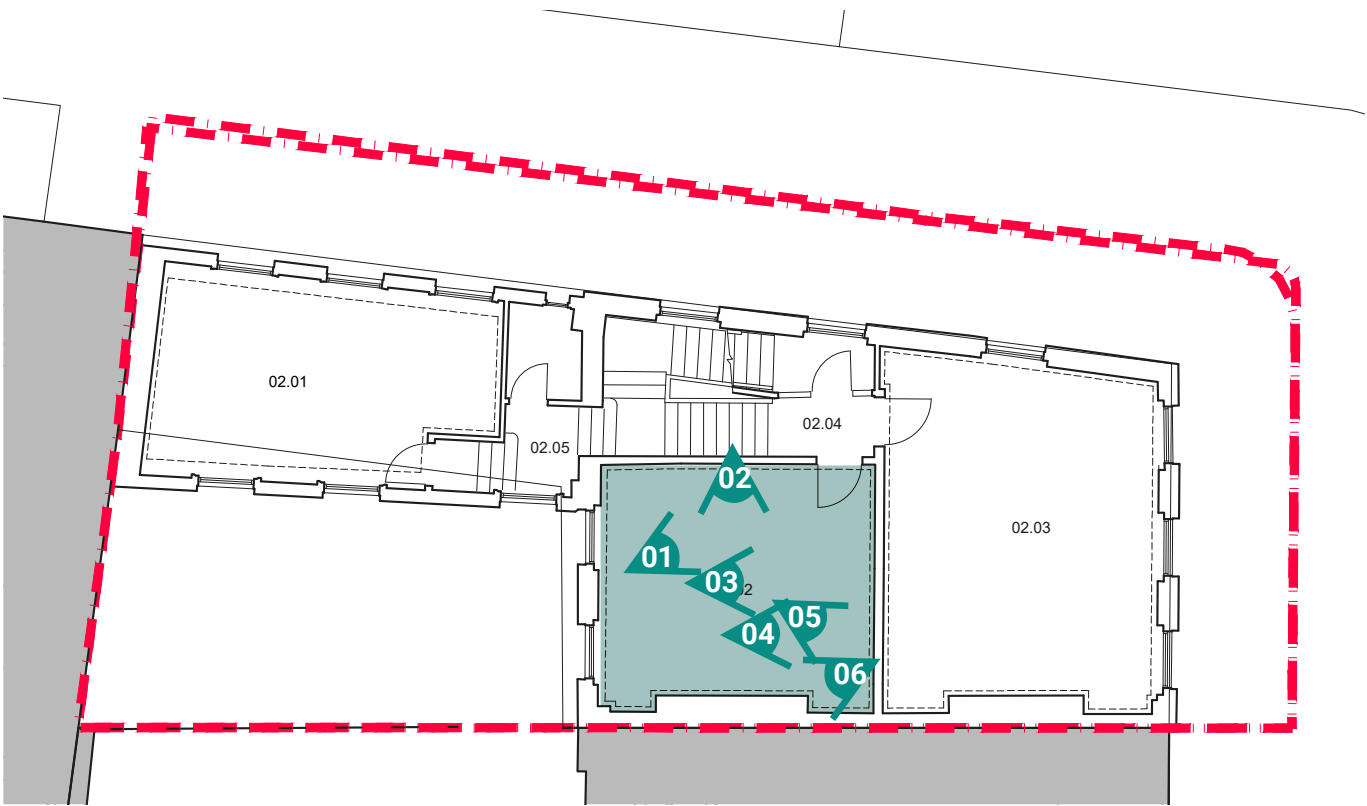
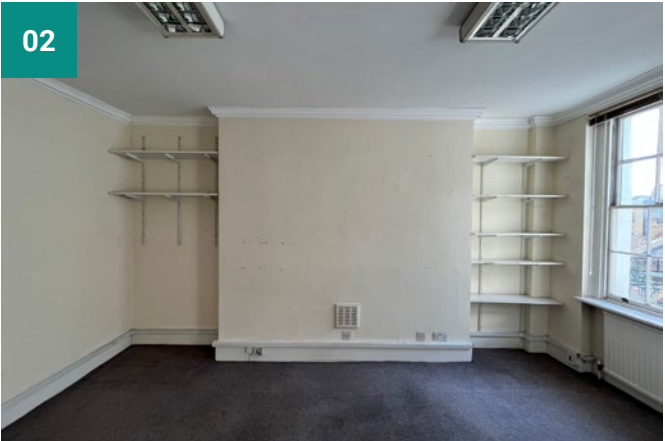
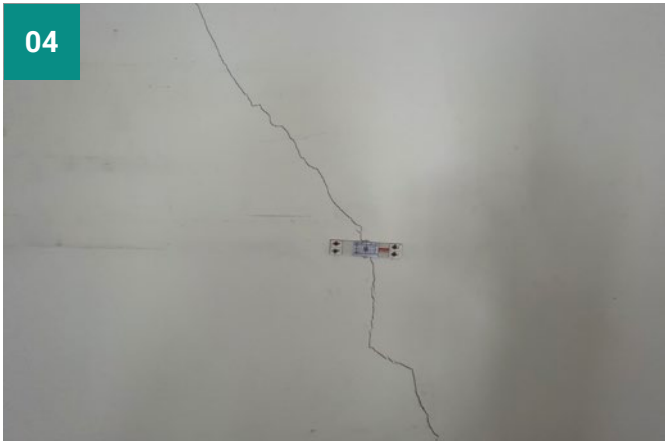
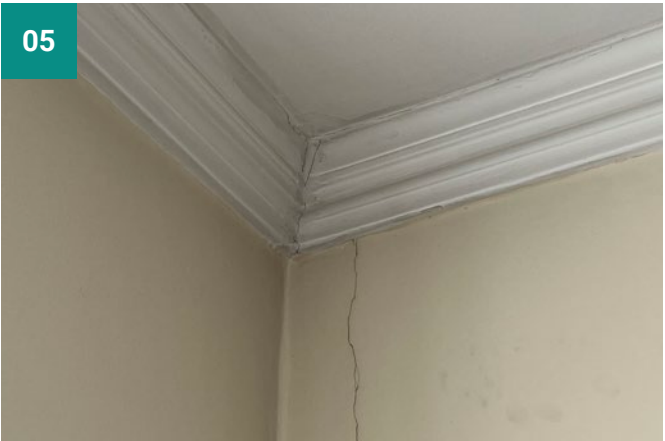
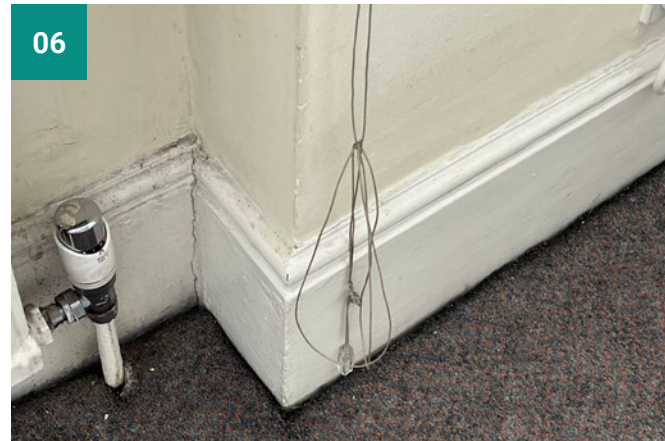
FIGURE 17 ROOM 02.02

LOCATION	DESCRIPTION	CONDITION / SCOPE OF REPAIR	COMMENTS
02.02	Ceiling / Cornice	Ceiling and cornice in poor condition	All to be retained (where possible), refurbished and redecorated

02.02	Floor	Modern carpet covering floor - to be inspected to confirm condition	Depending on floor quality either sand and stain or replace floor with new boards. joists to be inspected

02.02	Walls / Skirting	<ul style="list-style-type: none">• Poor condition• Skirting to be retained	<ul style="list-style-type: none">• All to be retained (where possible), refurbished and redecorated• All surface mounted fixtures, fixings and services to be removed

02.02	Windows	<ul style="list-style-type: none">• Traditional timber sash windows, single glazed to be retained.• Extremely poor condition, stuck and covered in several layers of painting. Most timber forming the bars seems to be rotten and beyond repairable state	Repair where possible, and replace components beyond repair

02.02	Internal Doors	Six panel door to stair retained	Retained and refurbished, ironmongery to be replaced
02.02	Radiators	Double panel metal radiato beneath windows	Replaced and renewed

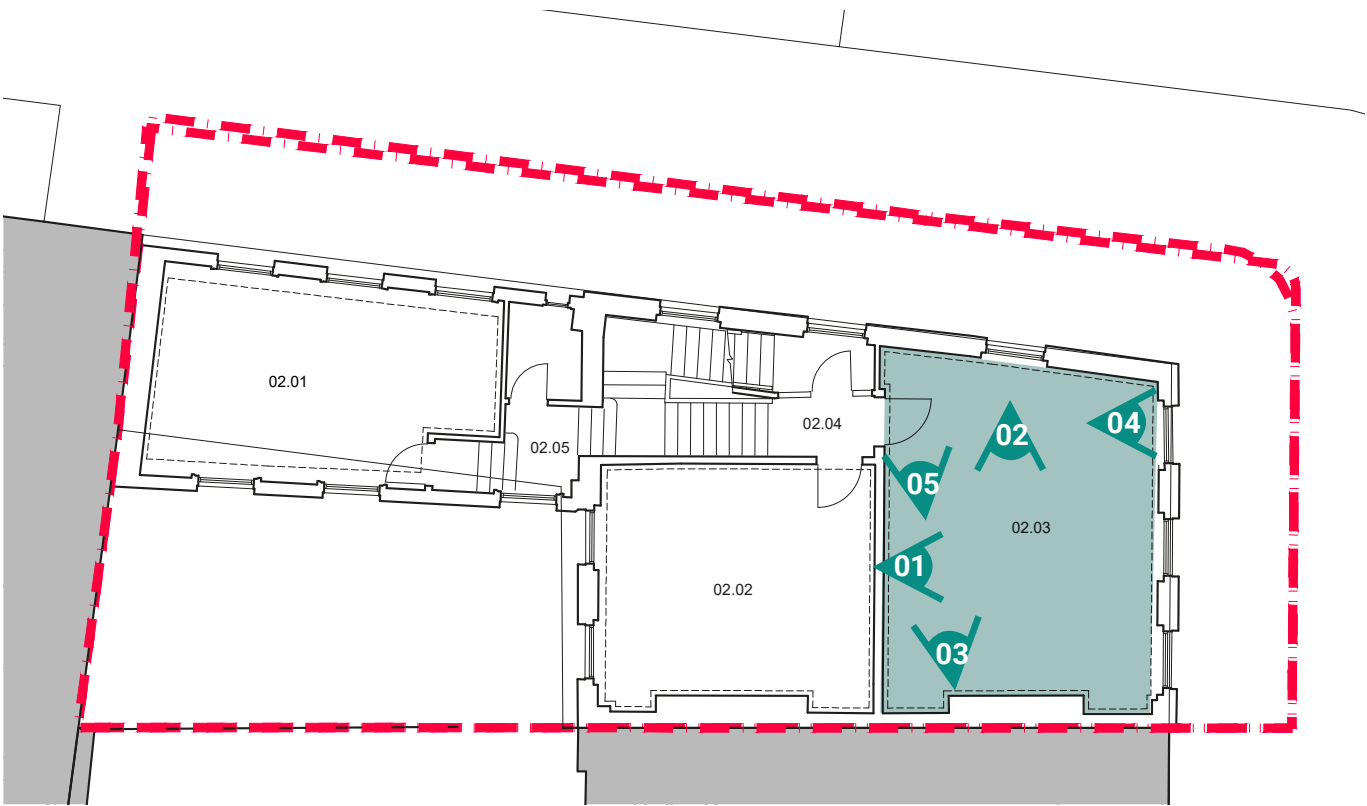
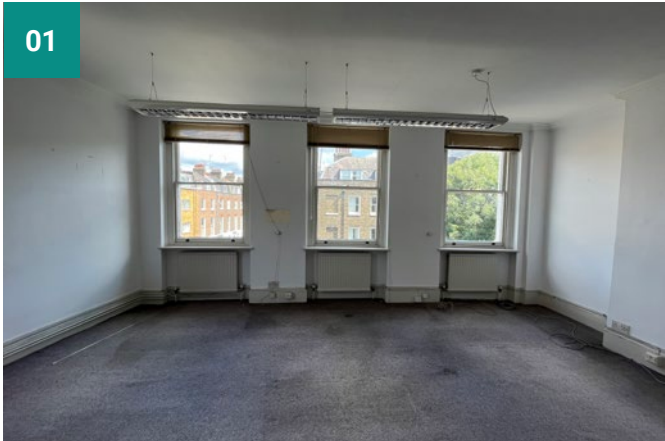
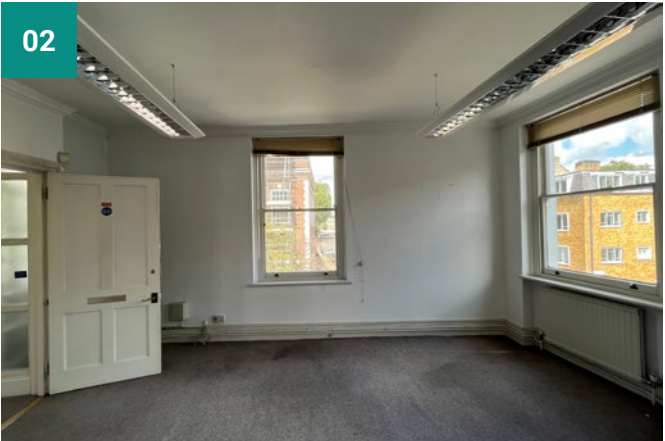
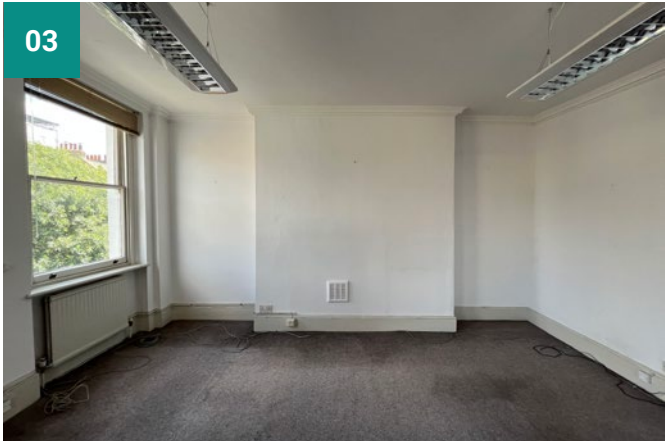
FIGURE 18 ROOM 02.03

LOCATION	DESCRIPTION	CONDITION / SCOPE OF REPAIR	COMMENTS
02.03	Ceiling / Cornice	Plaster ceiling and cornice retained	<ul style="list-style-type: none">All to be repaired and redecorated

02.03	Floor	<ul style="list-style-type: none">Modern carpetfloor to be inspected to confirm condition below carpet	Renew floor finishes
02.03	Walls / Skirting	<ul style="list-style-type: none">Plaster wall and skirting retainedElectrical plastic conduit running above skirting	<ul style="list-style-type: none">Walls to be repaired and redecoratedConduit to be stripped outAll wiring to de concealed under floor/ceiling/walls

02.03	Internal Doors	Existing timber door retained	To be retained and redecorated with new ironmongery
02.03	Radiators	Double panel metal radiator	Radiators to be removed and replaced

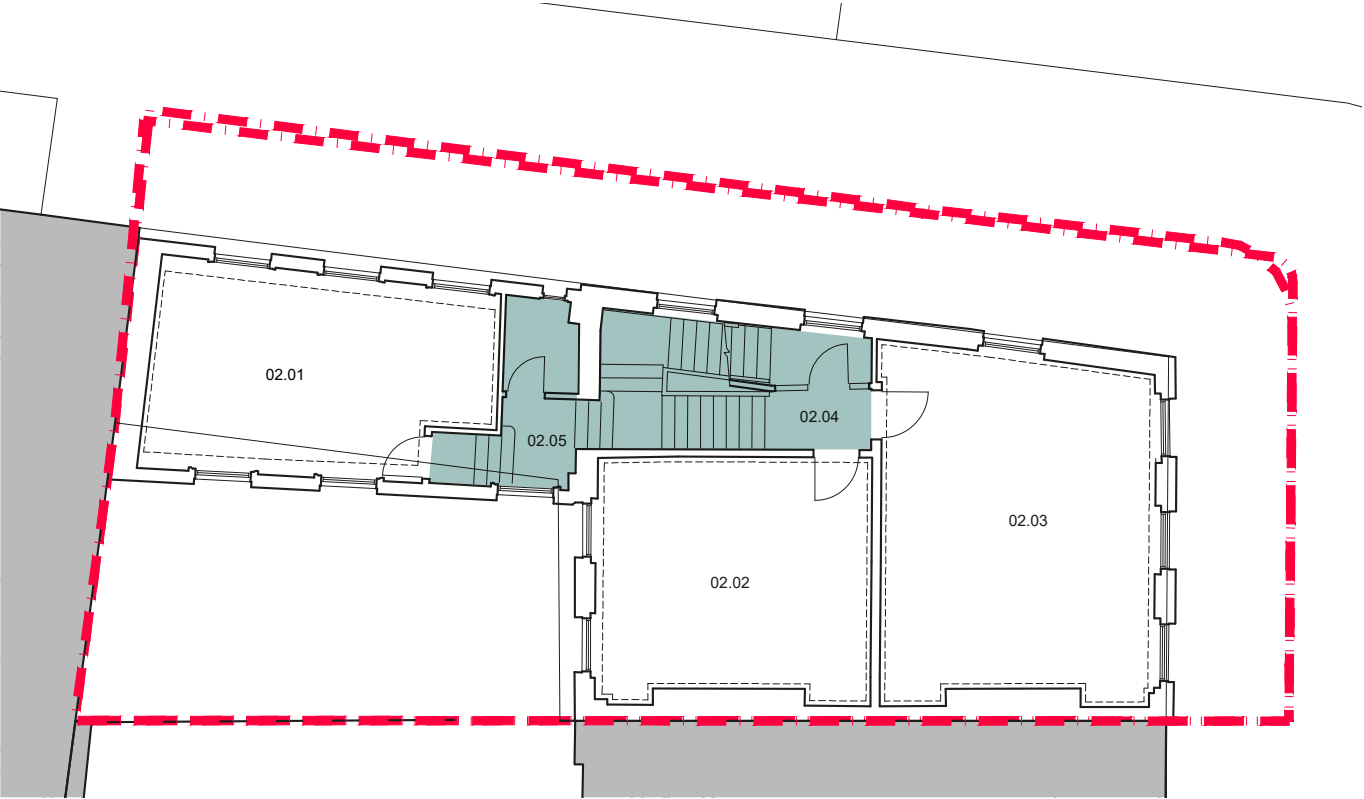
FIGURE 19 ROOM 02.04 / 02.05

LOCATION	DESCRIPTION	CONDITION / SCOPE OF REPAIR	COMMENTS
02.04	Stairs	Steps covered with modern new carpet	Carpet to be removed and replaced
02.04	Railings	Handrail to baluster and newel posts appear to be original elements, but the balusters appear to be modern	All to be retained and refurbished
02.04	Floor	Modern carpet	Carpet to be removed and replaced
02.04	Walls	Painted plaster walls	To be made good and repainted
02.05	Toilet		To be removed
02.04	Glazed Partition	Modern timber framed obscured glass partition	To be removed

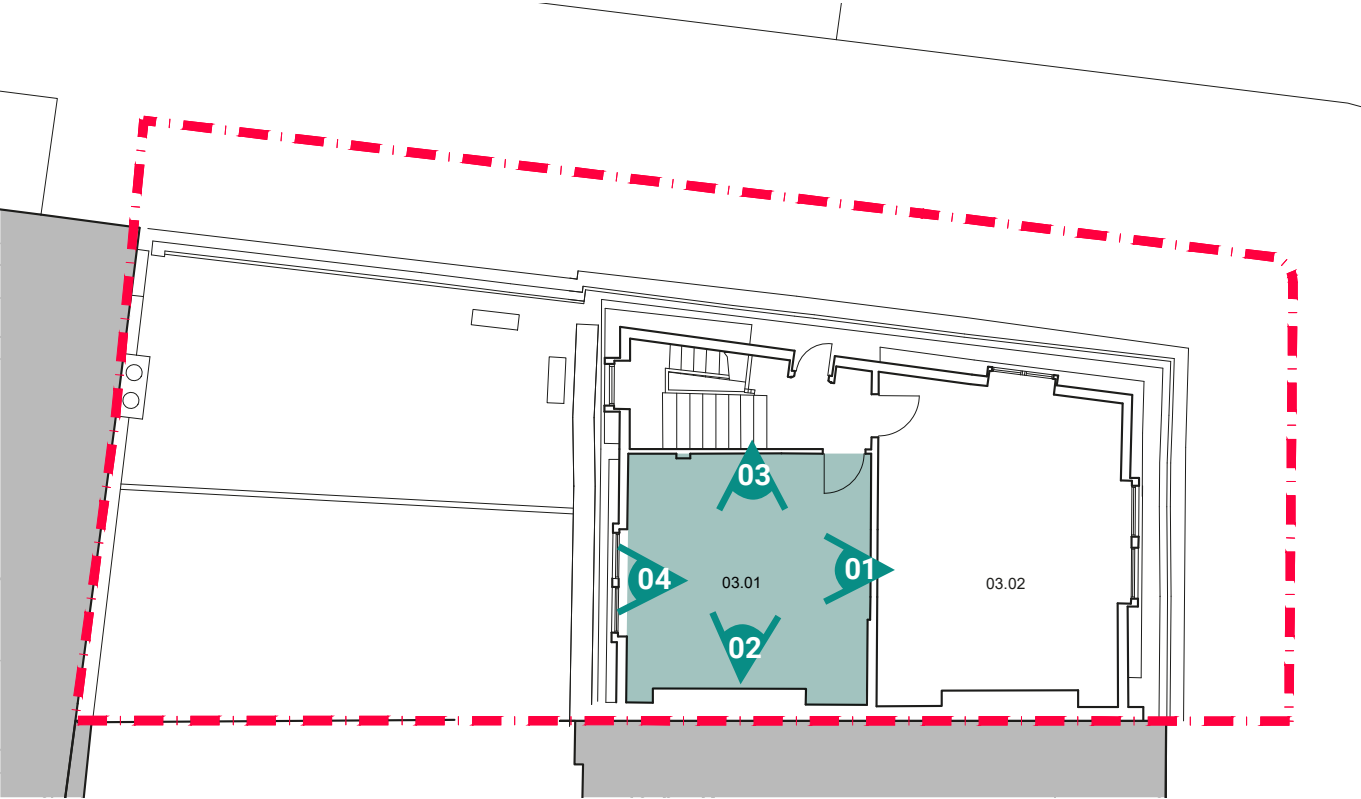
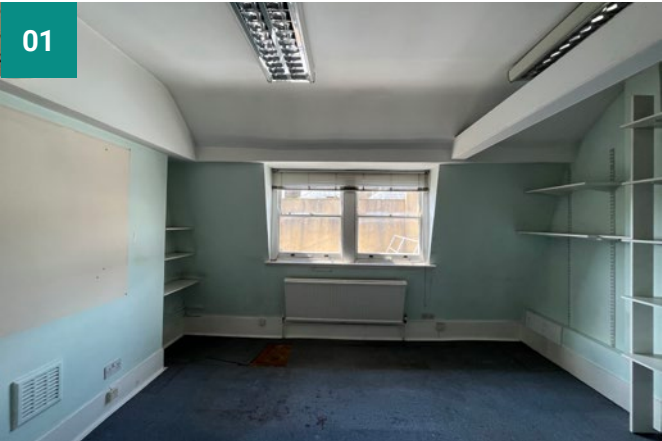
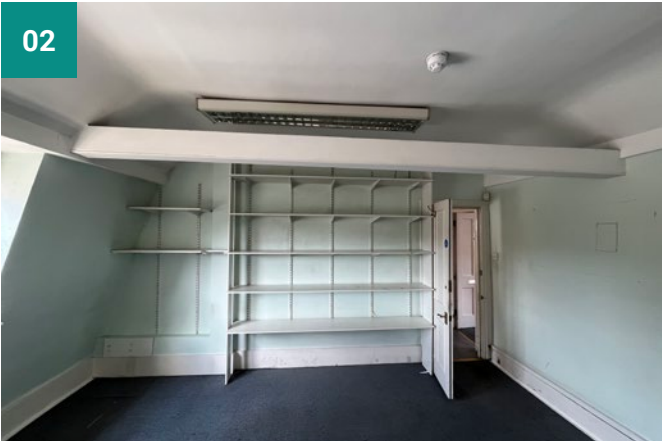
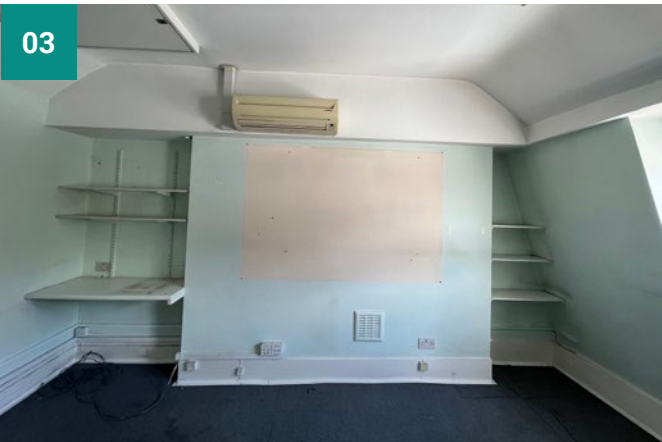
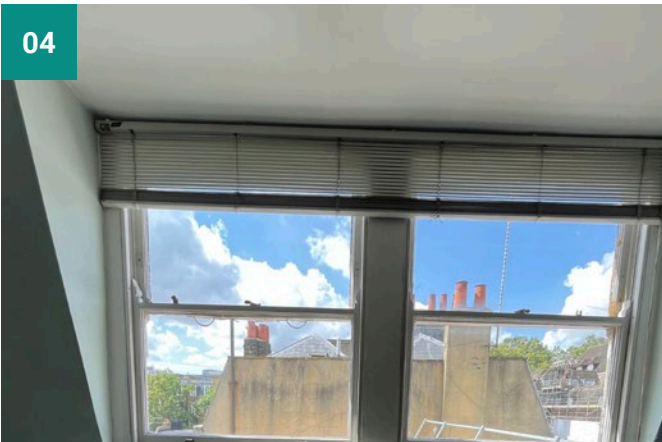
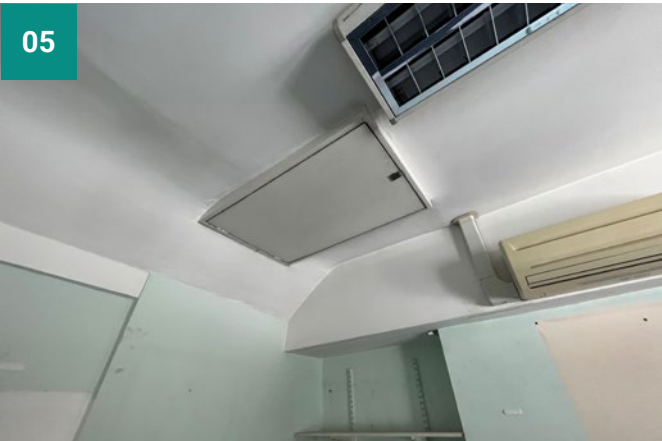
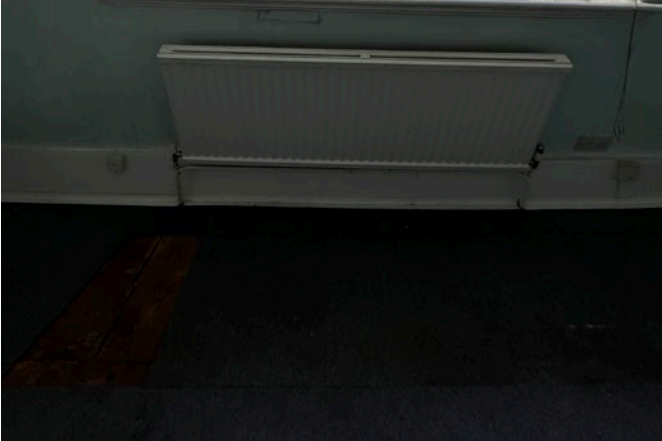
FIGURE 20 ROOM 03.01

LOCATION	DESCRIPTION	CONDITION / SCOPE OF REPAIR	COMMENTS
03.01	Ceiling	<ul style="list-style-type: none">• Modern lasterboard ceiling and cornice• Ceiling bulkhead covering part of existing window	All to be adapted to suit layout of conversion to residential use

03.01	Floor	Modern carpet covering timber floor	All to be adapted to suit layout of conversion to residential use
03.01	Walls / Skirting	<ul style="list-style-type: none">• Plasterboard walls• Modern skirting• Electrical plastic conduit running above skirting	All to be adapted to suit layout of conversion to residential use

03.01	Internal Doors	Modern doors to be retaned for possible reuse	Doors to be retained, refurbished for possible reuse
03.01	Radiators	Modern double panel radiators	Radiators to be removed and replaced

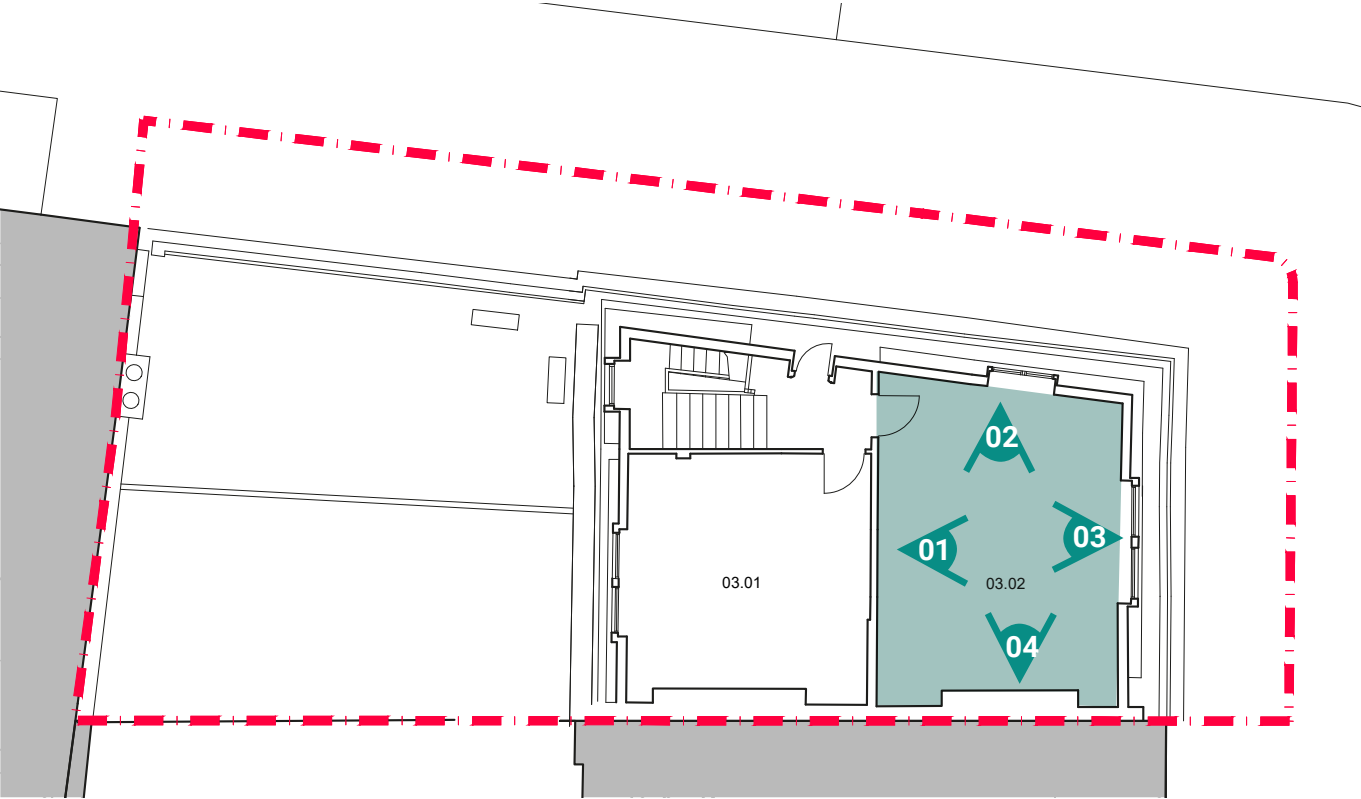
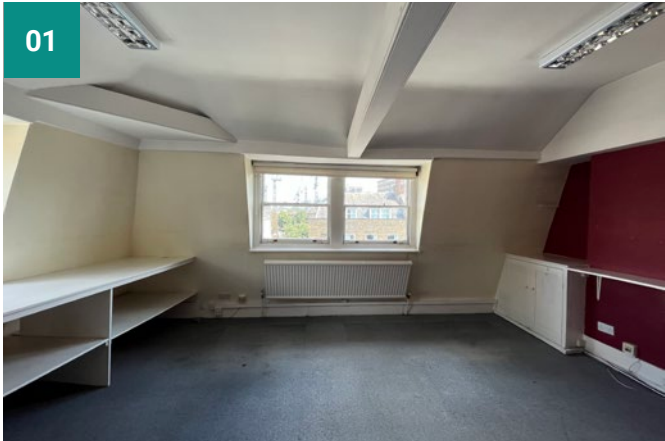
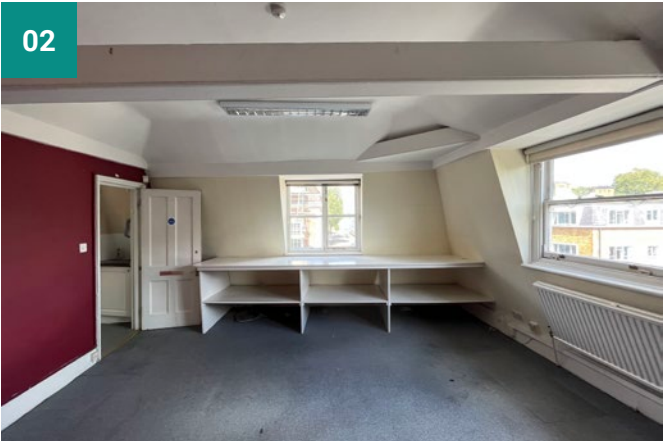
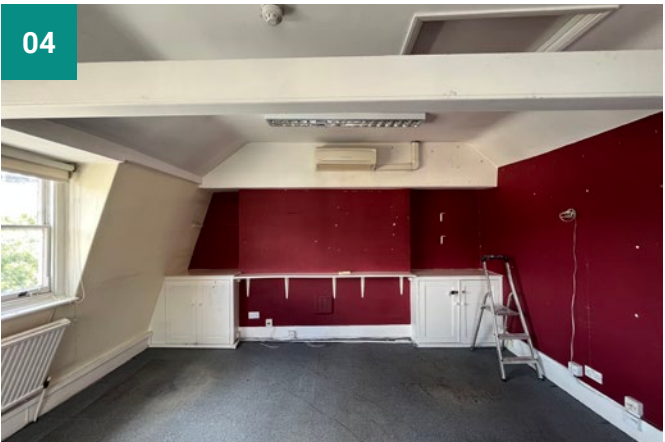
FIGURE 21 ROOM 03.02

LOCATION	DESCRIPTION	CONDITION / SCOPE OF REPAIR	COMMENTS
03.02	Ceiling / Cornice	Ceiling and cornice in poor condition	All to be retained (where possible), refurbished and redecorated

03.02	Floor	Modern carpet covering floor - to be inspected to confirm condition	Depending on floor quality either sand and stain or replace floor with new boards. joists to be inspected

03.02	Walls / Skirting	<ul style="list-style-type: none">• Poor condition• Skirting to be retained	<ul style="list-style-type: none">• All to be retained (where possible), refurbished and redecorated• All surface mounted fixtures, fixings and services to be removed

03.02	Windows	<ul style="list-style-type: none">• Traditional timber sash windows, single glazed to be retained.• Extremely poor condition, stuck and covered in several layers of painting. Most timber forming the bars seems to be rotten and beyond repairable state	Repair where possible, and replace components beyond repair

03.02	Internal Doors	Six panel door to stair retained	Retained and refurbished, ironmongery to be replaced
03.02	Radiators	Double panel metal radiator beneath windows	Replaced and renewed
