From: Joshua Cheung <Joshua.Cheung@camden.gov.uk>
Sent: Wednesday, May 17, 2023 9:22:23 AM
To: Hassan Howlader <hassan@sohoha.org.uk>
Subject: RE: EN23/0247: DO NOT IGNORE: CAMDEN COUNCIL ENFORCEMENT

22 Montague Street, London, WC1B 5BH Our Ref: EN23/0247 Date: 28th June 2023

Our ref: 2882-r1-230718-Report
18 July 2023
by email (hassan@sohoha.org.uk)

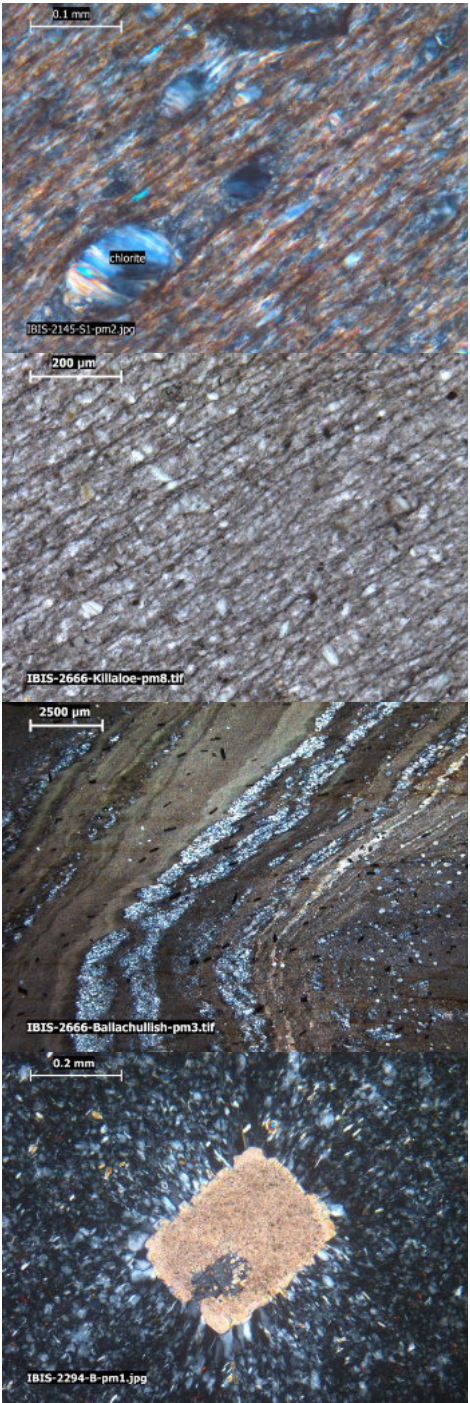
Greaves Welsh slate with chlorite lenses floating in a mass of phyllosilicate minerals. There is rutile and a strong secondary splitting direction.

Killaloe Irish slate with a microgranular texture and the presence of carbonates in discontinuous veins. Also present is micro-lensing of chlorite and framboidal pyrite forms.

Ballachullish Scottish slate with a heavily banded structure resulting in a rough texture with variable quartz and phyllosilicate rich bands. There is a high opaques content.

Spanish slate with occasional rhombic carbonate crystals with radiating quartz and phyllosilicates, wavy secondary splitting planes and occasional higher-grade metamorphic mineral 'spots'.

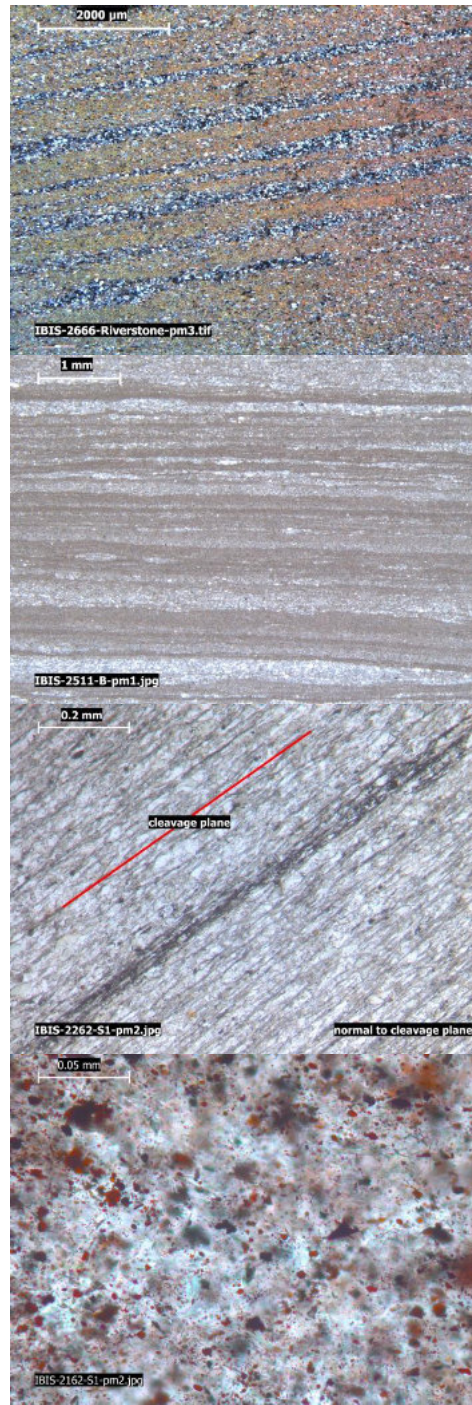
Argentinian 'Riverstone' slate that geologically classifies as a type of phyllite, with coarser quartz crystals often concentrated into bands.

Minas Gerais Brazilian slate that geologically classifies as a type of shale borderline with slate. This has irregular lamination related to the size and proportion of different mineral components that were part of a repeated sedimentary fining-up sequence.

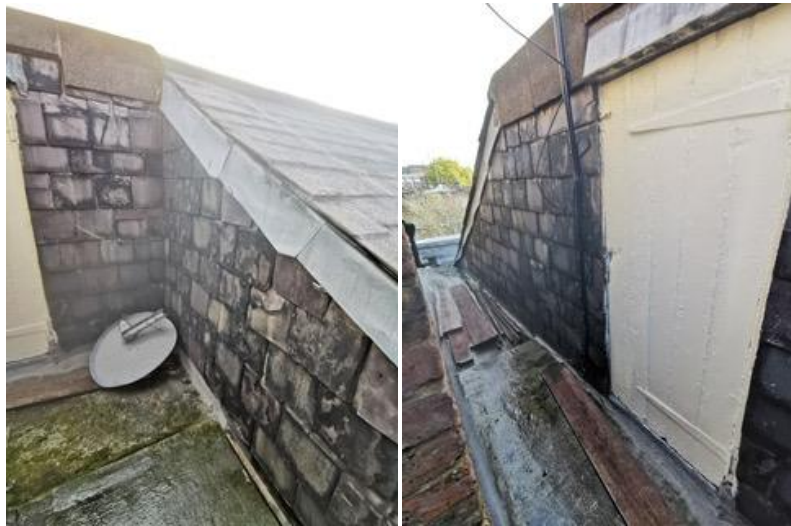
We would recommend on the flat pitched roof area above the stairwell/roof access landing to remove the lead flashings to enable us to overlay all the flat roof area and box gutter with new LP system bauer and then renew the lead flashings with new 6" lead flashing and renew the 12" lead drip detail that covers the vertical slating.

In conclusion, the roof renewal is necessary to address the identified issues, improve the performance and lifespan of the roof, and protect the property from water damage. The recommended actions outlined in this report will ensure a reliable and visually appealing roof system.

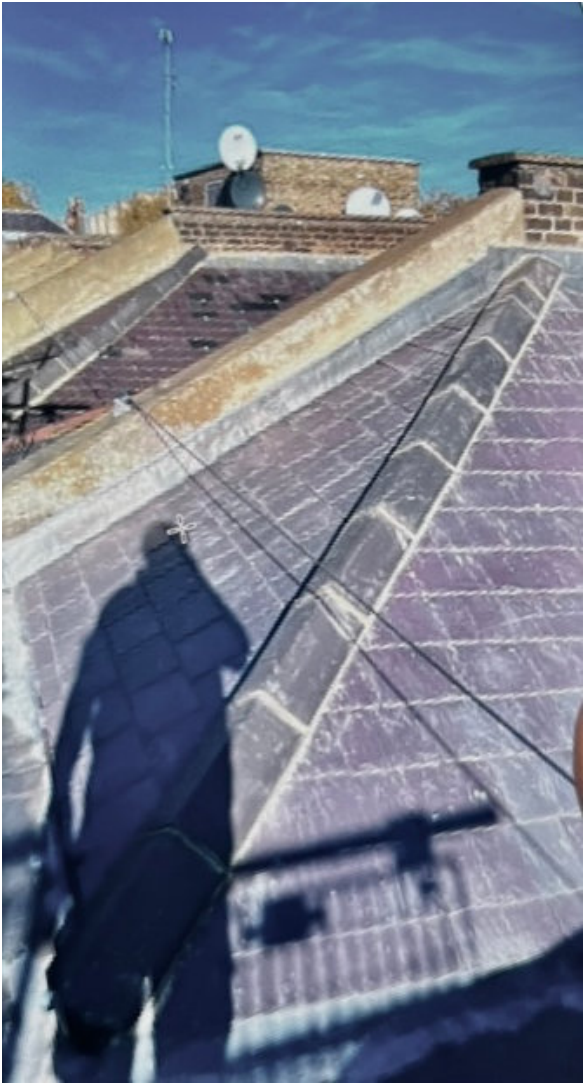
Photo 2

I am not sure who took the photograph (Photo 1) of the adjacent building but it has been processed, there is an unnaturally blue sky, and the slate colours are unnatural. I took this image, albeit at very low resolution and reprocessed it trying to get the sky to be a more natural colour (see Photo 2), the slates now appear to be somewhere between grey and purple, which is not atypical of weathered slates from the Ffestiniog area in Wales. There is no great roughness to the slates so they do not appear to be from Cumbria or other locations in the British Isles.
