**INITIAL TECHNICAL REPORT**  
**Retained**

| JR Clare<br>MS Amlin<br>Davies Group Ltd (Stoke)<br>[REDACTED] | 73 Aberdare Gardens<br>London<br>NW6 3AN |

| POLICYHOLDER DETAILS | |
|---|---|
| Supposed cause: | Subsidence |

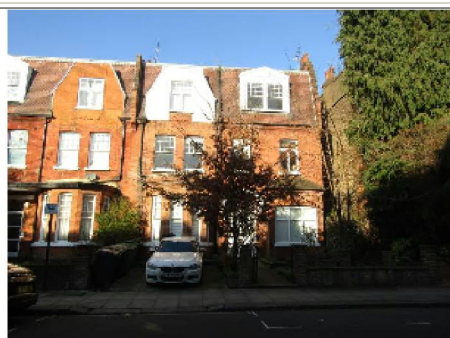
Photograph 1 front

Diagonal and vertical tapering crack damage is evident within the face brickwork to the right and left front bay windows measuring up to 3mm in width.
