Site Investigation Report

Job Information	
Client	Crawford & Co
Client ref	[Redacted]
Visit date	21/02/2023
Report date	05/04/2023

Auger were commissioned by Crawford & Co to undertake a site investigation and CCTV inspection of the underground drainage within the area of concern (AOC) at the property.

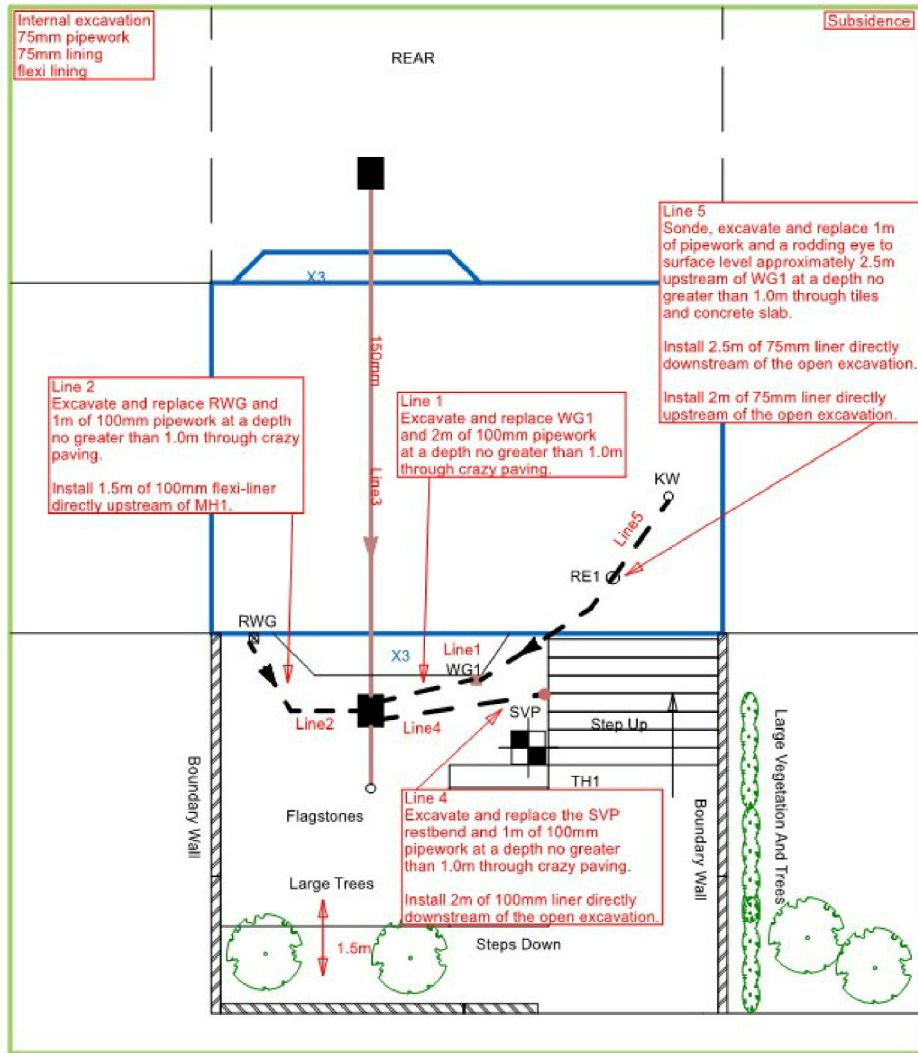
Our survey of these lines revealed joint displacements and fractures at multiple points throughout the line.

The above mentioned defects to the below ground drainage system have been caused by ground movement.

It is recommended that the following repairs are carried out to prevent an escape of water from the system:

Excavate and replace WG1 and 2m of 100mm pipework at a depth no greater than 1.0m through crazy paving.

Excavate and replace RWG and 1m of 100mm pipework at a depth no greater than 1.0m through crazy paving.

Install 1.5m of 100mm flexi-liner directly upstream of MH1.

Excavate and replace the SVP restbend and 1m of 100mm pipework at a depth no greater than 1.0m through crazy paving.

Sonde, excavate and replace 1m of pipework and a rodding eye to surface level approximately 2.5m upstream of WG1 at a depth no greater than 1.0m through tiles and concrete slab.

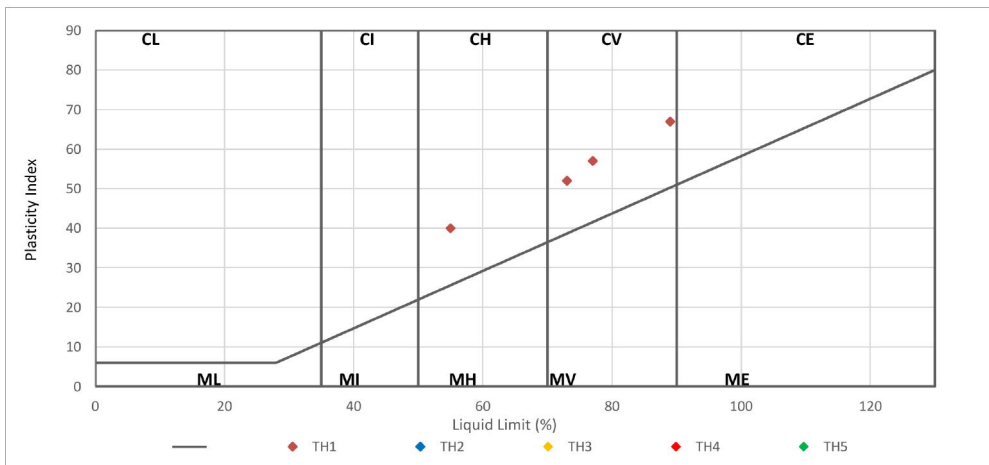
Modified Plasticity Index (PI) <10	: Non Classified
Modified PI = 10 to <20	: Low volume change potential (LOW VCP)
Modified PI = 20 to <40	: Medium volume change potential (Med VCP)
Modified PI = 40 or greater	: High volume change potential (HIGH VCP)

The Atterberg Limits May also be used to classify the volume change potential of fine soils using the National House building system, as given in the NHBC's Standards Chapter 4.2 (2003) "Building Near Trees"
