Greencroft Gardens

Structural Condition Report

02018-ENG-XX-RP-XXX-0001

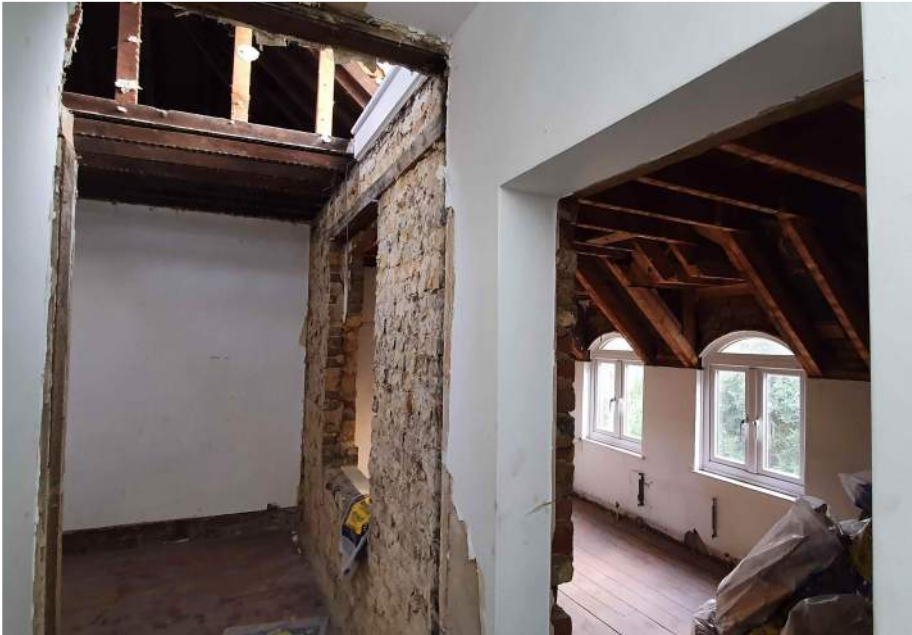
View C: Roof Type 2 (LHS), Ceiling Joists & Roof Type 3 (RHS)
Note: Masonry partition wall and ceiling joists in photograph now removed

The roof build-up comprises slate tiles supported off timber rafters and purlins. A perimeter gutter is formed by a masonry parapet at the roof edge, which is capped with stone/concrete coping stones. The exact structural arrangement of the roof build-up differs throughout the property, due to previous extensions and refurbishments carried out. All roof types are constructed in timber rafters, with additional structural elements dependent on roof type. Most of the roof timbers appear to be in good condition, with no photographic evidence of water ingress or rot. There are signs of limited localised water ingress to roof type 1, with water staining to the ceiling.

Given the age of the structure it is likely that the gutter detail has failed in some locations resulting in water ingress and subsequent rotting of rafters, it should be expected that some rafter ends will need replacement.

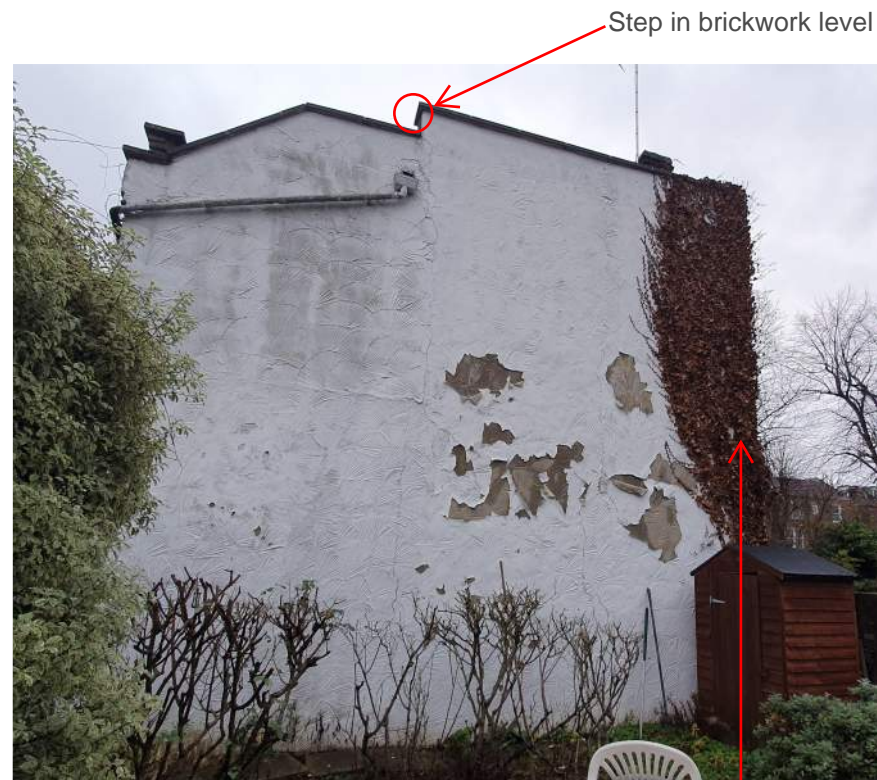
The South Elevation is fully rendered and steps down at one point, reflecting different phases of development of the property. The façade is visibly in poor condition, with the paint peeling in several areas. The wall sits up against low level planting, with several large bushes and small trees in the near vicinity. There is an existing climbing plant wrapping around the South-East corner of the property; the extent of the implications of this plant are unknown. Refer to Appendix C for sketches and photographs.

Whilst the cracks to the East correlate with previous building alterations, the cause of the vertical cracks to the West and associated cracks at lower levels are unclear. It is likely that the vegetation within the garden has caused shrinking from change in moisture content, or that there has been previously removed larger planting that has allowed for re-saturation of the ground below, causing swelling of the clay soil. From visual inspection of the East elevation, it appears that the base of the climbing plant has been removed, although it is unknown when this was done. This is likely to have caused the re-saturation of the soil below, and therefore has potential to be the cause for the vertical cracking to the East.

Step in brickwork level

Climbing plant with removed base

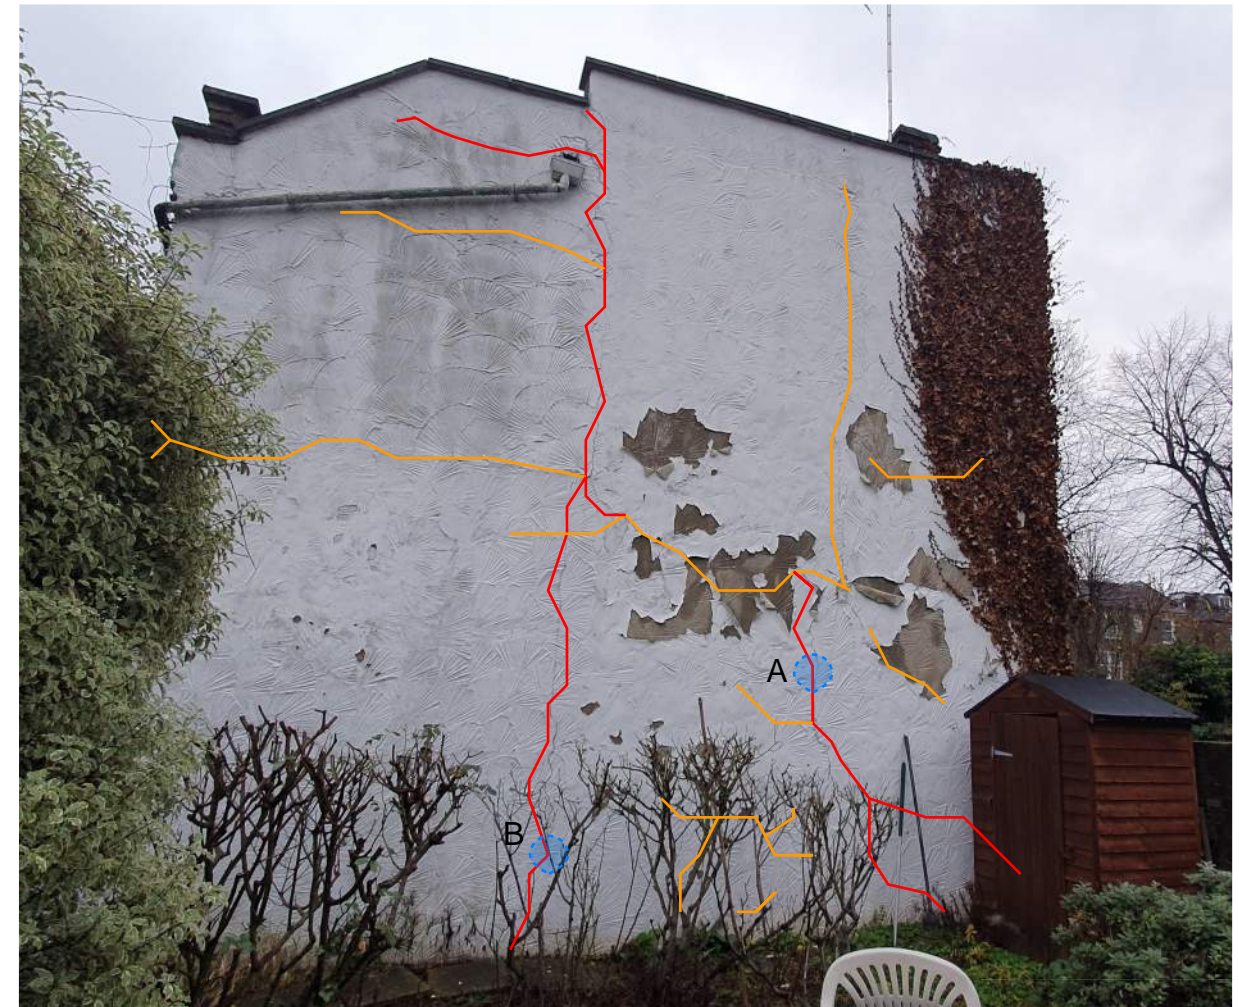
Crack Location Elevation Sketch

Extensive cracks are visible in the render along the external wall, with cracks running through the brickwork in several areas. There are two main vertical cracks from ground level up to the top of the wall, one in line with a previous extension to the property, reaching the step in the façade at the top. From visual inspection, the cracks appear to increase in width towards the top of the wall. Horizontal cracking is visible at first floor level to the West, along the assumed line of a previous extension to the property. It is unknown if this crack extends through to the brickwork. Refer to Appendix C for a sketch markup of the extent of the cracking in the façade.

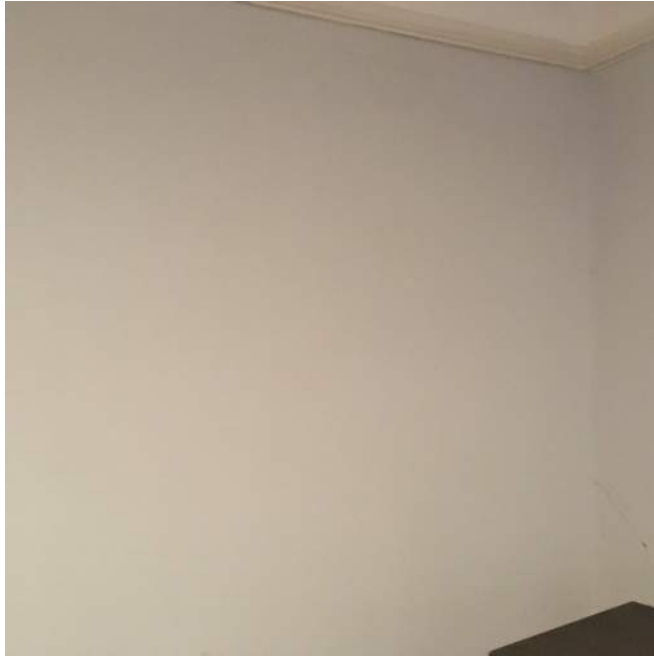
Figure 04:- Ground Floor North-East corner, facing North

The Agent pointed us to the relevant cracking internally, principally one location at ground floor and one location at first floor. Cracking was observed within the main reception room at ground floor, in the north-east corner of the Property. There were very fine hairline cracks extending vertically down from the coving on the north wall and then horizontally (Figure 04). These were visible with the naked eye but may not be clear in the photos.

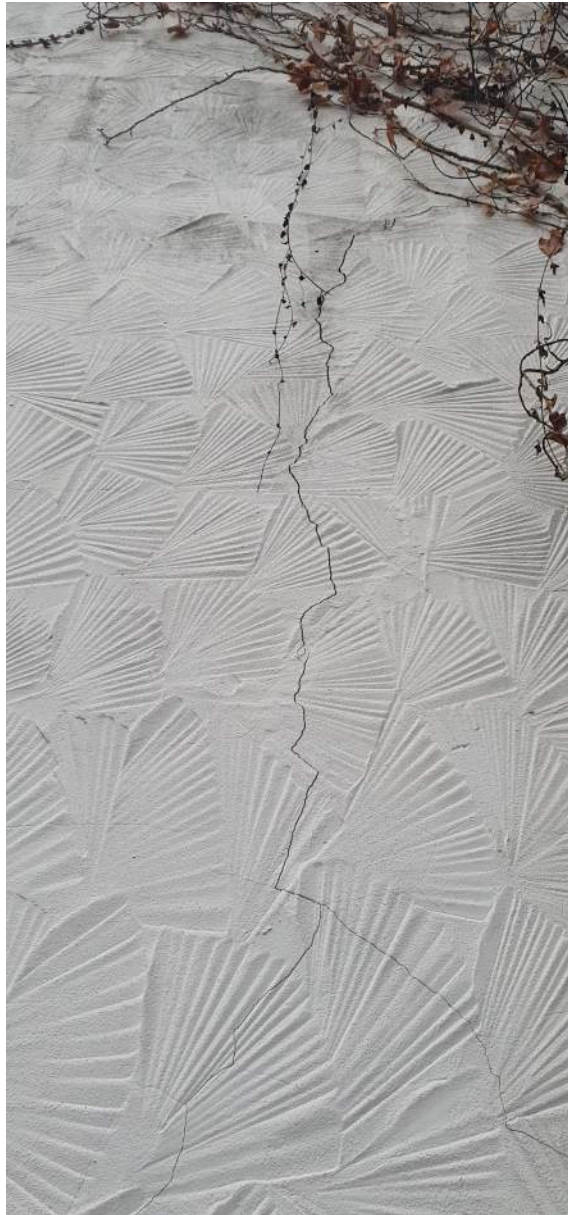
Figure 10:- East Elevation looking up

The East Elevation has a large crack (Figure 10) approximately a third of the width of the wall away from the North-East corner where cracking was observed internally.

The external crack is vertical and was measured at ground level as 1mm wide but appeared to be more pronounced at height and is thought to exceed 2mm in places.
