FIRE SAFETY RISK ASSESSMENT EUSTON TOWER

Document Version: ETFRA2015

Fire Safety Report for:

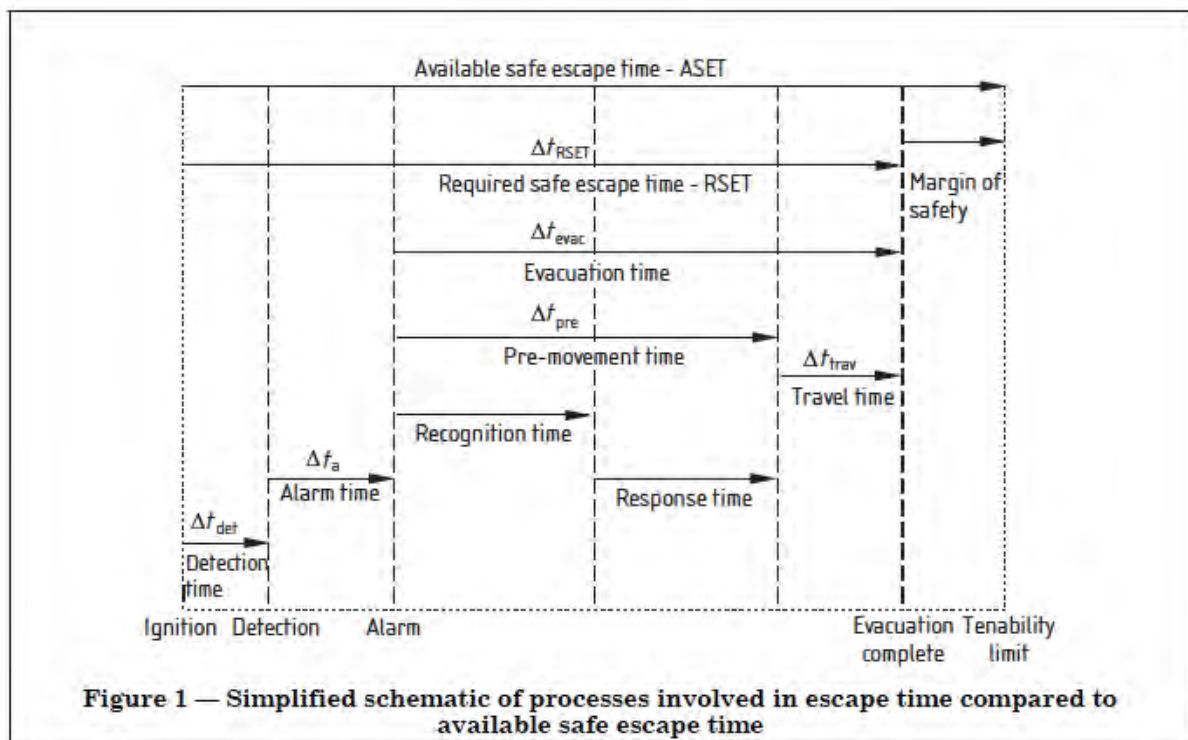
Evacuation Times

The building through carrying out full evacuations during fire drills takes between 30 minutes and 60 minutes to fully evacuate (Required Safe Escape Time). There is 120 minutes fire resistance provided to the stairwell so the times for full evacuation are well within the limits of building design (Available Safe Escape Time). Therefore based on ASET/RSET (Diagram below) evacuation times are well within the margin of safety.
