ASBESTOS REINSPECTION REPORT

Site: RPE Euston Tower
Address: Regents Place Estate, London, NW1 3HF
Client: British land
Survey Date: 18 July 2022 to 19 July 2022
Surveyor: Andrew Johnson
Issue Number: 1

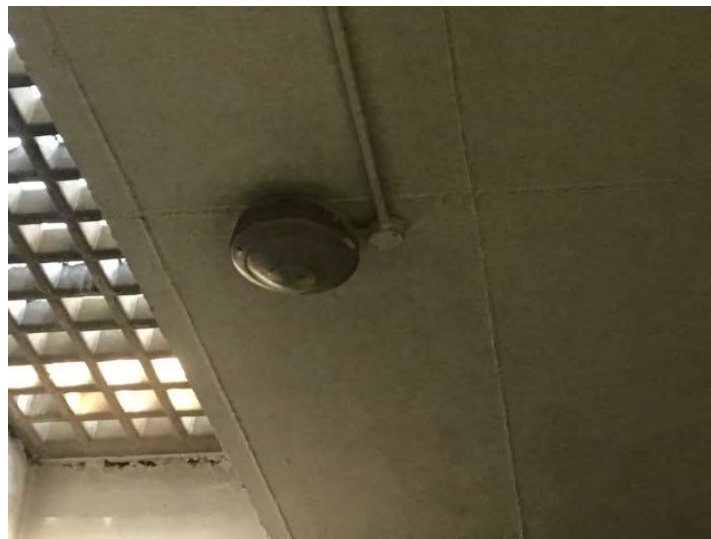
Sample Number:	F971/VR537		
Building:	Euston Tower	Floor:	Basement
Room Name/Number:	B.06 Store Room	Material/Amount:	Putty 1 no
Sample Description:	Putty to Emergency Lighting Unit to Soffit

Product Type:	Putty	Total Risk Score:	3
Condition:	Some Minor Damage	Risk Category:	Very Low
Surface Treatment:	Composite/Self Sealed		
Asbestos Types:	Chrysotile	Action:	Manage
Comments:	Periodic inspections should be carried out in accordance with Regulation 4 of the Control of Asbestos Regulations 2012. Do not disturb this ACM. Ensure all employees, contractors & tenants who may come into contact with this ACM are made aware.

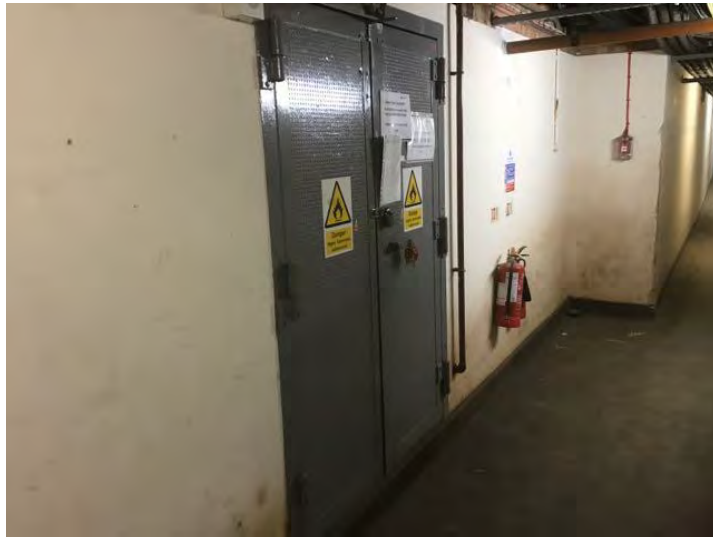
Sample Number:	AS F971/S037 F971/VR533		
Building:	Euston Tower	Floor:	Basement
Room Name/Number:	B.13 Pump Room	Material/Amount:	Cement Product 2 no
Sample Description:	Durasteel Fire Door

Product Type:	Cement Product	Total Risk Score:	4
Condition:	Some Minor Damage	Risk Category:	Very Low
Surface Treatment:	Sealed		
Asbestos Types:	Chrysotile	Action:	Manage
Comments:	Periodic inspections should be carried out in accordance with Regulation 4 of the Control of Asbestos Regulations 2012. Do not disturb this ACM. Ensure all employees, contractors & tenants who may come into contact with this ACM are made aware.

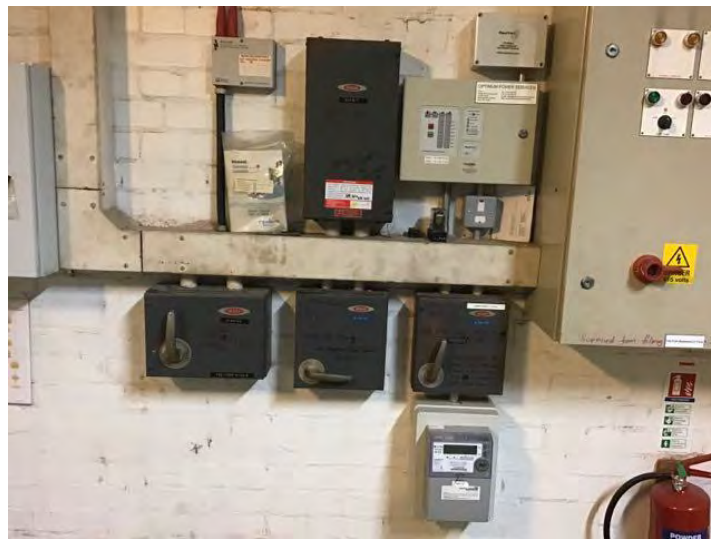
Sample Number:	F971/VR542		
Building:	Euston Tower	Floor:	Basement
Room Name/Number:	B.13 Pump Room	Material/Amount:	Woven Material 4 no
Sample Description:	Within Electric Boxes

Product Type:	Woven Material	Total Risk Score:	5
Condition:	Some Minor Damage	Risk Category:	Low
Surface Treatment:	Sealed		
Asbestos Types:	Chrysotile	Action:	Manage

Periodic inspections should be carried out in accordance with Regulation 4 of the Control of Asbestos Regulations 2012. Do not disturb this ACM. Ensure all employees, contractors & tenants who may come into contact with this ACM are made aware.

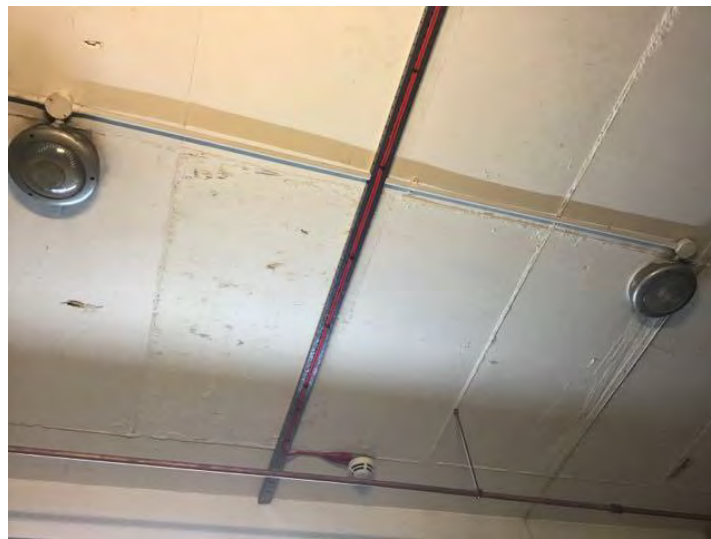
Sample Number:	AS F971/S042 F971/VR534		
Building:	Euston Tower	Floor:	Basement
Room Name/Number:	B.13 Pump Room	Material/Amount:	Putty 4 no
Sample Description:	Putty to Emergency Lighting Units to Soffit

Product Type:	Putty	Total Risk Score:	3
Condition:	Some Minor Damage	Risk Category:	Very Low
Surface Treatment:	Composite/Self Sealed		
Asbestos Types:	Chrysotile	Action:	Manage
Comments:	Periodic inspections should be carried out in accordance with Regulation 4 of the Control of Asbestos Regulations 2012. Do not disturb this ACM. Ensure all employees, contractors & tenants who may come into contact with this ACM are made aware.

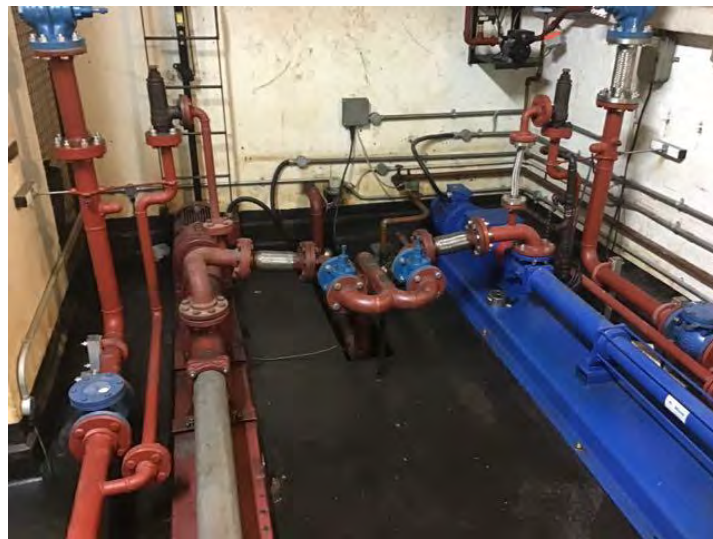
Sample Number:	F971/S046		
Building:	Euston Tower	Floor:	Basement
Room Name/Number:	B.13 Pump Room	Material/Amount:	Gaskets (Compressed) 50 no
Sample Description:	Within Pipework Flanges

Product Type:	Gaskets (Compressed)	Total Risk Score:	4
Condition:	Some Minor Damage	Risk Category:	Very Low
Surface Treatment:	Composite/Self Sealed		
Asbestos Types:	Chrysotile	Action:	Manage
Comments:	Periodic inspections should be carried out in accordance with Regulation 4 of the Control of Asbestos Regulations 2012. Do not disturb this ACM. Ensure all employees, contractors & tenants who may come into contact with this ACM are made aware.

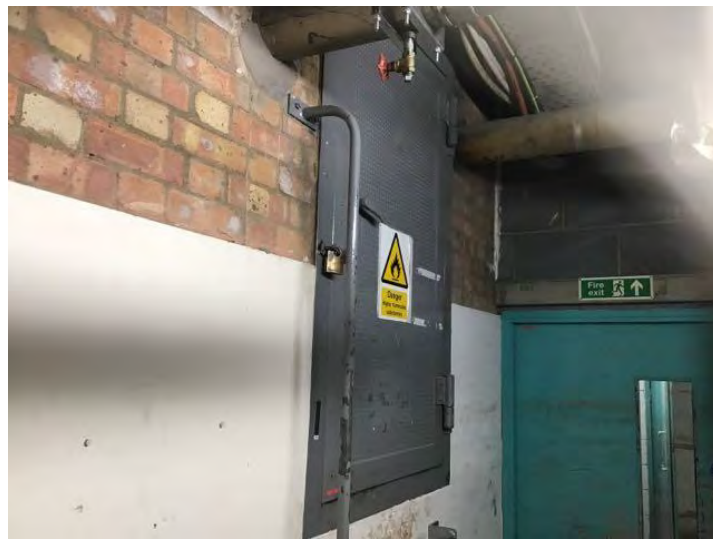
Sample Number:	AS F971/S037 F971/VR538		
Building:	Euston Tower	Floor:	Basement
Room Name/Number:	B.14 Oil Store	Material/Amount:	Cement Product 1 no
Sample Description:	Durasteel Fire Door

Product Type:	Cement Product	Total Risk Score:	4
Condition:	Some Minor Damage	Risk Category:	Very Low
Surface Treatment:	Sealed		
Asbestos Types:	Chrysotile	Action:	Manage
Comments:	Periodic inspections should be carried out in accordance with Regulation 4 of the Control of Asbestos Regulations 2012. Do not disturb this ACM. Ensure all employees, contractors & tenants who may come into contact with this ACM are made aware.

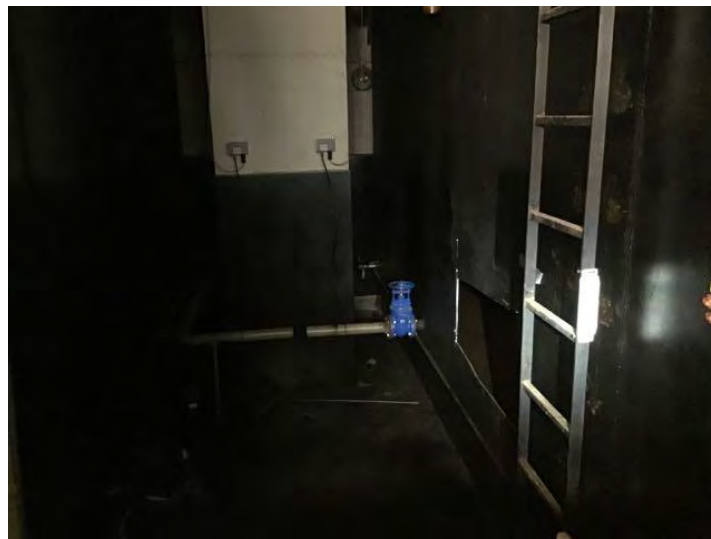
Sample Number:	AS F971/S046 F971/VR539		
Building:	Euston Tower	Floor:	Basement
Room Name/Number:	B.14 Oil Store	Material/Amount:	Gaskets (Compressed) 10 no
Sample Description:	Within Pipework Flanges

Product Type:	Gaskets (Compressed)	Total Risk Score:	4
Condition:	Some Minor Damage	Risk Category:	Very Low
Surface Treatment:	Composite/Self Sealed		
Asbestos Types:	Chrysotile	Action:	Manage
Comments:	Periodic inspections should be carried out in accordance with Regulation 4 of the Control of Asbestos Regulations 2012. Do not disturb this ACM. Ensure all employees, contractors & tenants who may come into contact with this ACM are made aware.

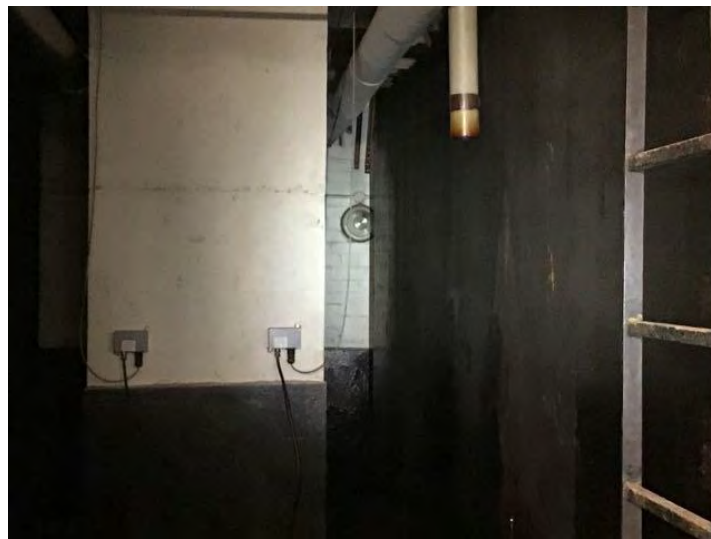
Sample Number:	AS F971/S042 F971/VR540		
Building:	Euston Tower	Floor:	Basement
Room Name/Number:	B.14 Oil Store	Material/Amount:	Putty 4 no
Sample Description:	Putty to Emergency Lighting Units to Soffit

Product Type:	Putty	Total Risk Score:	3
Condition:	Some Minor Damage	Risk Category:	Very Low
Surface Treatment:	Composite/Self Sealed		
Asbestos Types:	Chrysotile	Action:	Manage
Comments:	Periodic inspections should be carried out in accordance with Regulation 4 of the Control of Asbestos Regulations 2012. Do not disturb this ACM. Ensure all employees, contractors & tenants who may come into contact with this ACM are made aware.

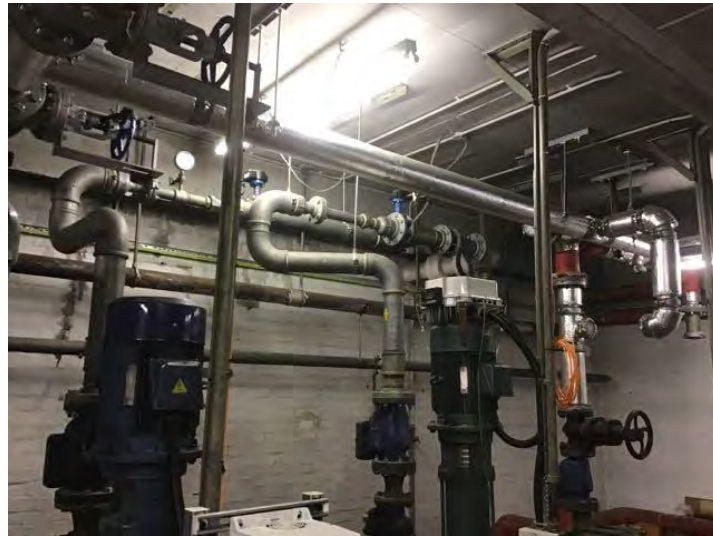
Sample Number:	F971/S048		
Building:	Euston Tower	Floor:	Basement
Room Name/Number:	B.18 Fuel Pump Room	Material/Amount:	Gaskets (Compressed) 50 no
Sample Description:	Within Pipework Flanges

Product Type:	Gaskets (Compressed)	Total Risk Score:	4
Condition:	Some Minor Damage	Risk Category:	Very Low
Surface Treatment:	Composite/Self Sealed		
Asbestos Types:	Chrysotile	Action:	Manage
Comments:	Periodic inspections should be carried out in accordance with Regulation 4 of the Control of Asbestos Regulations 2012. Do not disturb this ACM. Ensure all employees, contractors & tenants who may come into contact with this ACM are made aware.

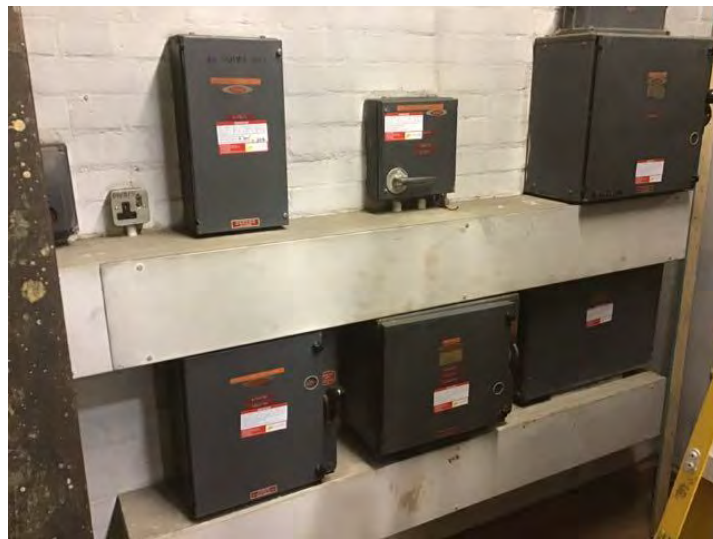
Sample Number:	F971/VR535		
Building:	Euston Tower	Floor:	Basement
Room Name/Number:	B.18 Fuel Pump Room	Material/Amount:	Woven Material 7 no
Sample Description:	Within Electric Boxes

Product Type:	Woven Material	Total Risk Score:	5
Condition:	Some Minor Damage	Risk Category:	Low
Surface Treatment:	Sealed		
Asbestos Types:	Chrysotile	Action:	Manage
Comments:	Periodic inspections should be carried out in accordance with Regulation 4 of the Control of Asbestos Regulations 2012. Do not disturb this ACM. Ensure all employees, contractors & tenants who may come into contact with this ACM are made aware.

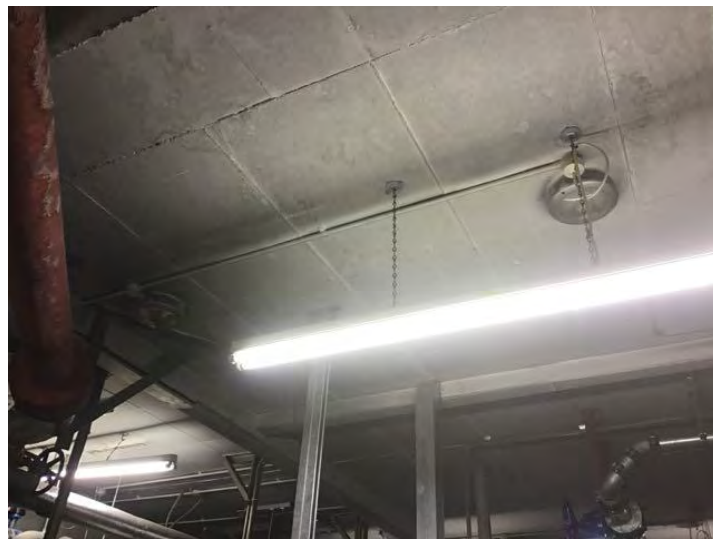
Sample Number:	AS F971/S042 F971/VR536		
Building:	Euston Tower	Floor:	Basement
Room Name/Number:	B.18 Fuel Pump Room	Material/Amount:	Putty 4 no
Sample Description:	Putty to Emergency Lighting Units to Soffit

Product Type:	Putty	Total Risk Score:	3
Condition:	Some Minor Damage	Risk Category:	Very Low
Surface Treatment:	Composite/Self Sealed		
Asbestos Types:	Chrysotile	Action:	Manage
Comments:	Periodic inspections should be carried out in accordance with Regulation 4 of the Control of Asbestos Regulations 2012. Do not disturb this ACM. Ensure all employees, contractors & tenants who may come into contact with this ACM are made aware.

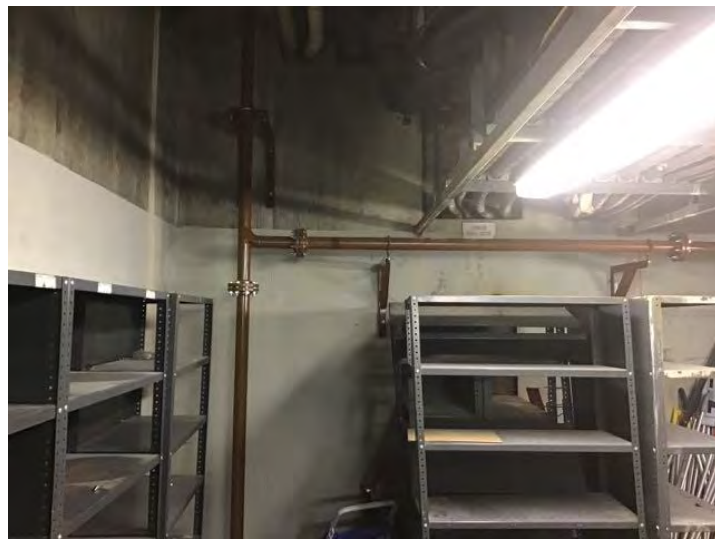
Sample Number:	F971/S049		
Building:	Euston Tower	Floor:	Basement
Room Name/Number:	B.20 Store Room	Material/Amount:	Gaskets (Compressed) 6 no
Sample Description:	Within Pipework Flanges

Product Type:	Gaskets (Compressed)	Total Risk Score:	4
Condition:	Some Minor Damage	Risk Category:	Very Low
Surface Treatment:	Composite/Self Sealed		
Asbestos Types:	Chrysotile	Action:	Manage
Comments:	Periodic inspections should be carried out in accordance with Regulation 4 of the Control of Asbestos Regulations 2012. Do not disturb this ACM. Ensure all employees, contractors & tenants who may come into contact with this ACM are made aware.

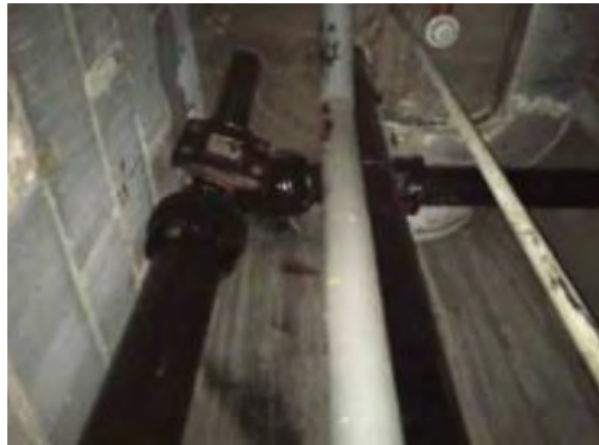
Sample Number:	F971/S043		
Building:	Euston Tower	Floor:	Ground Floor
Room Name/Number:	G.12 Store Room	Material/Amount:	Gaskets (Compressed) 1 Visible
Sample Description:	Gaskets to Bolted Flange

Product Type:	Gaskets (Compressed)	Total Risk Score:	4
Condition:	Some Minor Damage	Risk Category:	Very Low
Surface Treatment:	Composite/Self Sealed		
Asbestos Types:	Chrysotile	Action:	Manage

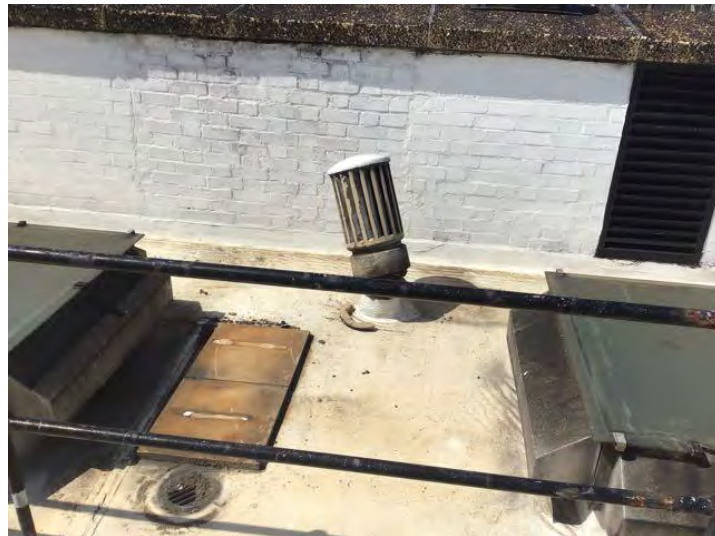
Sample Number:	AS F971/S003 F971/VR509		
Building:	Euston Tower	Floor:	External
Room Name/Number:	RF.02 - Roof	Material/Amount:	Cement Product Various throughout Roof Area
Sample Description:	Flues & Cowls

Product Type:	Cement Product	Total Risk Score:	4
Condition:	Some Minor Damage	Risk Category:	Very Low
Surface Treatment:	Sealed		
Asbestos Types:	Chrysotile	Action:	Manage

Periodic inspections should be carried out in accordance with Regulation 4 of the Control of Asbestos Regulations 2012. Do not disturb this ACM. Ensure all employees, contractors & tenants who may come into contact with this ACM are made aware.

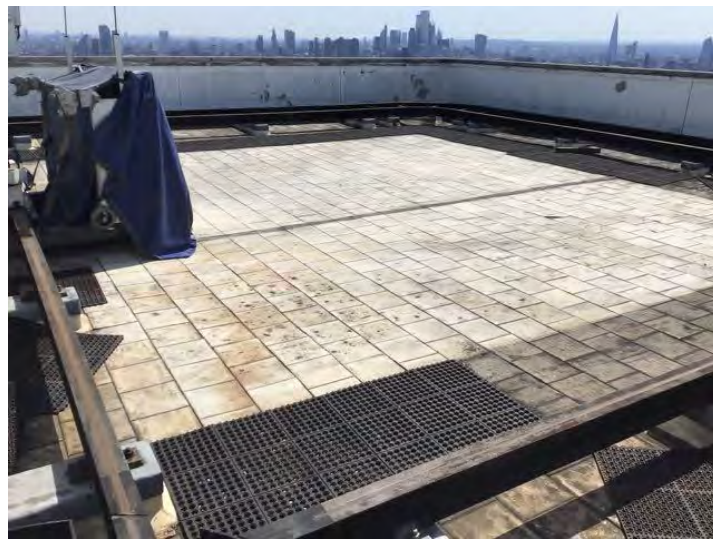
Sample Number:	F971/S004		
Building:	Euston Tower	Floor:	External
Room Name/Number:	RF.01 - Roof	Material/Amount:	Cement Product 300 m ²
Sample Description:	Promenade Floor Tiles to Roof

Product Type:	Cement Product	Total Risk Score:	4
Condition:	Some Minor Damage	Risk Category:	Very Low
Surface Treatment:	Sealed		
Asbestos Types:	Chrysotile	Action:	Manage
Comments:	Periodic inspections should be carried out in accordance with Regulation 4 of the Control of Asbestos Regulations 2012. Do not disturb this ACM. Ensure all employees, contractors & tenants who may come into contact with this ACM are made aware.

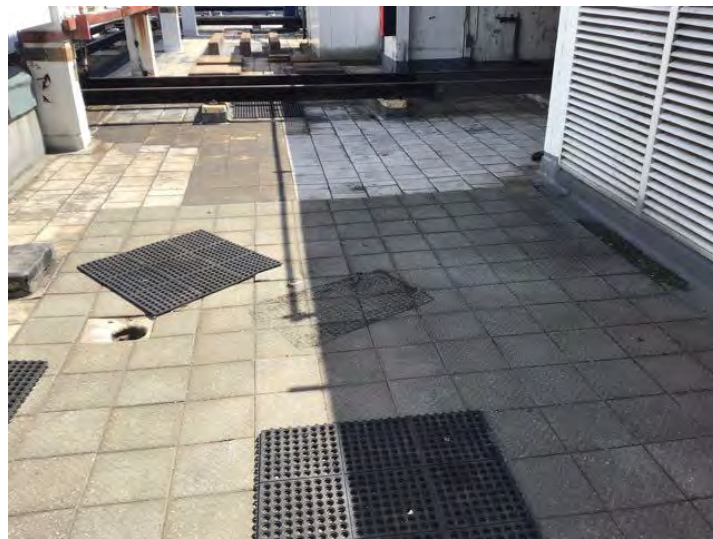
Sample Number:	F971/S008		
Building:	Euston Tower	Floor:	External
Room Name/Number:	RF.01 - Roof	Material/Amount:	Cement Product 300 m ²
Sample Description:	Promenade Floor Tiles to Roof

Product Type:	Cement Product	Total Risk Score:	4
Condition:	Some Minor Damage	Risk Category:	Very Low
Surface Treatment:	Sealed		
Asbestos Types:	Chrysotile	Action:	Manage
Comments:	<p>Only present in vegetation material settled on the surface of the tiles.</p> <p>Periodic inspections should be carried out in accordance with Regulation 4 of the Control of Asbestos Regulations 2012. Do not disturb this ACM. Ensure all employees, contractors & tenants who may come into contact with this ACM are made aware.</p>
