1. Case Details Insured Gilling Court Address Flat 26 & Common Areas, Gilling Court, Belsize Court, Hampstead, NW3 4UY Client Subsidence Management Services Contact Stephan Barnes Claim No. ES Ref Consultant Andrew Cayley Contact No.

Gilling Court, Belsize Grove, London, NW3 4UY

ITP/BH1 Foundation Detail and Borehole Log

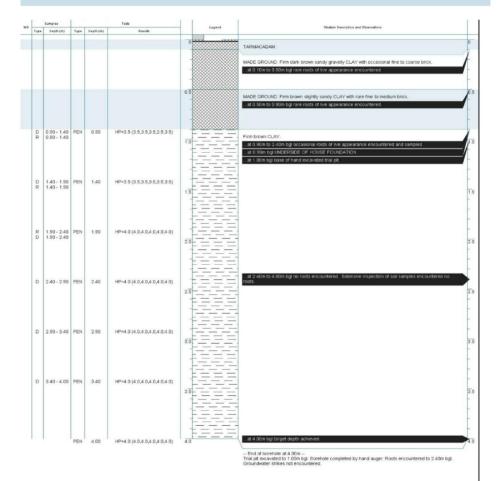
TP/BH2 Foundation Detail and Borehole Log

House foundation comprised of brick wall to 150mm bgl, bearing on stepped brickwork to 300mm bgl with a total projection of 120mm from the elevation. In turn, bearing on concrete to 900mm bgl with a total

projection of 200mm from the elevation. Underside of foundation (USF) was exposed to 100mm back from the face of the foundation and probed 300mm back from the face of the foundation.
