Site Investigation Report

Job Information	
Client	[Redacted]
Client ref	[Redacted]
Visit date	31/10/2022
Report date	03/11/2022

Auger were commissioned by Questgates to undertake a site investigation and CCTV inspection of the underground drainage within the area of concern (AOC) at the property.

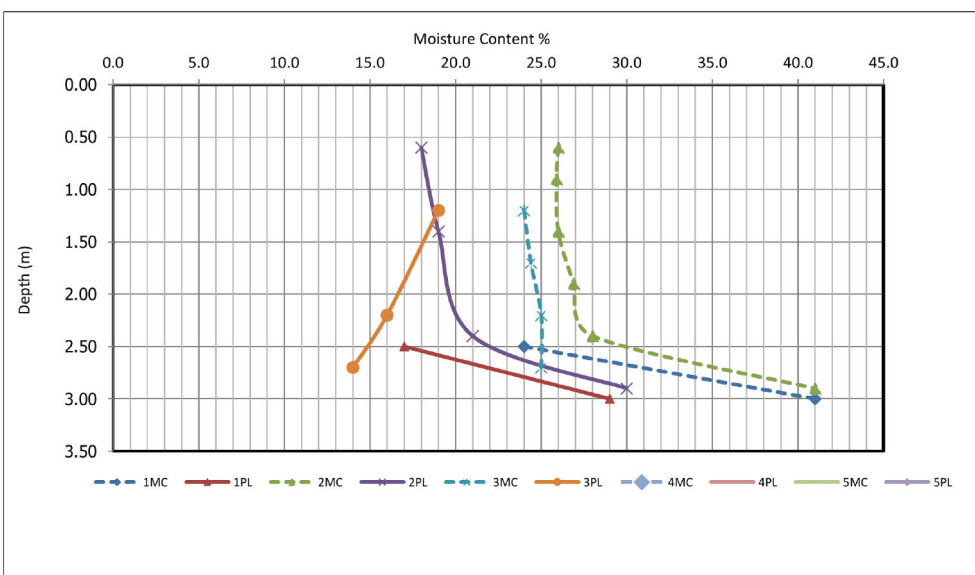
PLASTICITY CHART FOR CASAGRANDE CLASSIFICATION
BS 5930:1999+A2:2010

Modified Plasticity Index (PI) <10 : Non Classified
 Modified PI = 10 to <20 : Low volume change potential (LOW VCP)
 Modified PI = 20 to <40 : Medium volume change potential (Med VCP)
 Modified PI = 40 or greater : High volume change potential (HIGH VCP)

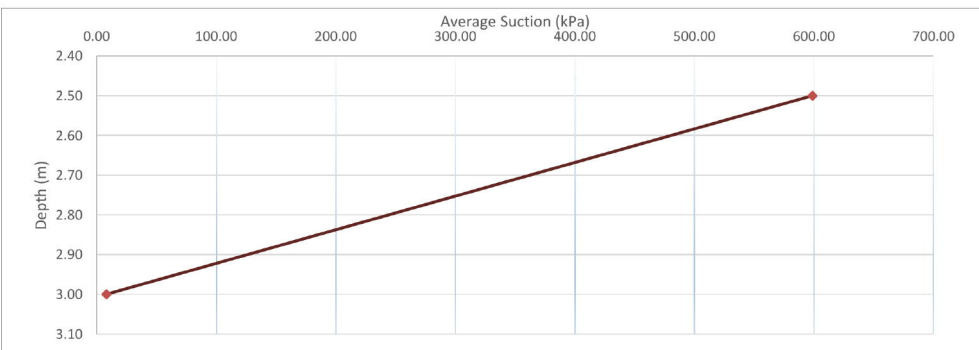
The values reported for heave above only apply to the strata the suction and plasticity have been performed on. The shallowest depth reported is assumed to be a strata thickness to GL and Heave is calculated based on that layer thickness, if the next sample is in 0.5m increments the heave is calculated based on the layer thickness of 0.5m and depths 1m from the sample above will include heave over 1m.

Consideration should be made for other stratas where values are not reported and when working out the heave potential over the entire trial hole.

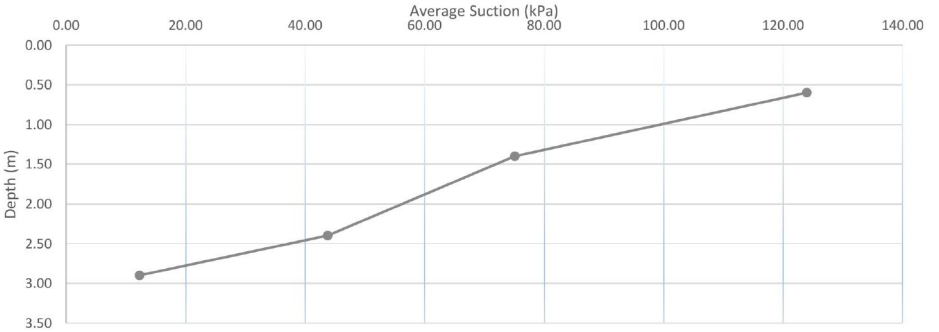
The values reported for heave above only apply to the strata the suction and plasticity have been performed on. The shallowest depth reported is assumed to be a strata thickness to GL and Heave is calculated based on that layer thickness, if the next sample is in 0.5m increments the heave is calculated based on the layer thickness of 0.5m and depths 1m from the sample above will include heave over 1m.

Consideration should be made for other stratas where values are not reported and when working out the heave potential over the entire trial hole.
