Alexandra Road Estate Heating Infrastructure

Technical Report | Feb 2020

In August 2019 Camden Council brought together a team to carry out a qualitative and quantitative review of the current heating infrastructure and evaluate which areas could be retained and re-used and which areas would require replacement and/or repair. This included a review of the heritage, visual, mechanical, technical and practical implications.

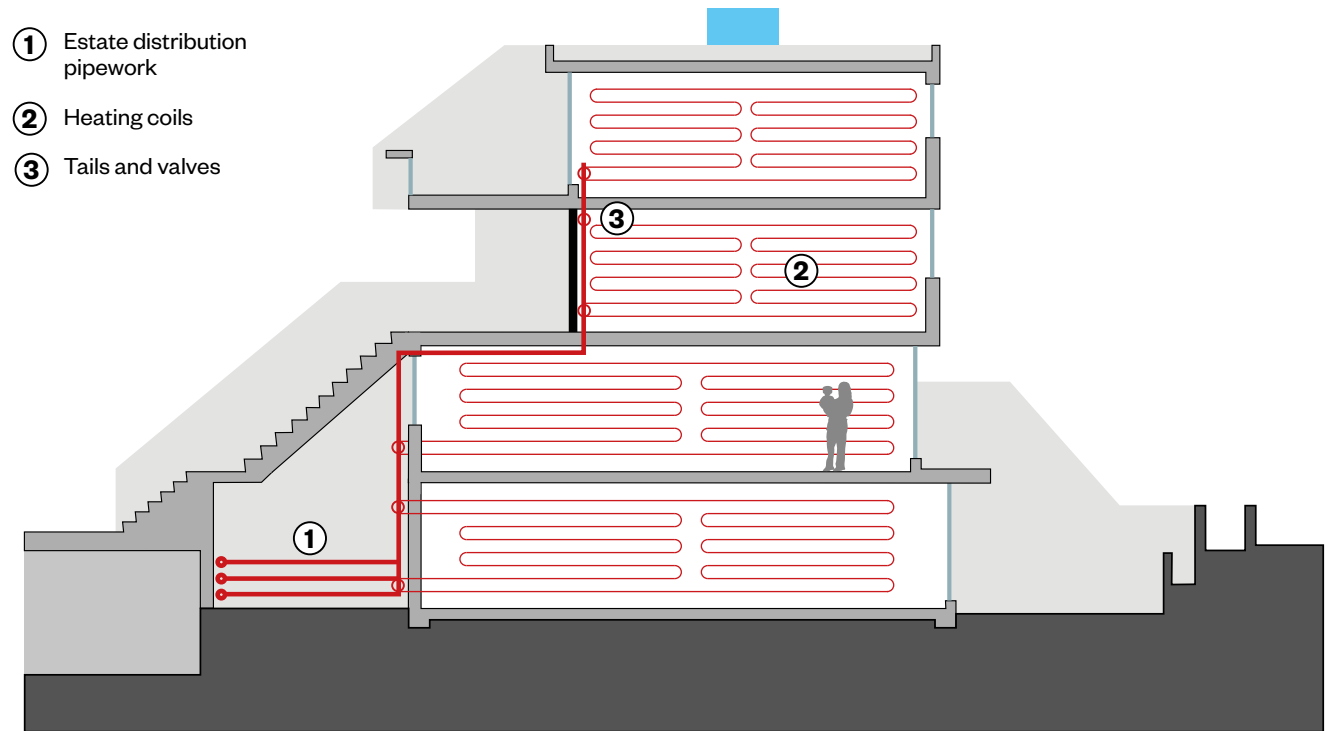
Figure 3.10 - Heating coils in Block B

Section through Block B - showing estate distribution pipework, heating coils and tails

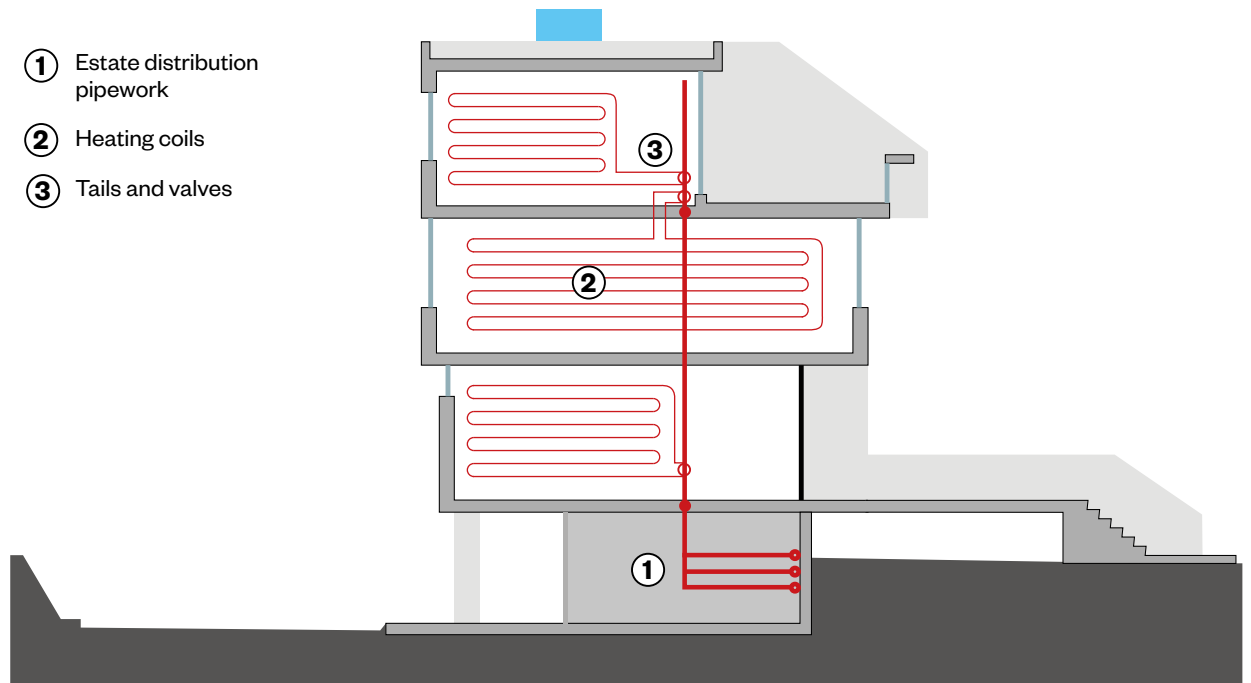
Figure 3.11 - Heating coils in Block C

Block C has additional complexities, with heating coils on both party walls, as opposed to every other party wall (as in Block A and B). Internal distribution pipework is set into the concrete floors and walls to allow the heating to pass across the dwellings.

Section through Block C - showing estate distribution pipework, heating coils and tails

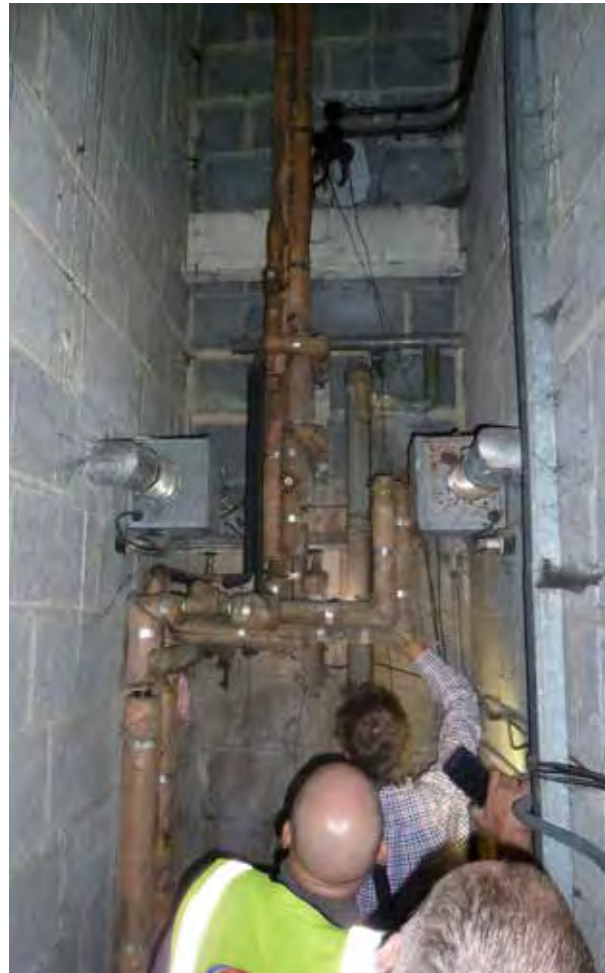
Figure 5.0 - Alexandra Road heating network inspection

The photos opposite show some of the access issues and disruption.

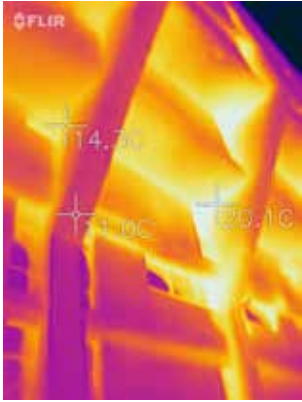
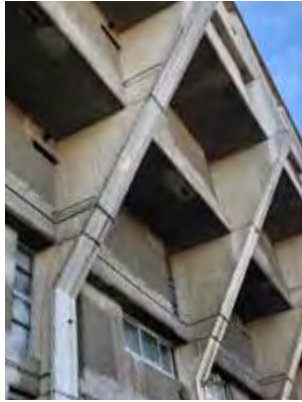
Figure 7.0 - Rear of block A showing the heated party wall from the coils is warmer than the unheated wall

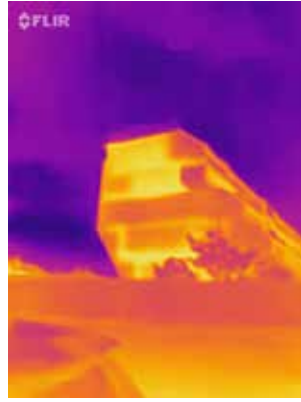
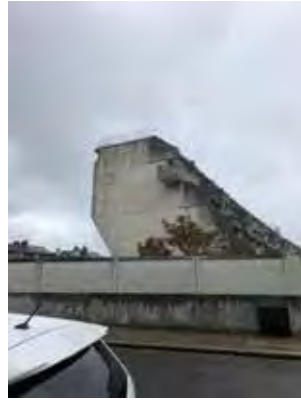
Figure 7.1 - The western end wall of block A illustrating heat loss from the dwellings and significant thermal bridges at the floor and wall junctions.

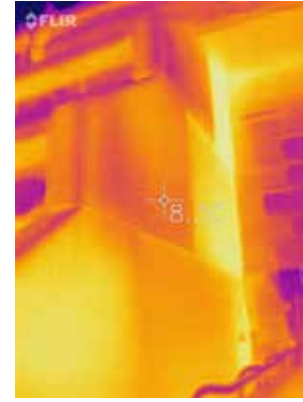
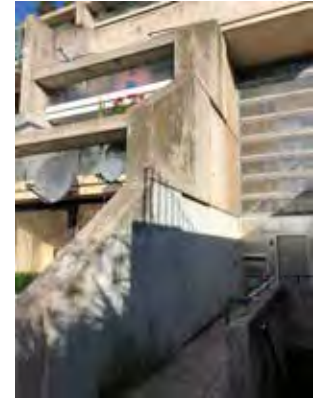
Figure 7.2 - Eastern end wall of block A illustrating heat loss from the heating coils in the dwellings.

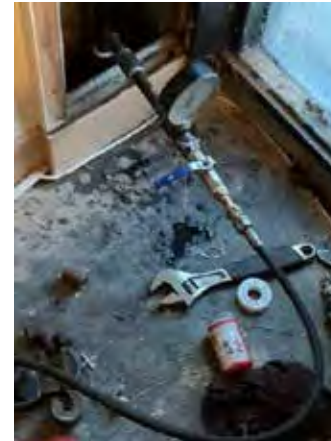
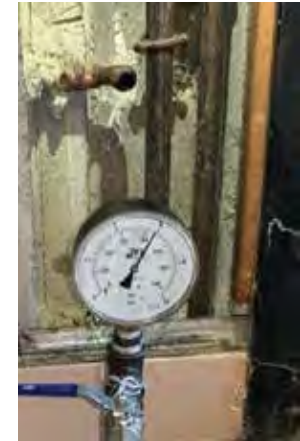
Coil 3: 16:36

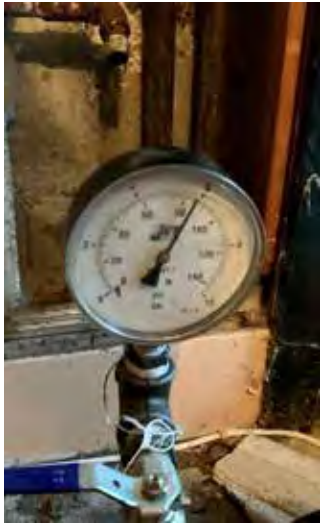
Coil 3: 17:18

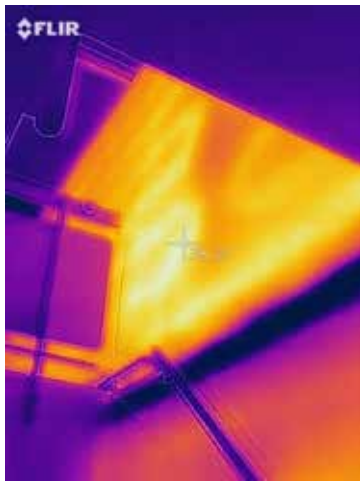
Figure 3: IR photo of Block B flat

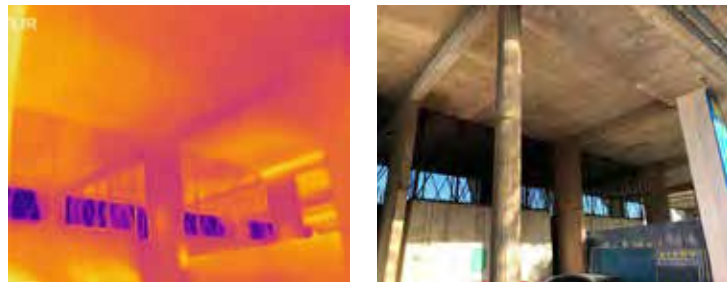
Figure 6 : Underside of block A at the eastern end showing the heat loss and thermal bridges through the exposed floors of the flats.

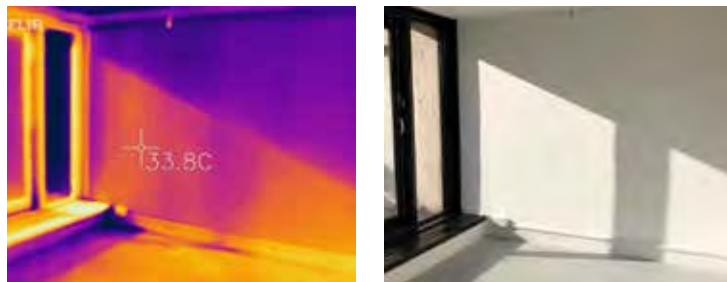
Figure 10: Internal image of the same A1 unit showing the unheated party wall and the effect of the thermal mass of the concrete with solar gains. It is assumed that the solar gains contributes approximately 9°C warming when compared to flat type A3 which received no solar gains on its unheated wall.

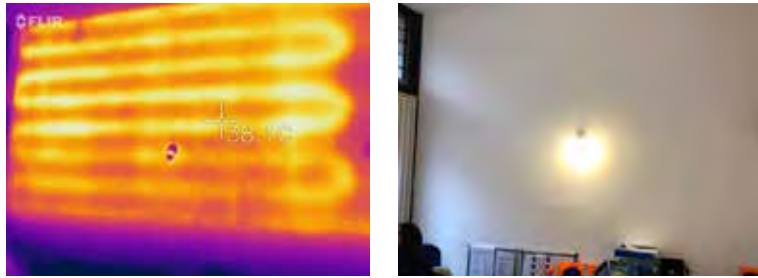
Figure 13: Internal image of a void A3 unit (Mulalley's site office), showing the coil heated party wall in the double height space.

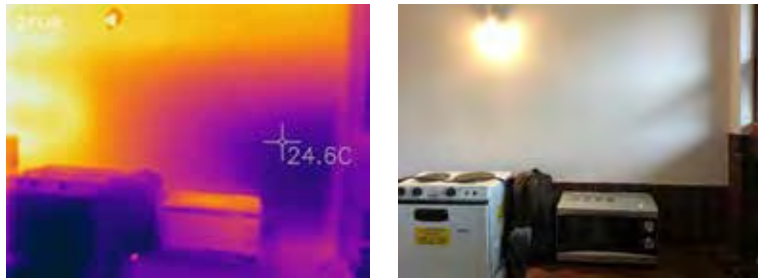
Figure 14: Image of the kitchen area in same A3 void unit at mezzanine level showing the location of heating coil tails.

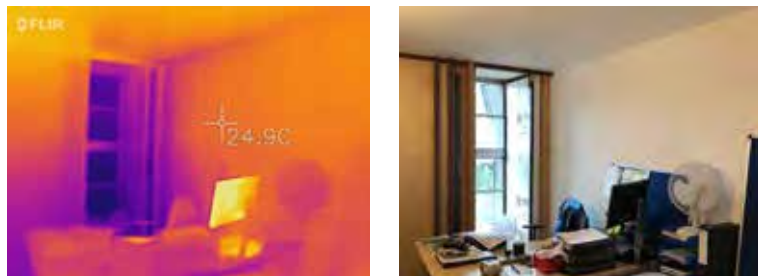
Figure 15: Image of the bedroom in same A3 void unit at mezzanine level showing the unheated wall 14°C cooler than the heated coil wall in figure 13.

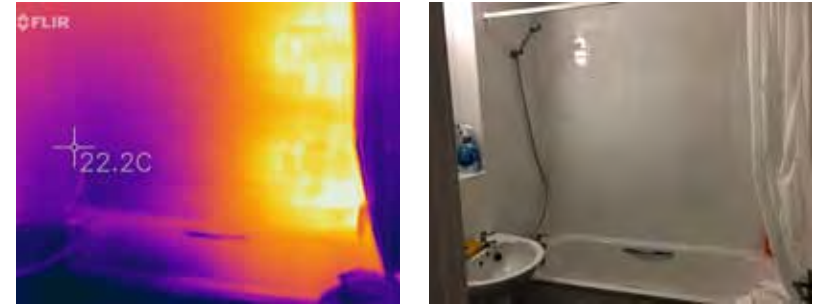
Figure 16: Image of the bathroom wall in same A3 void unit on the lower floor showing the heating coils and likely zone for the tails.

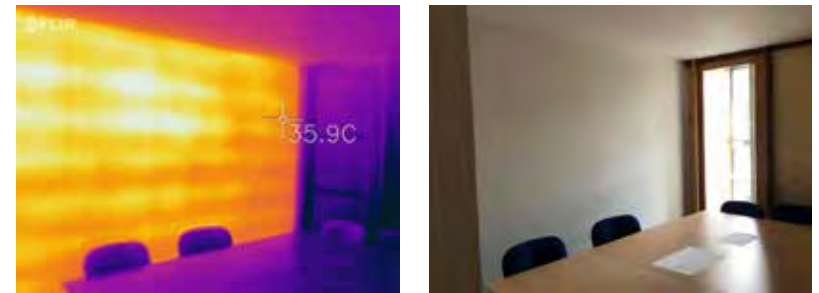
Figure 17: Image of the bedroom in same A3 void on the lower floor unit showing the location of heating coil.
