Pre-Redevelopment and Pre-Demolition Audit Report

Project 200 East Development – University College School

University College School Hampstead

08/12/2023

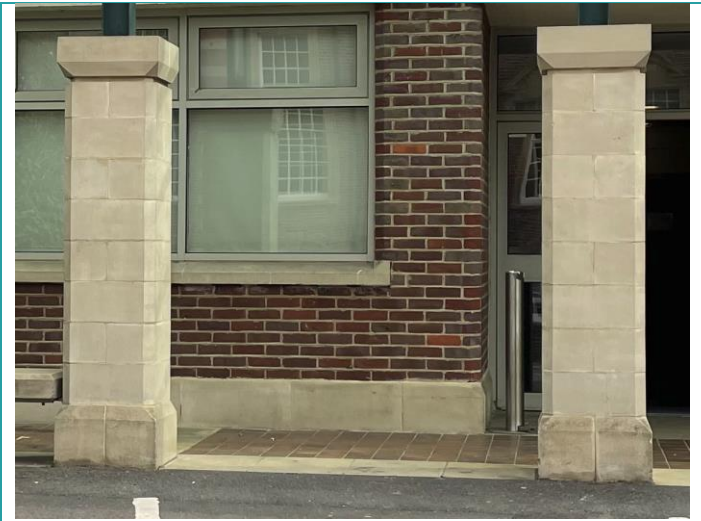
Image 63 GS Wing - Stone Cladding

All remaining stone will be sent off-site for recycling.

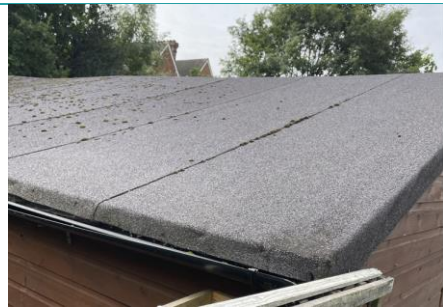
**Image 66 Maintenance Shed -
Mineral Roof Felt**

All bituminous mixtures (including mineral roof felt) will be sent off-site for recycling.
