**16 Church Row, Hampstead, London**

## Structural Assessment Report

**Ref:** 230595/K Clark

**Date:** 01 Dec 2023

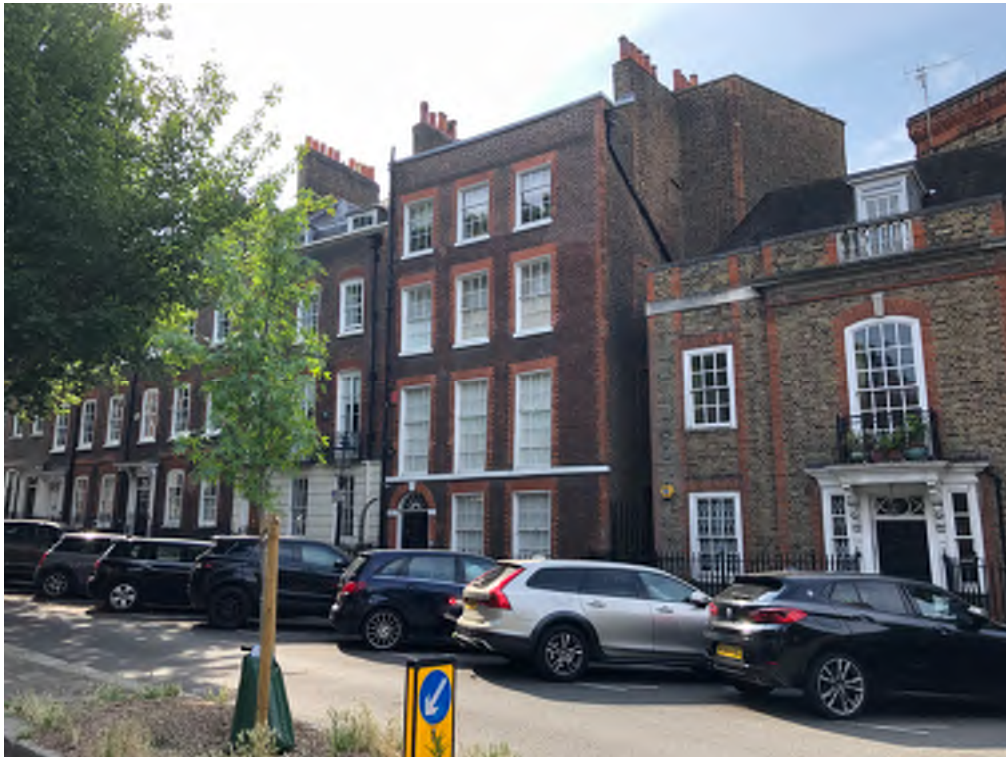
**Figure 2.3** Context view of front elevation

- 2.3 The front elevation is arranged traditionally in a geometrically regular pattern of window openings with flat arch brickwork lintels supported on brickwork piers and walls (see Figures 2.3 & 2.4). The Ground floor entrance doorway has a round headed brickwork arch in a style typical of the period which is similarly supported on the adjacent brickwork walls.

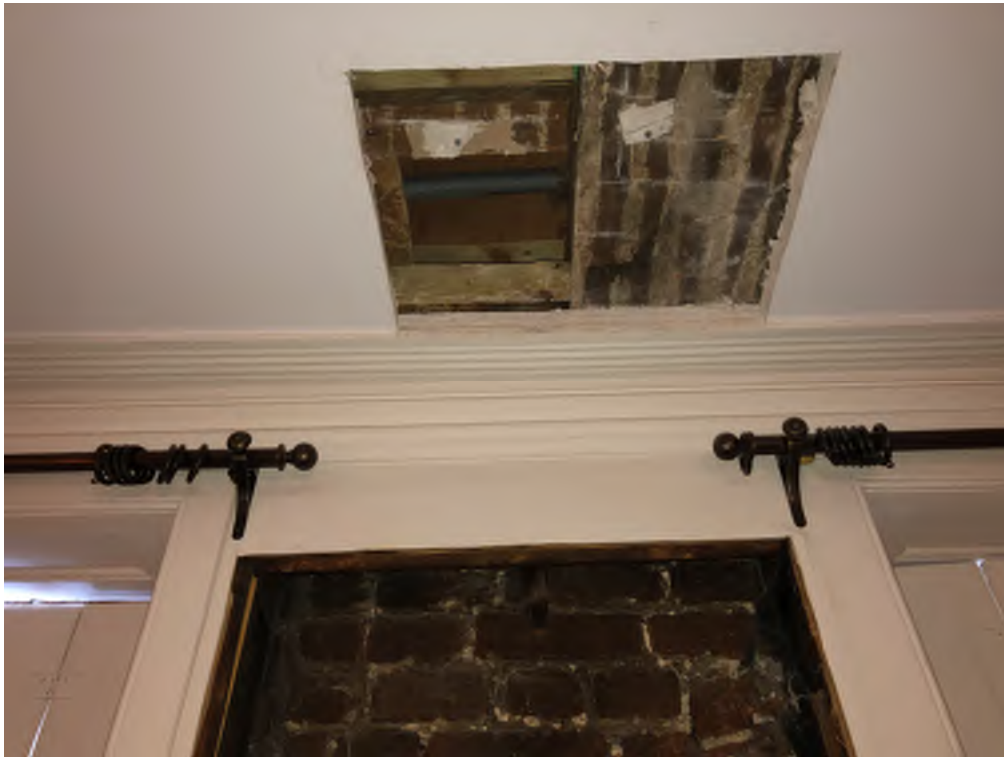
Figure 4.9 Intrusive investigation of floor structure at Ground floor

- At Second and Third floor levels the front elevation brickwork wall was found to be in good condition where investigated with no noteworthy separation between the refronting brickwork and the original brickwork (see Figures 4.7 & 4.8).
- Opening up of localised areas of the ceilings at Basement, Ground and First floor confirmed that the floors are of traditional timber construction, comprising primary timber beams spanning front to back and bearing on the brickwork piers of the front elevation via timber wall plates, supplemented with timber floor joists spanning side to side between the primary beams (see Figures 4.9 & 4.10). The floor structure was found to be in good condition where investigated.
