Donald Insall Associates

Discharge of Conditions 4a - LBC application 2021/4813/L - approved on 19th of May 2022

Floorboard Repairs Method Statement

January 2024

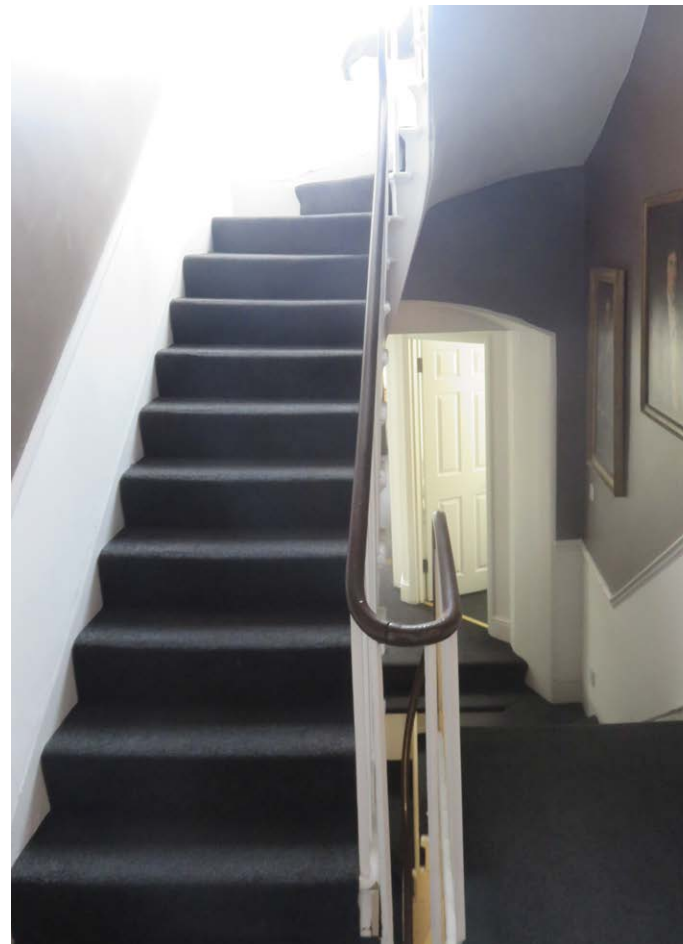
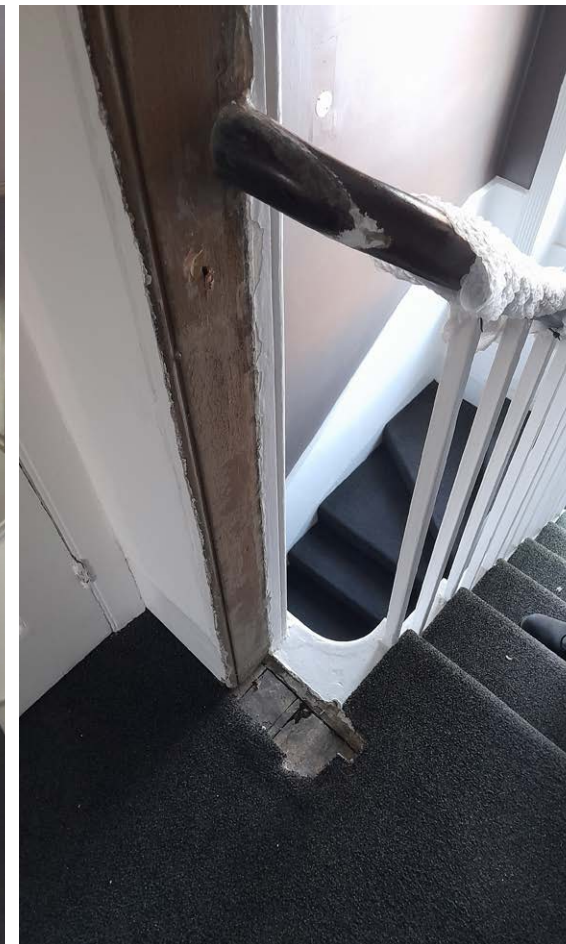
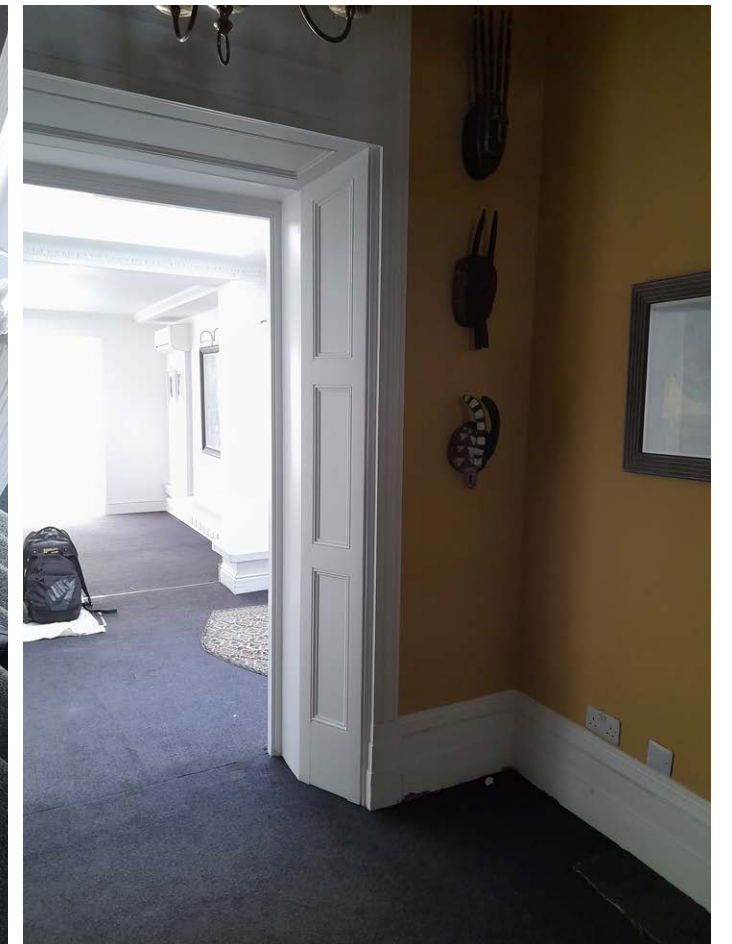
The removal of the office carpets also revealed a build up of recent paint, on the main stairs, including both risers and treads, from ground to second floor.

Office carpet on stairs when property was in office use.

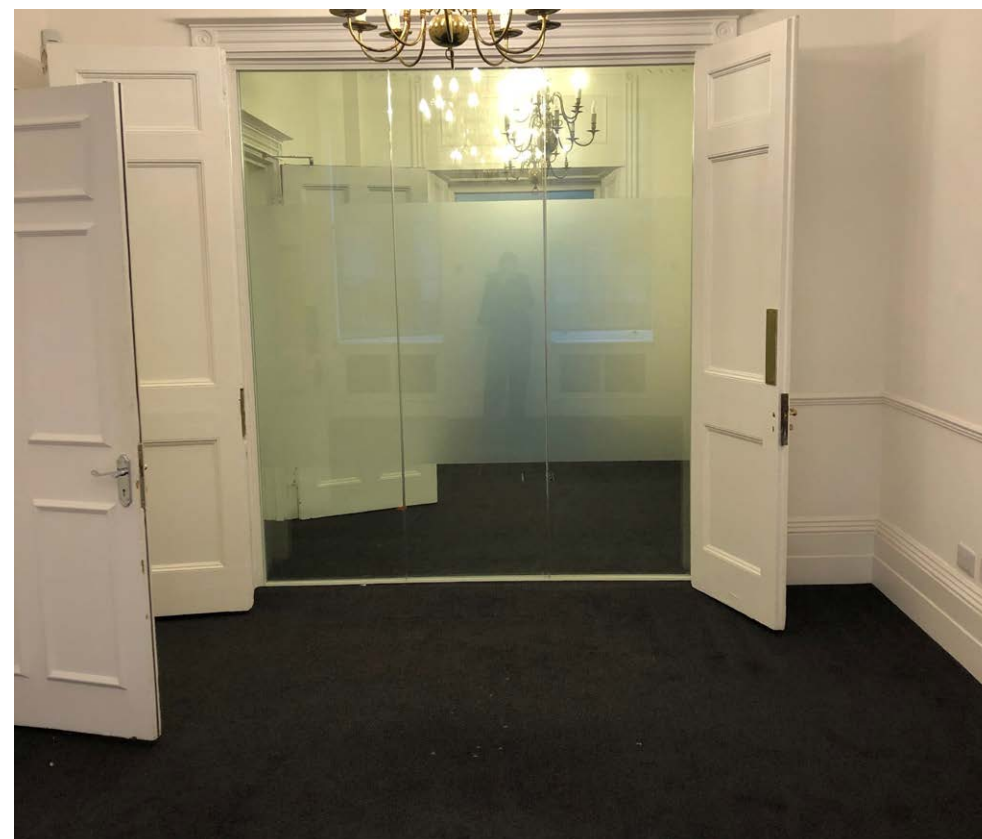
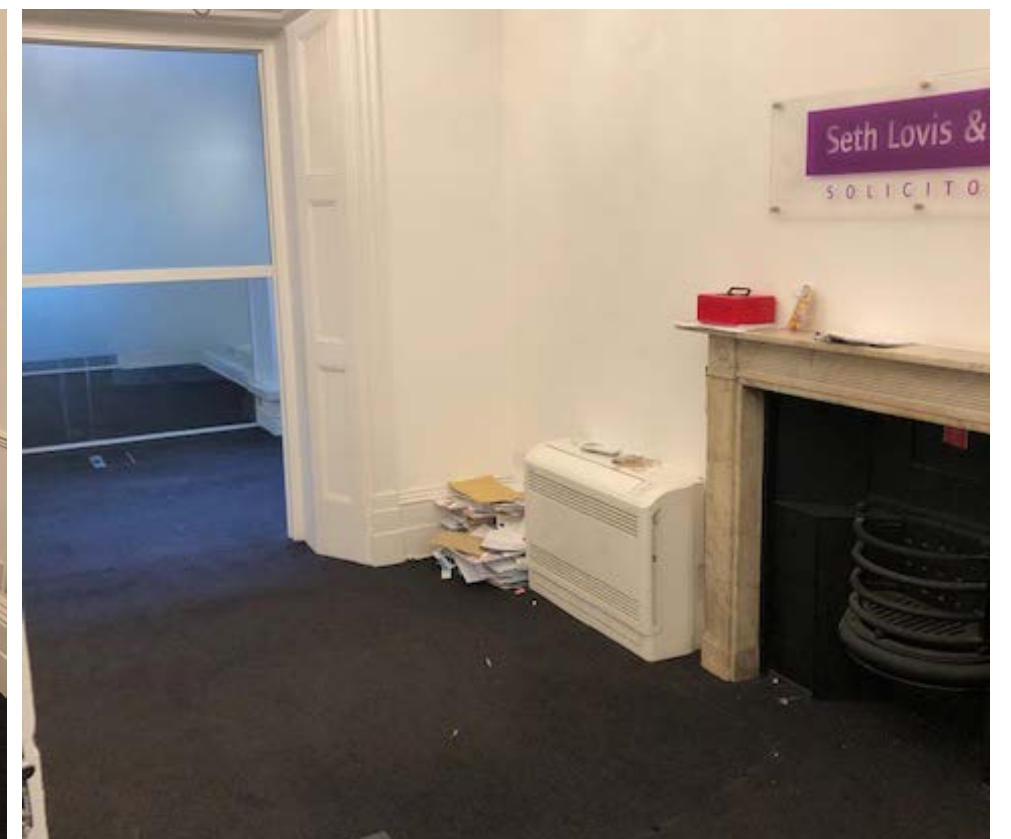
Office carpet in main reception rooms (Ground floor shown here) when property was in office use.

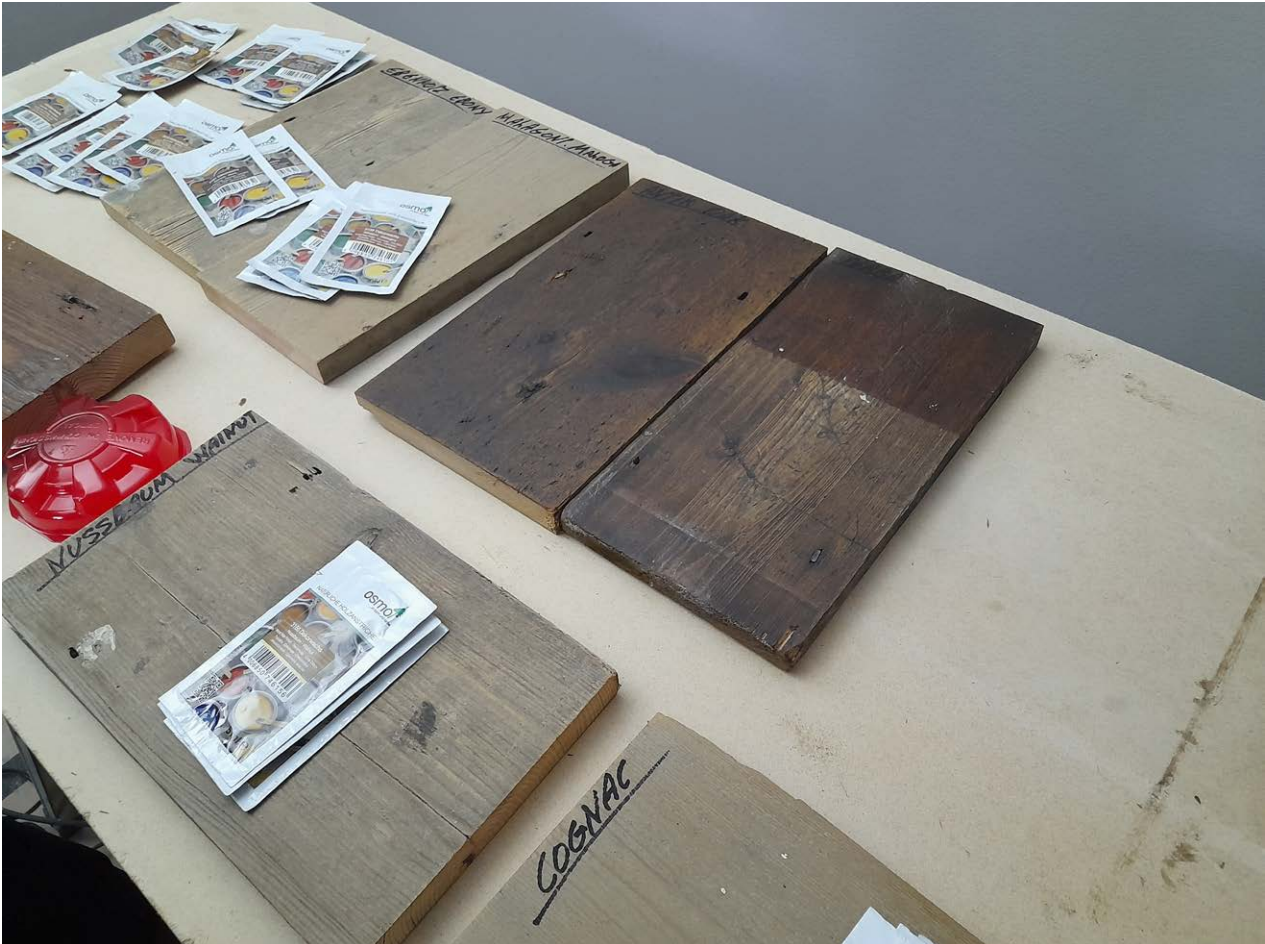
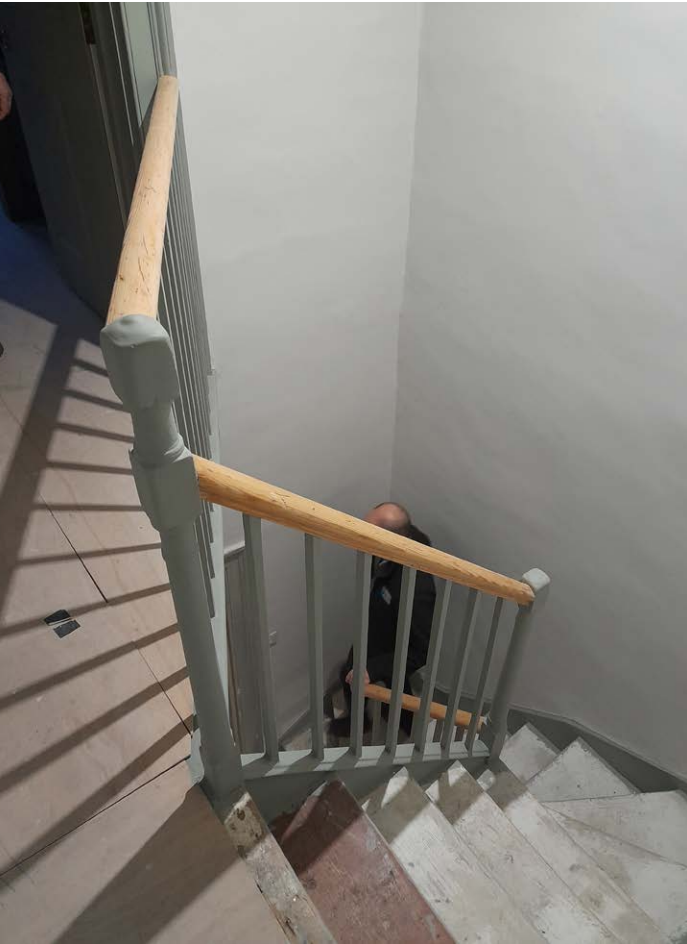
Sample of colour shades from OSMO, and stairs from second floor to third floor.

The main stairs' treads, the stairs leading from the second to the third floor, and the floorboards of the second floor master bathroom will receive a water-based paint finish (1 or 2 coats as necessary) supplied by Farrow and Ball, colour to be determined.
