REMEDIAL WORKS TO BASEMENT AND GROUND FLOOR:

State Street Street Proposed Basement & Ground Floor Plans PROJECT REF. | SHEET NO. CP-2023-41 | S1-10 SCALE SHEET SIZE DATE CLIENT PURPOSE 1:50 A2 02|10|2023 - PURPOSE

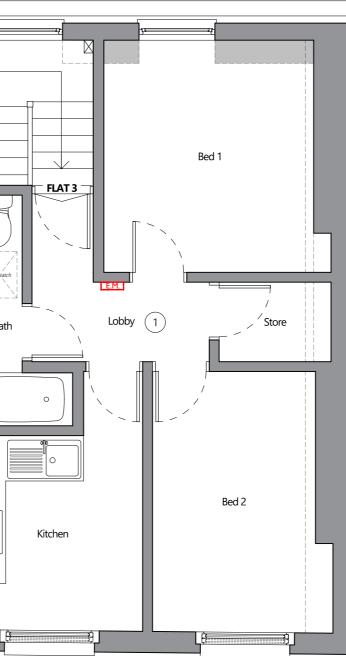
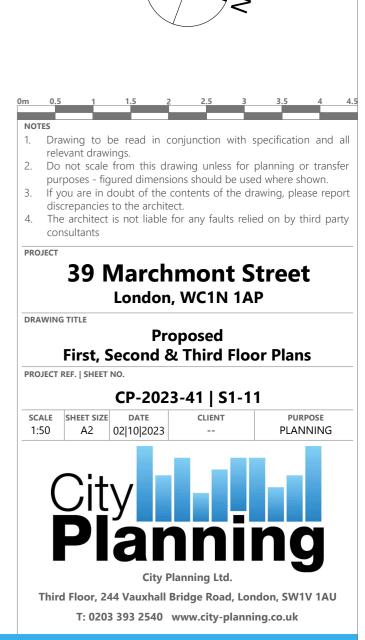
Third Floor Scale: 1:50 @ A2

- 1. The timber floors at the upper levels show extensive sag / deflection due to both age and historic defects such as excessive notching. The additional load applied due to partition works has also contribute to the joists becoming overstressed and hence deflecting further than expected. New joists are to be introduced adjacent to the existing joists or at 600mm ctrs (whichever greater), supported on the external walls at one end and the central spine structure at the other end of the joist. They shall be through bolted to the existing joists at regular centres. The new joists shall be installed to be level across the entire floor plate.

- 2. Where joists meet the external walls, brick repairs are likely required. Investigations show the façade may reduce to one brick thickness through the zone of the floor. New reclaimed brickwork to be introduced in lime based mortars.

REMEDIAL WORKS TO INTERNAL STRUCTURE:

(subject to a full investigation of the existing floor joists)

- Proposed drainage run through floor to connect to existing soil pipe.
- 4. Historic (blocked up) opening to be reinstated to form new fire protected entrance lobby into Flat 1.

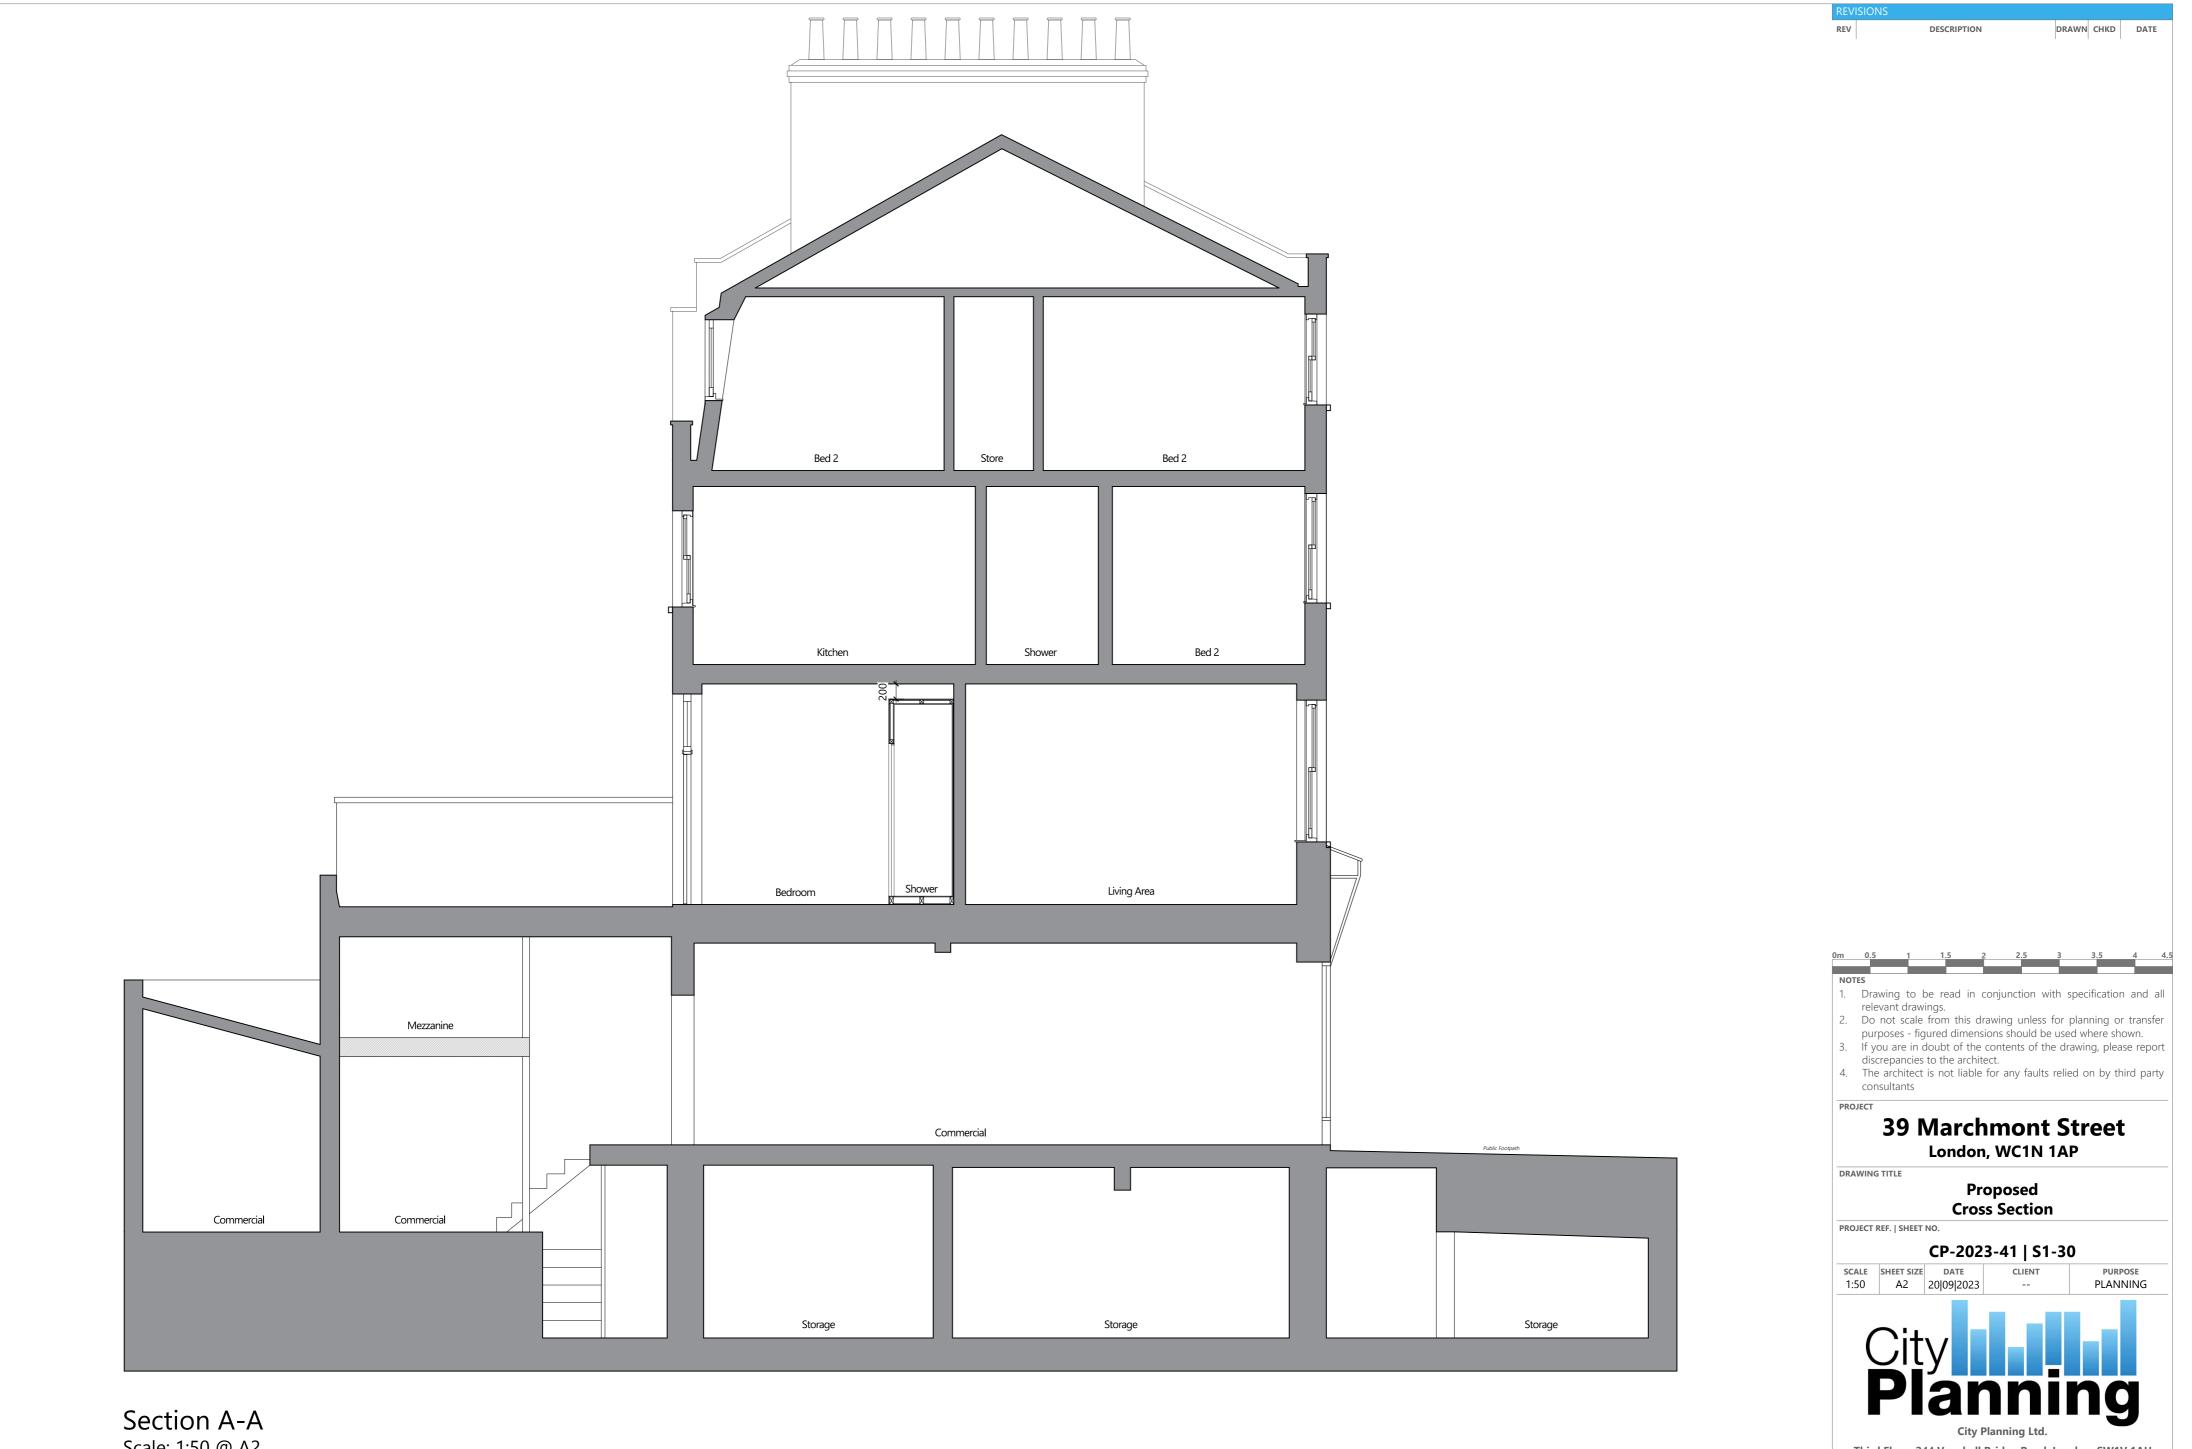
Note: Historic structural interventions at the ground and lower ground floor below the façade are to be fully repaired with new suitable structural supports to ensure the ongoing stability of the rear of the property.

REMEDIAL WORKS TO REAR ELEVATION:

- 1. Repair the cracks to the facades (internally and externally) using proprietary crack bonding steel ties and lime-based replacement mortars.
- 2. Remove soil pipes and repair damaged brickwork behind.
- 3. Temporarily support and repair failed lintels using new reclaimed masonry and lime mortar to reinstate cracked bricks and failed supports.
- 4. Remove all cementitious render.
