Proposed Extension, Travelodge, Drury Lane, Covent Garden, WC2B 5RE

Appendix D – COMMERCIALDW Report

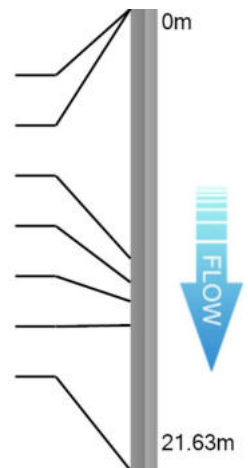
Position	Code	Description	CD	Pic	Video Ref	
00.00m	MH	Start node type, manhole		0_0		
00.00m	WL	Water level 0%		0_1	0:00:00	
11.71m	WL	Water level 5%		0_2	0:00:43	
12.82m	WL	Water level 10%		0_3	0:00:47	
13.71m	DES	Settled deposits fine 10%		0_4	0:00:52	
14.83m	WL	Water level 40%		0_5	0:00:59	
21.63m	MHF	Finish node type, manhole		0_99

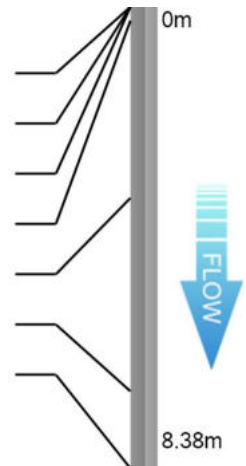
Position	Code	Description	CD	Pic	Video Ref		
00.00m	MH	Start node type, manhole		1_0			
00.00m	WL	Water level 0%		1_1	0:00:00		
00.00m	WL	Water level 5%		1_2	0:00:01		
00.25m	LRH	Line of drain/sewer deviates right [half]		1_3	0:00:04		
03.47m	WL	Water level 10%		1_4	0:00:24		
06.98m	DES	Settled deposits fine 10%		1_5	0:00:31		
08.38m	MHF	Finish node type, manhole		1_99

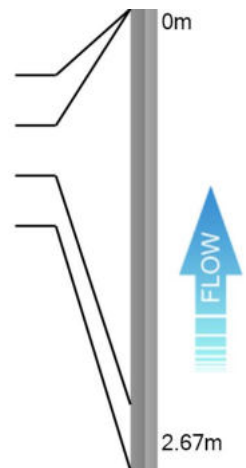
Position	Code	Description	CD	Pic	Video Ref		
00.00m	MH	Start node type, manhole		2_0			
00.00m	WL	Water level 0%		2_1	0:00:00		
02.29m	DEE	Attached deposits, encrustation 04-08 20%		2_2	0:00:29		
02.67m	SA	Survey abandoned		2_99

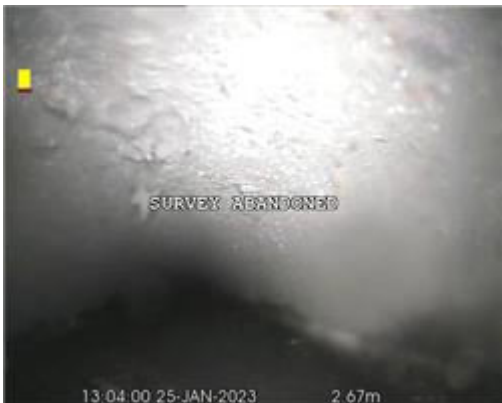
Pos	Video Ref	Code	Description	Image
02.67m		SA	Survey abandoned LAT A	<p>Image Provided - Ref: 2_9999</p>

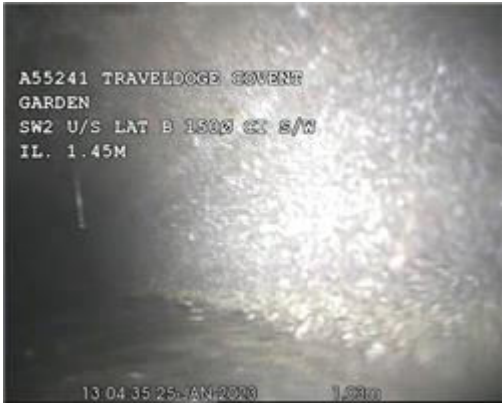
Pos	Video Ref	Code	Description	Image
01.03m	0:00:06	DES	Settled deposits fine: 5% Cross sectional area loss - Severity 3	<p>Image Provided - Ref: 3_3</p>

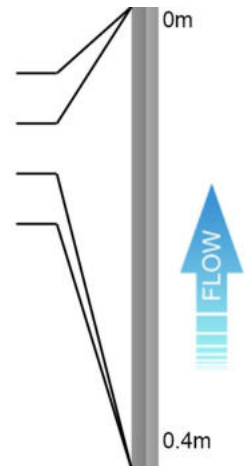
Position	Code	Description	CD	Pic	Video Ref	
00.00m	MH	Start node type, manhole		4_0		
00.00m	WL	Water level 0%		4_1	0:00:00	
00.40m	LUH	Line of drain/sewer deviates up [half]		4_2	0:00:03	
00.40m	SA	Survey abandoned		4_99

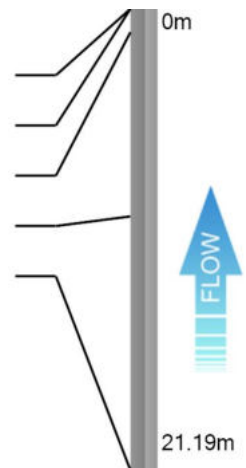
Position	Code	Description	CD	Pic	Video Ref	
00.00m	MH	Start node type, manhole		5_0		
00.00m	WL	Water level 0%		5_1	0:00:00	
01.07m	DES	Settled deposits fine 5%		5_2	0:00:07	
09.53m	DES	Settled deposits fine 10%		5_3	0:00:35	
21.19m	MHF	Finish node type, manhole		5_99

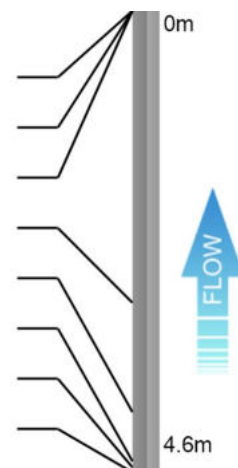
Position	Code	Description	CD	Pic	Video Ref		
00.00m	MH	Start node type, manhole		6_0			
00.00m	WL	Water level 0%		6_1	0:00:00		
00.00m	DES	Settled deposits fine 10%		6_2	0:00:00		
02.91m	LUQ	Line of drain/sewer deviates up [quarter]		6_3	0:00:41		
04.00m	LDQ	Line of drain/sewer deviates down [quarter]		6_4	0:00:44		
04.49m	DEE	Attached deposits, encrustation 04-08 10%		6_5	0:00:50		
04.55m	CU	Loss of vision		6_6	0:00:56		
04.60m	MHF	Finish node type, manhole		6_99

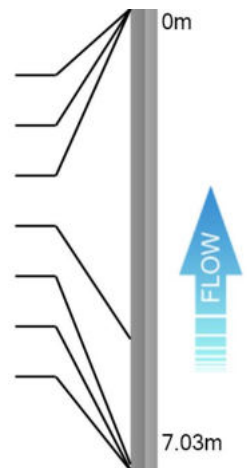
Position	Code	Description	CD	Pic	Video Ref		
00.00m	MH	Start node type, manhole		7_0			
00.00m	WL	Water level 5%		7_1	0:00:00		
00.00m	DEE	S1 Attached deposits, encrustation 04-08 10%	S1	7_2	0:00:00		
05.03m	LRQ	Line of drain/sewer deviates right [quarter]		7_3	0:00:30		
06.94m	LUQ	Line of drain/sewer deviates up [quarter]		7_4	0:00:39		
07.03m	DEE	F1 Attached deposits, encrustation 04-08 10%	F1	7_-2	0:00:00		
07.03m	MHF	Finish node type, manhole		7_99

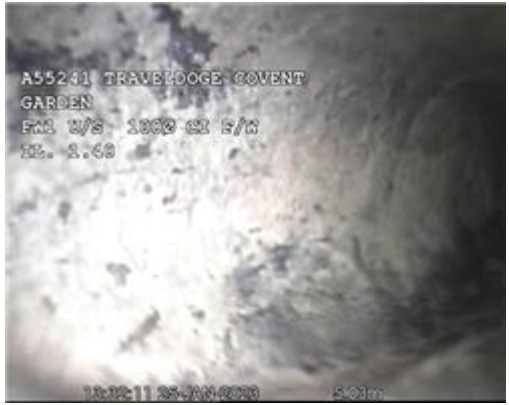
Pos	Video Ref	Code	Description	Image
05.03m	0:00:30	LRQ	Line of drain/sewer deviates right [quarter]	Image Provided - Ref: 7_3

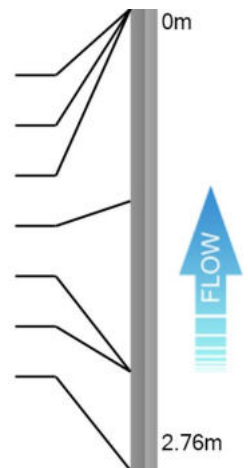
Position	Code	Description	CD	Pic	Video Ref		
00.00m	MH	Start node type, manhole		8_0			
00.00m	WL	Water level 5%		8_1	0:00:00		
00.00m	DEE	S1 Attached deposits, encrustation 03-09 5%	S1	8_2	0:00:00		
01.15m	LDH	Line of drain/sewer deviates down [half]		8_3	0:00:09		
02.17m	DEE	F1 Attached deposits, encrustation 03-09 5%	F1	8_-2	0:00:00		
02.17m	LUQ	Line of drain/sewer deviates up [quarter]		8_4	0:00:13		
02.76m	MHF	Finish node type, manhole		8_99

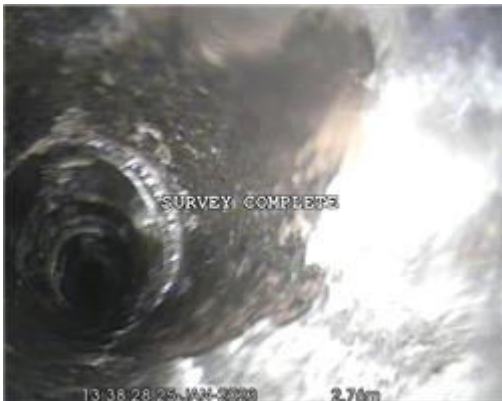
02.76m		MHF	Finish node type, manhole LAT A	Image Provided - Ref: 8_9999

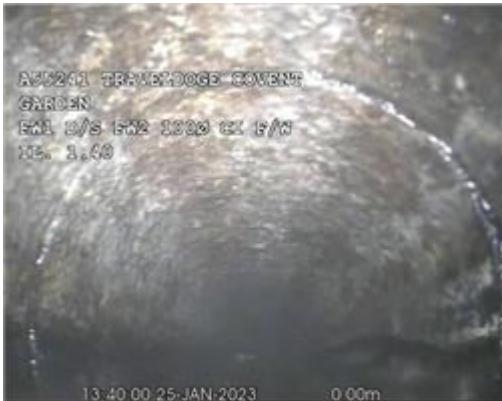
Pos	Video Ref	Code	Description	Image
00.00m		MH	Start node type, manhole FW1	Image Provided - Ref: 9_0

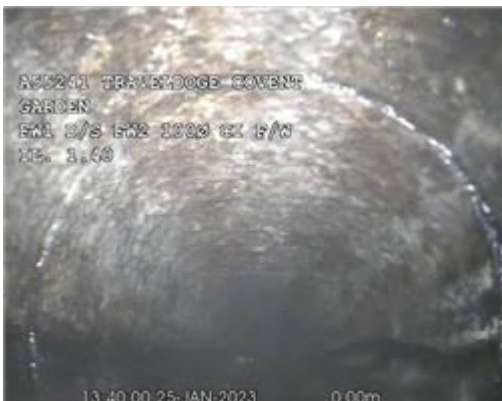
00.00m	0:00:00	WL	Water level: 5% Height/Diameter	Image Provided - Ref: 9_1

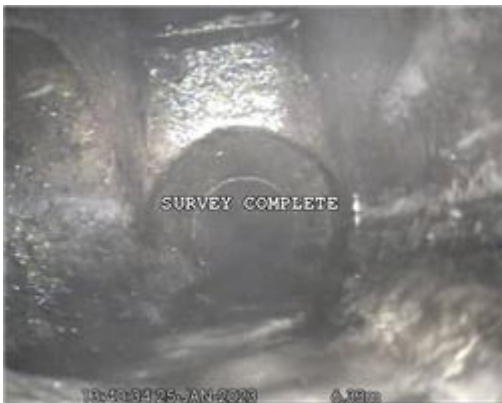
06.07m	0:00:16	F1 DEE	Attached deposits, encrustation Defect End from 04 o'clock to 08 o'clock: 5% Cross sectional area loss - Severity 3	
06.33m		MHF	Finish node type, manhole FW2	Image Provided - Ref: 9_9999

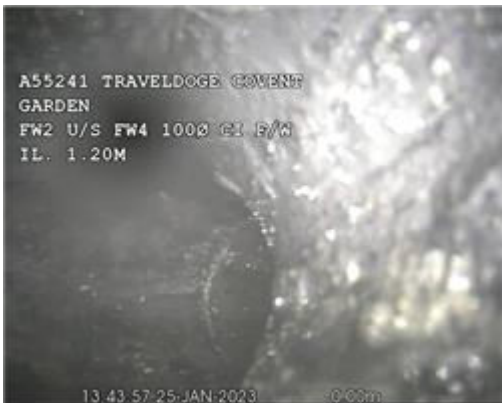
Pos	Video Ref	Code	Description	Image
00.00m		MH	Start node type, manhole FW2	Image Provided - Ref: 10_0

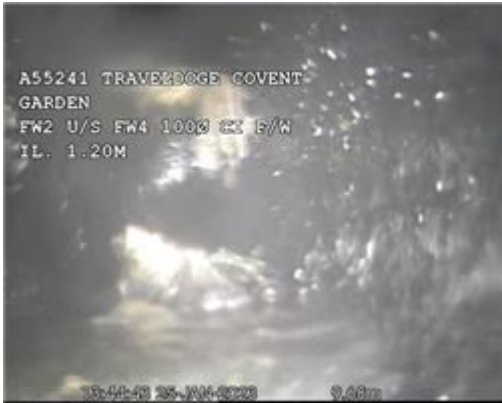
Pos	Video Ref	Code	Description	Image
09.68m	0:00:46	DES	Settled deposits fine: 5% Cross sectional area loss - Severity 3	<p>Image Provided - Ref: 10_3</p>

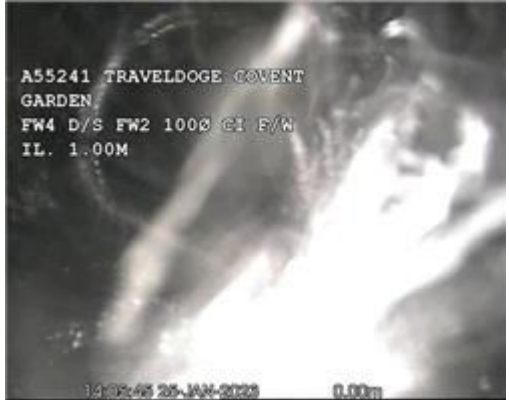
Pos	Video Ref	Code	Description	Image
00.00m		MH	Start node type, manhole FW4	Image Provided - Ref: 11_0

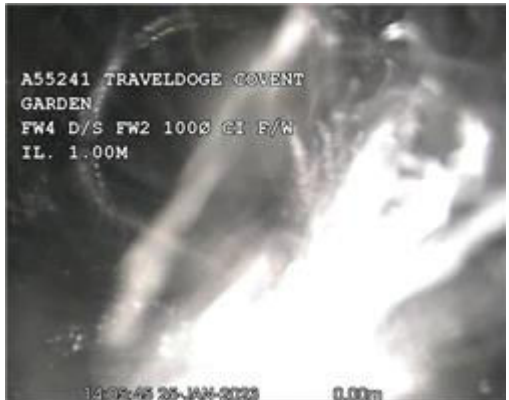
00.00m	0:00:00	WL	Water level: 5% Height/Diameter	Image Provided - Ref: 11_1

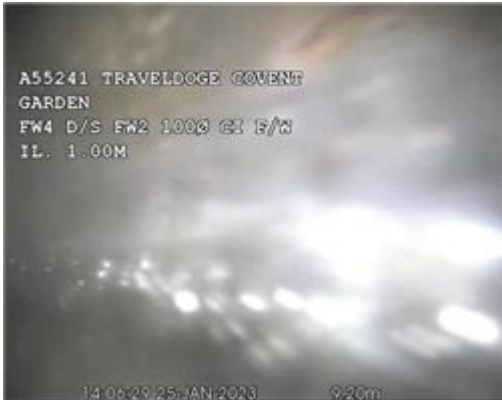
Pos	Video Ref	Code	Description	Image
09.20m	0:00:43	LLH	Line of drain/sewer deviates left [half]	<p>Image Provided - Ref: 11_3</p>

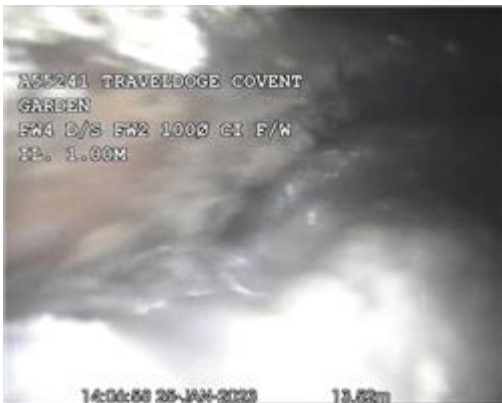
Pos	Video Ref	Code	Description	Image
13.52m	0:01:12	LRH	Line of drain/sewer deviates right [half]	<p>Image Provided - Ref: 11_6</p>

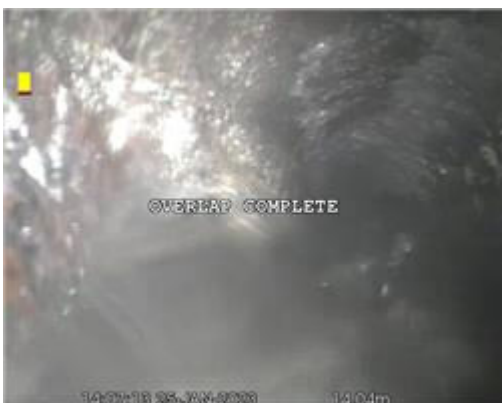
14.04m		MHF	Finish node type, manhole FW2, OVERLAP COMPLETE	<p>Image Provided - Ref: 11_9999</p>

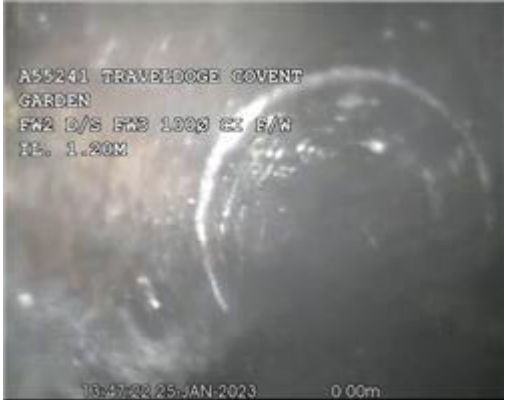
Pos	Video Ref	Code	Description	Image
00.00m		MH	Start node type, manhole FW2	Image Provided - Ref: 12_0

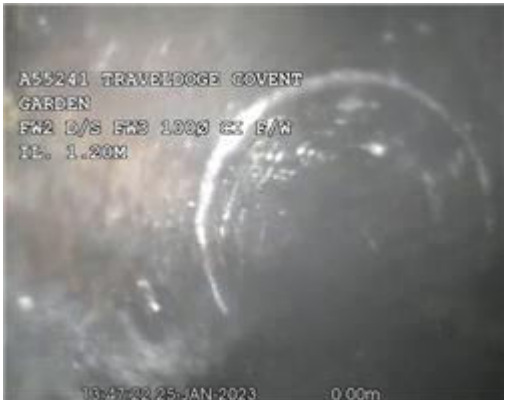
00.00m	0:00:00	WL	Water level: 5% Height/Diameter	Image Provided - Ref: 12_1

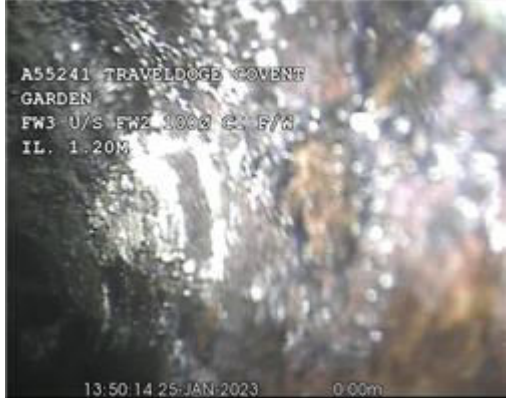
Pos	Video Ref	Code	Description	Image
00.00m		MH	Start node type, manhole FW3	<p>Image Provided - Ref: 13_0</p>

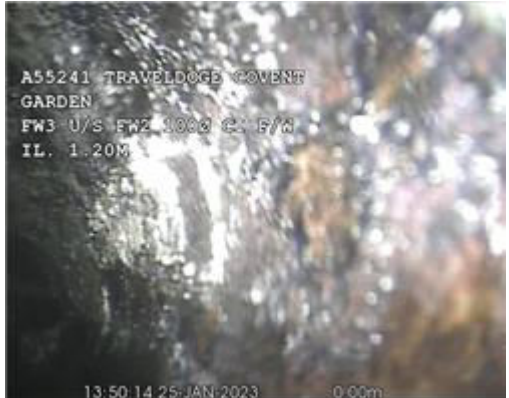
00.00m	0:00:00	WL	Water level: 5% Height/Diameter	<p>Image Provided - Ref: 13_1</p>

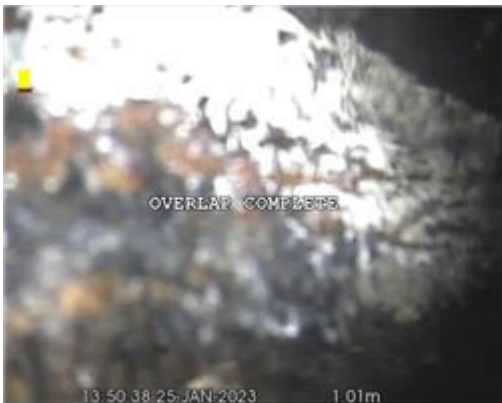
Pos	Video Ref	Code	Description	Image
00.50m		MHF	Finish node type, manhole FW2, OVERLAP COMPLETE	<p>Image Provided - Ref: 13_9999</p>

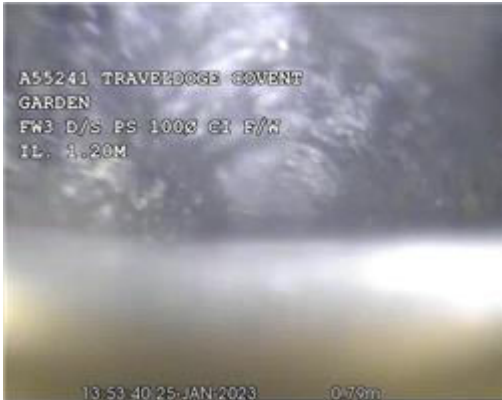
Pos	Video Ref	Code	Description	Image
00.80m	0:00:05	S1 DES	Settled deposits fine 0.8m - 13.5m: 10% Cross sectional area loss - Severity 3	<p>Image Provided - Ref: 14_3</p>

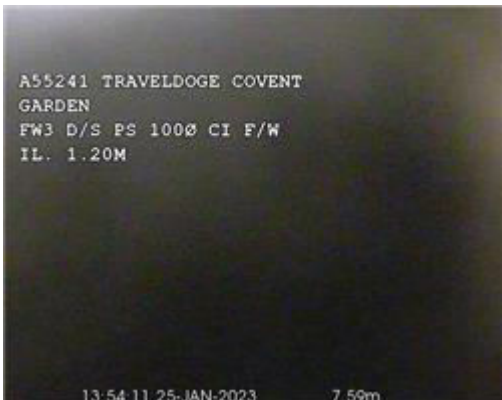
07.59m	0:00:36	CU	Loss of vision	<p>Image Provided - Ref: 14_4</p>

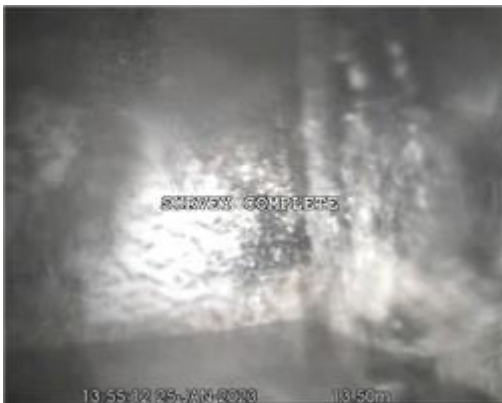
Pos	Video Ref	Code	Description	Image
13.50m		MHF	Finish node type, manhole PUMP STATION	<p>Image Provided - Ref: 14_9999</p>

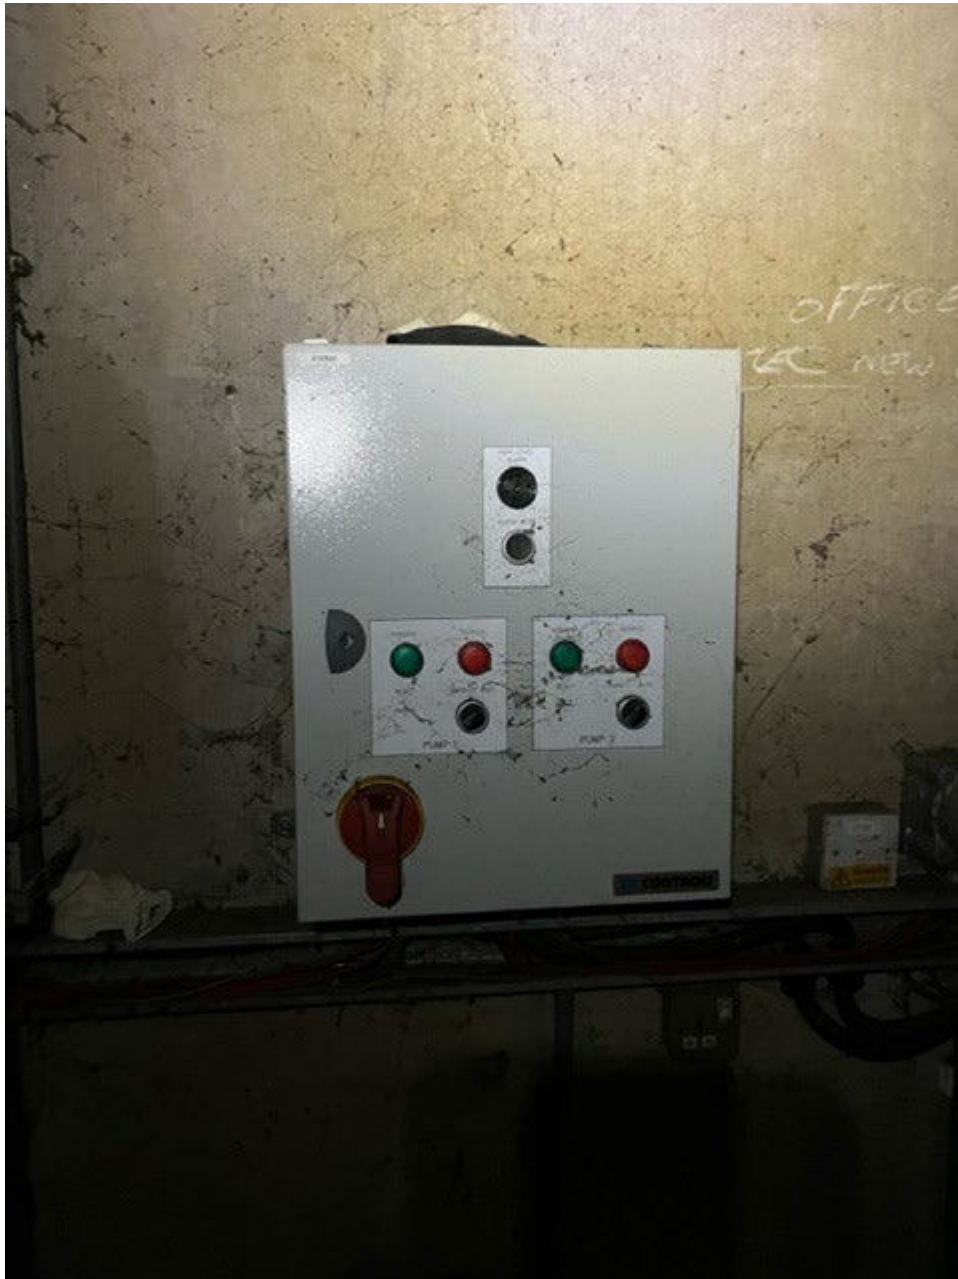
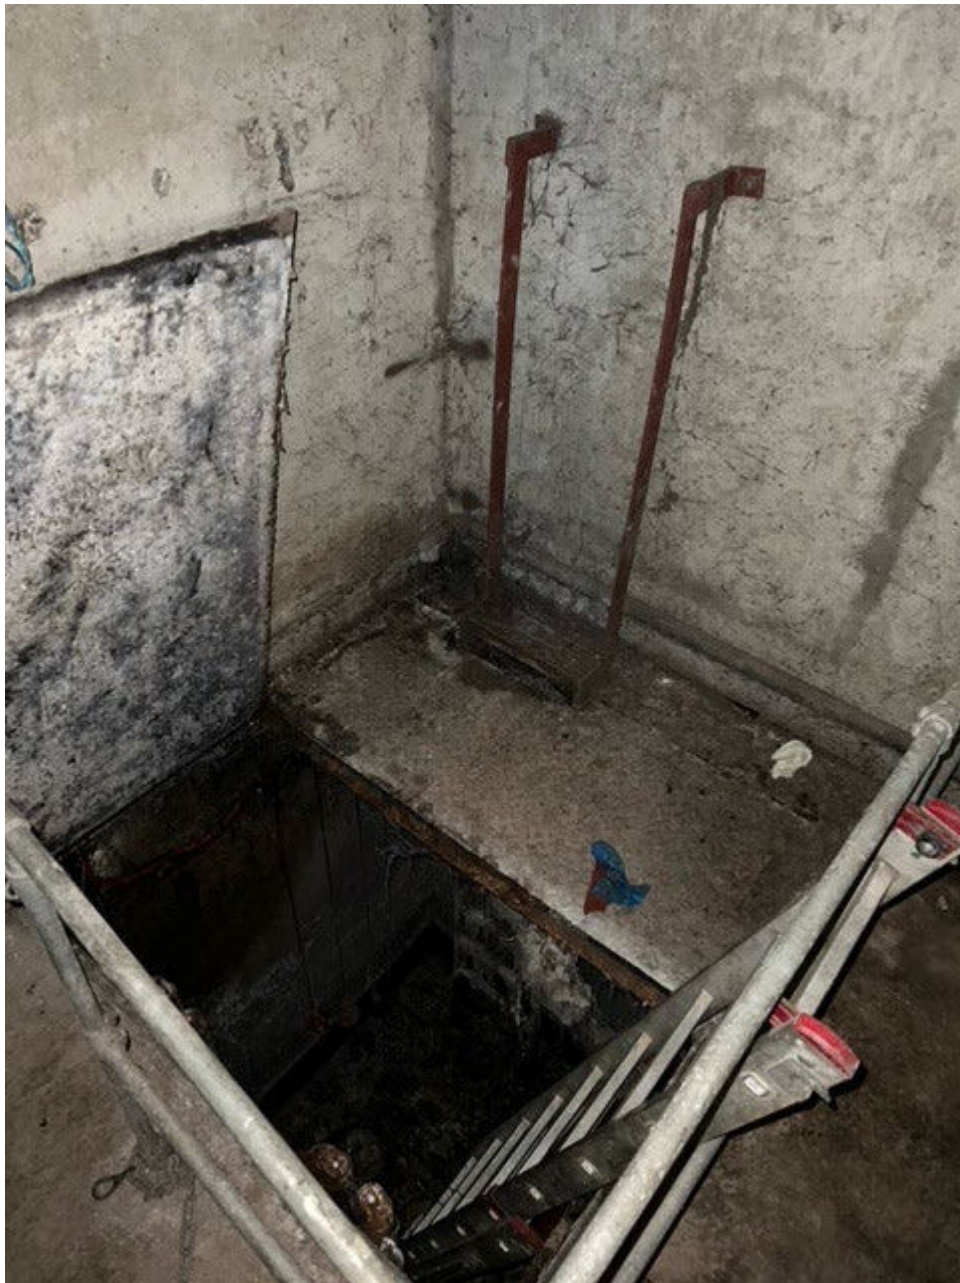
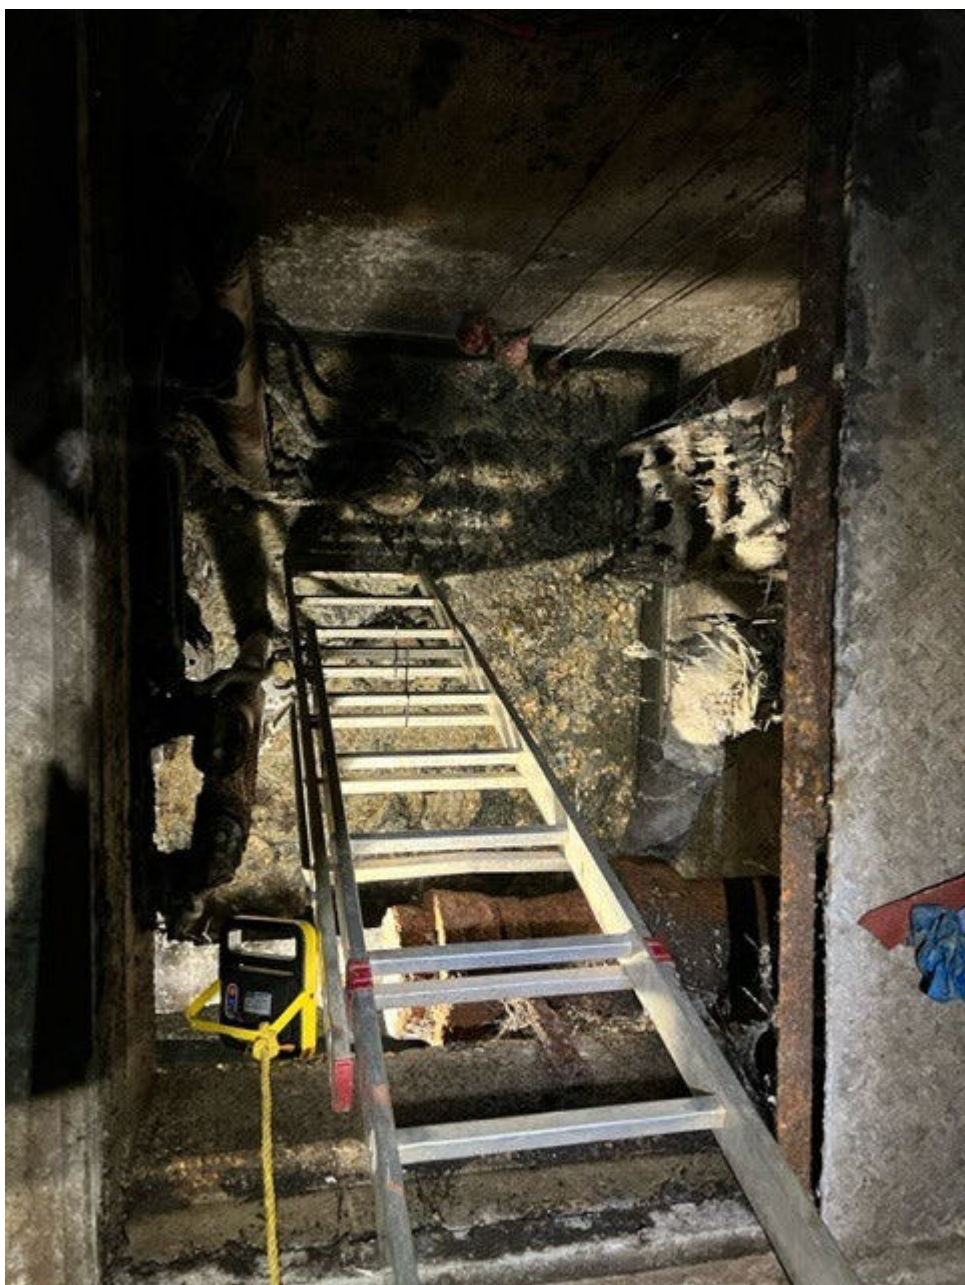
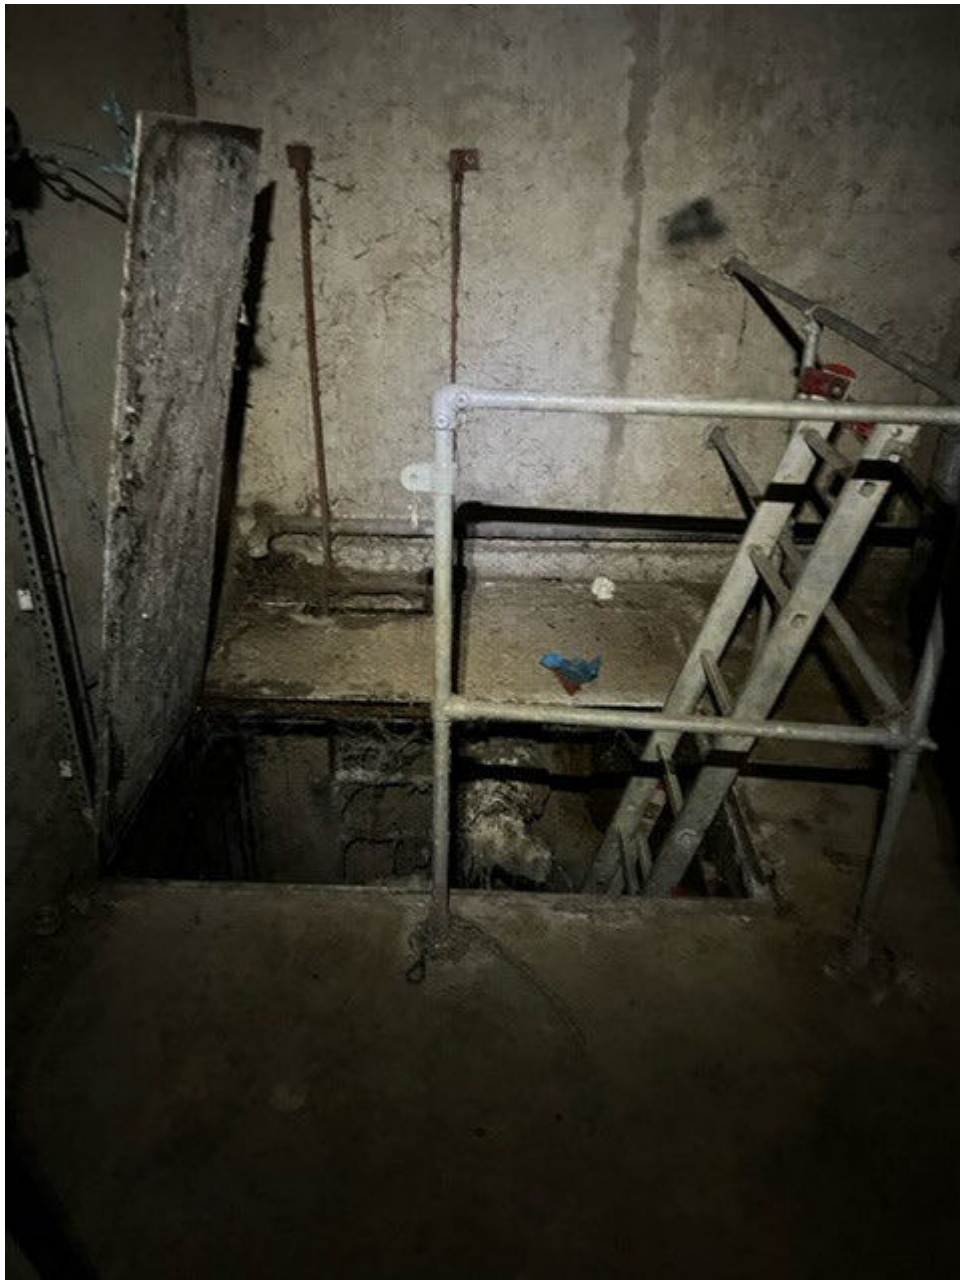
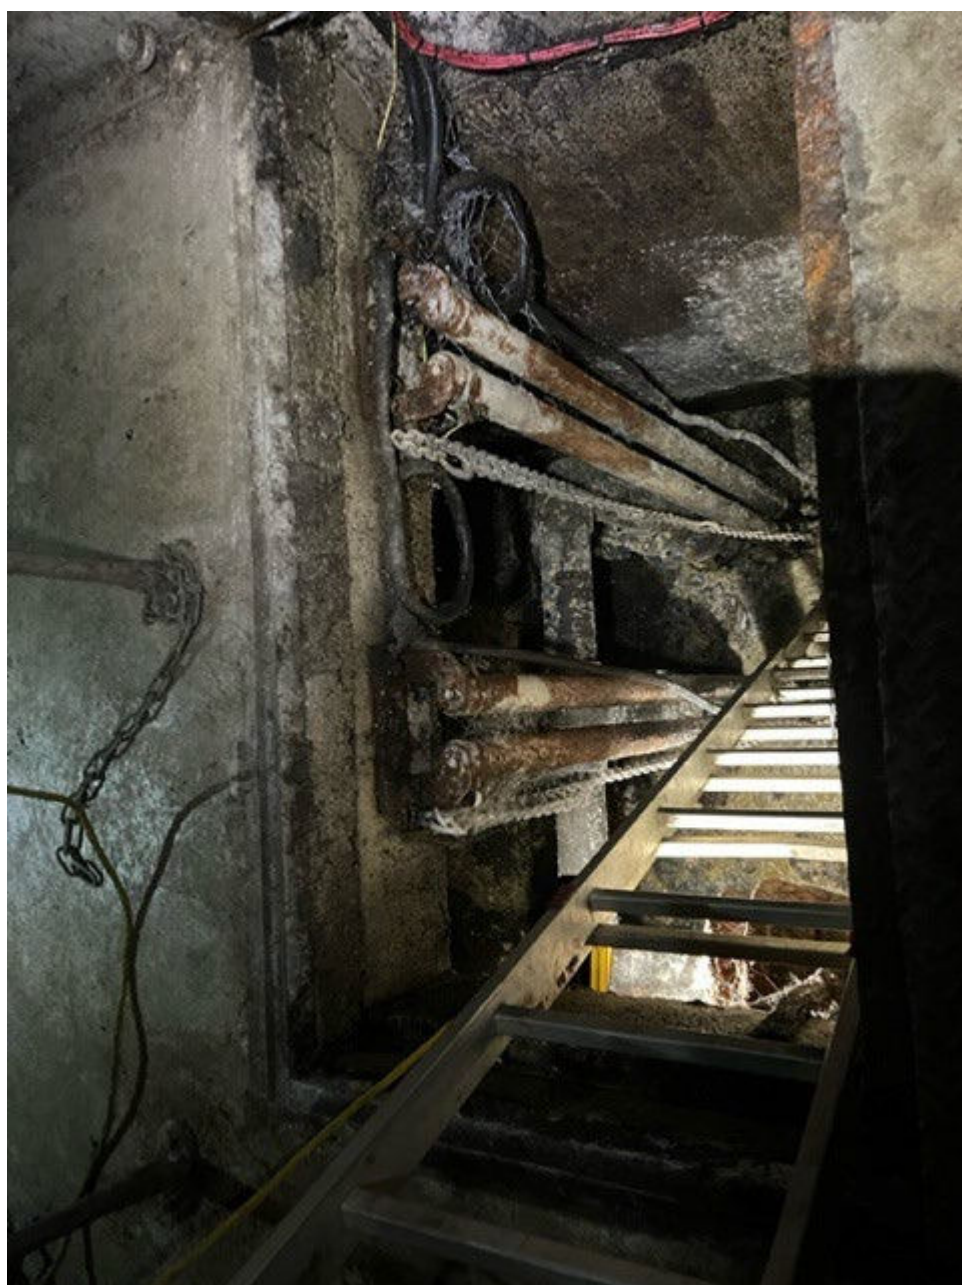
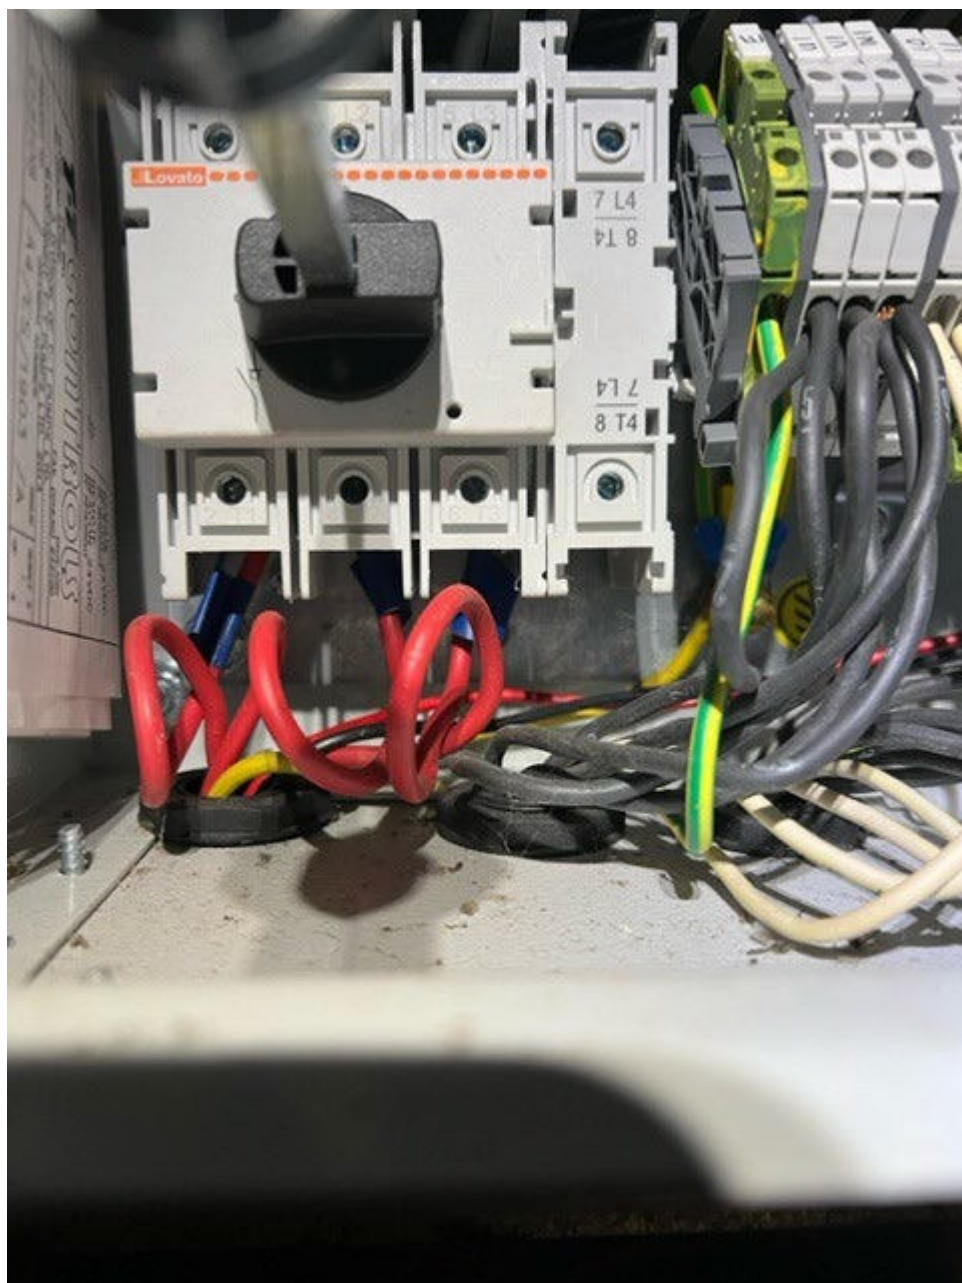
Foul Station Switch Room

- Switch Room Foul Station: Station works but needs Refurbing to bring up to current Spec.
- Switch Room Storm Station: Station works but needs Refurbing to bring up to current Spec.
- Foul Station by Stairs: Station is in fairly good condition however there are a few issues to be addressed.

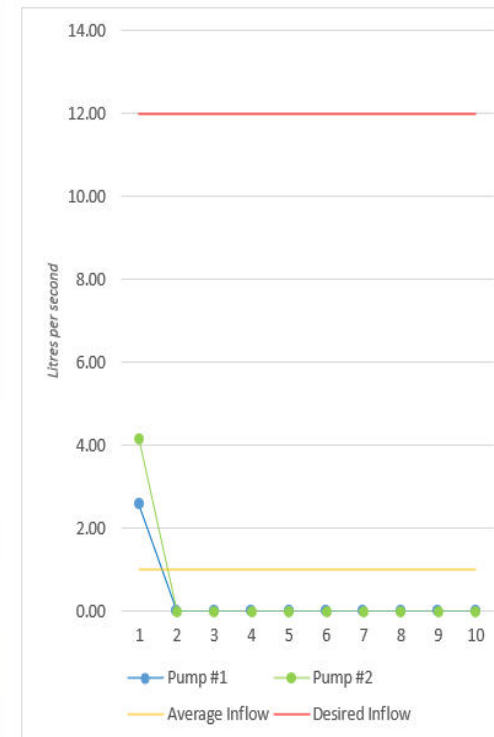
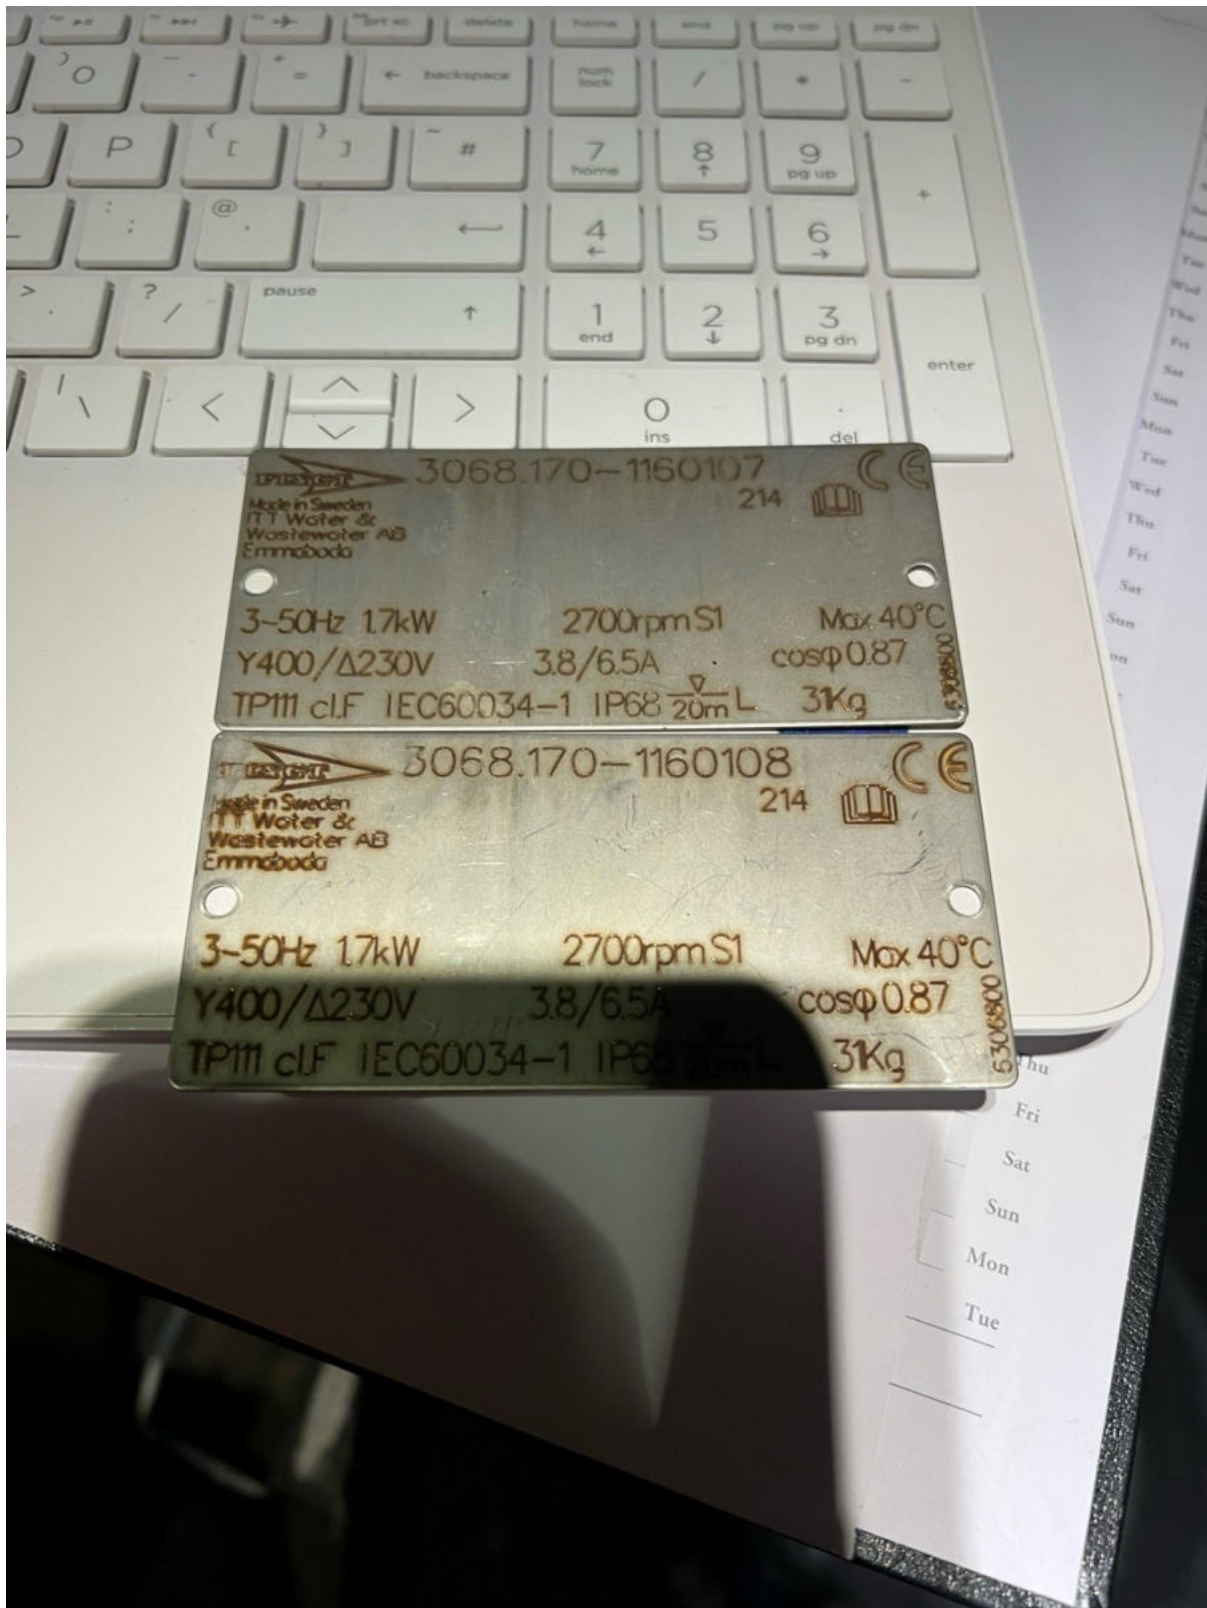
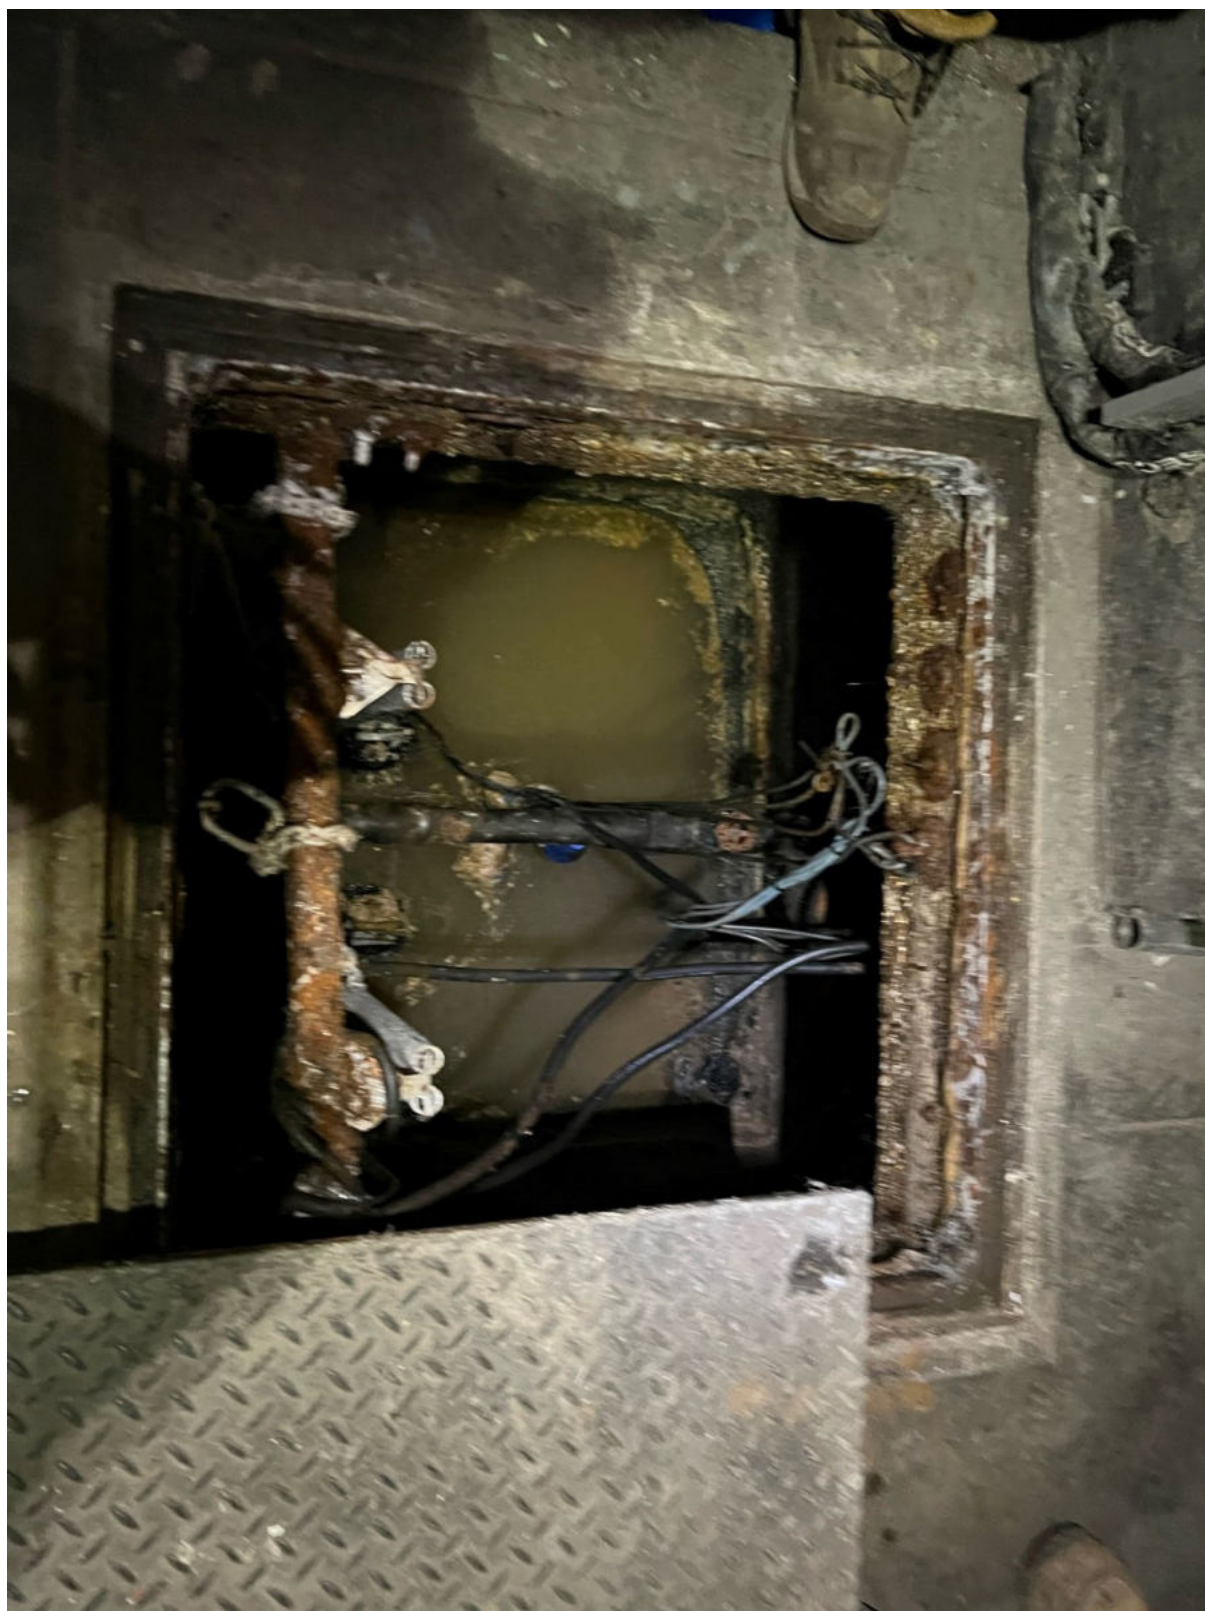
Foul Station at bottom of steps

Foul Station by Stairs: This station is in good condition however needs new floats as cables are stiff and Unistrut is very corroded. The panel works fine with no issues.
