Proposed Extension, Travelodge, Drury Lane, Covent Garden, WC2B 5RE

Appendix D – COMMERCIALDW Report

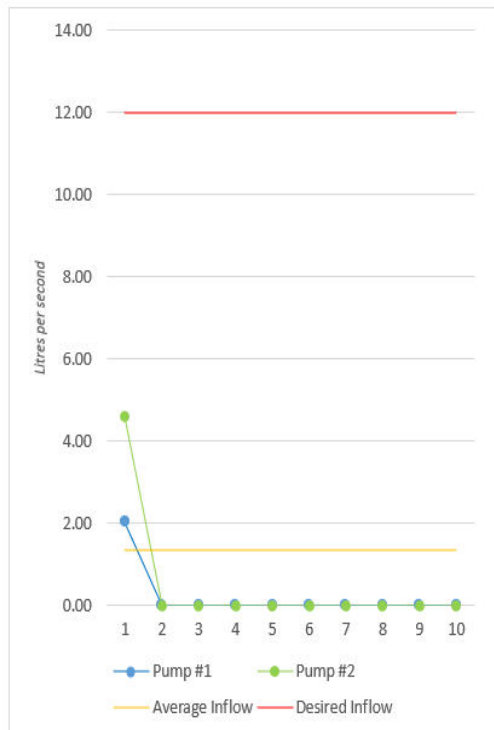
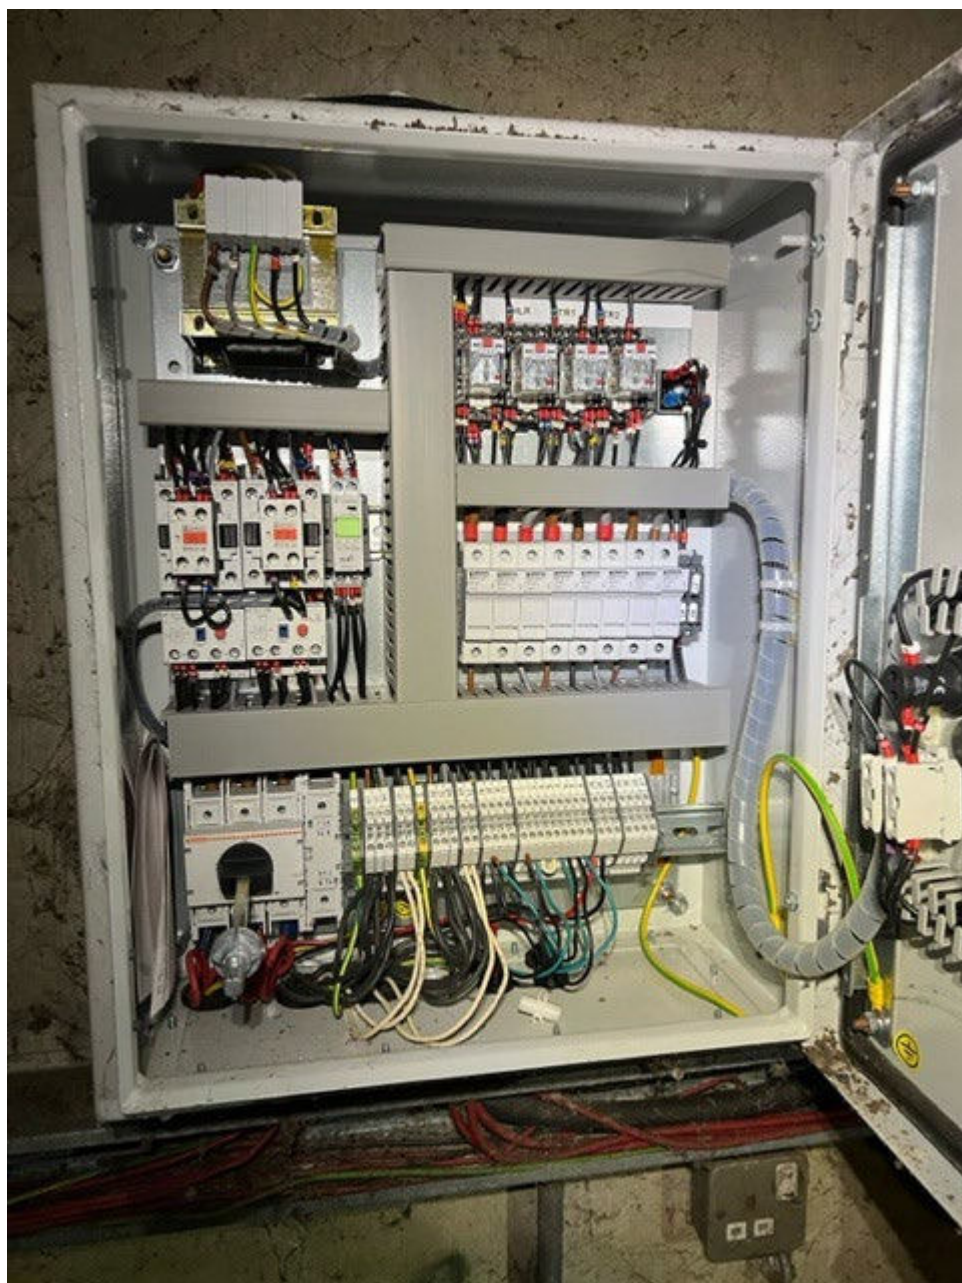
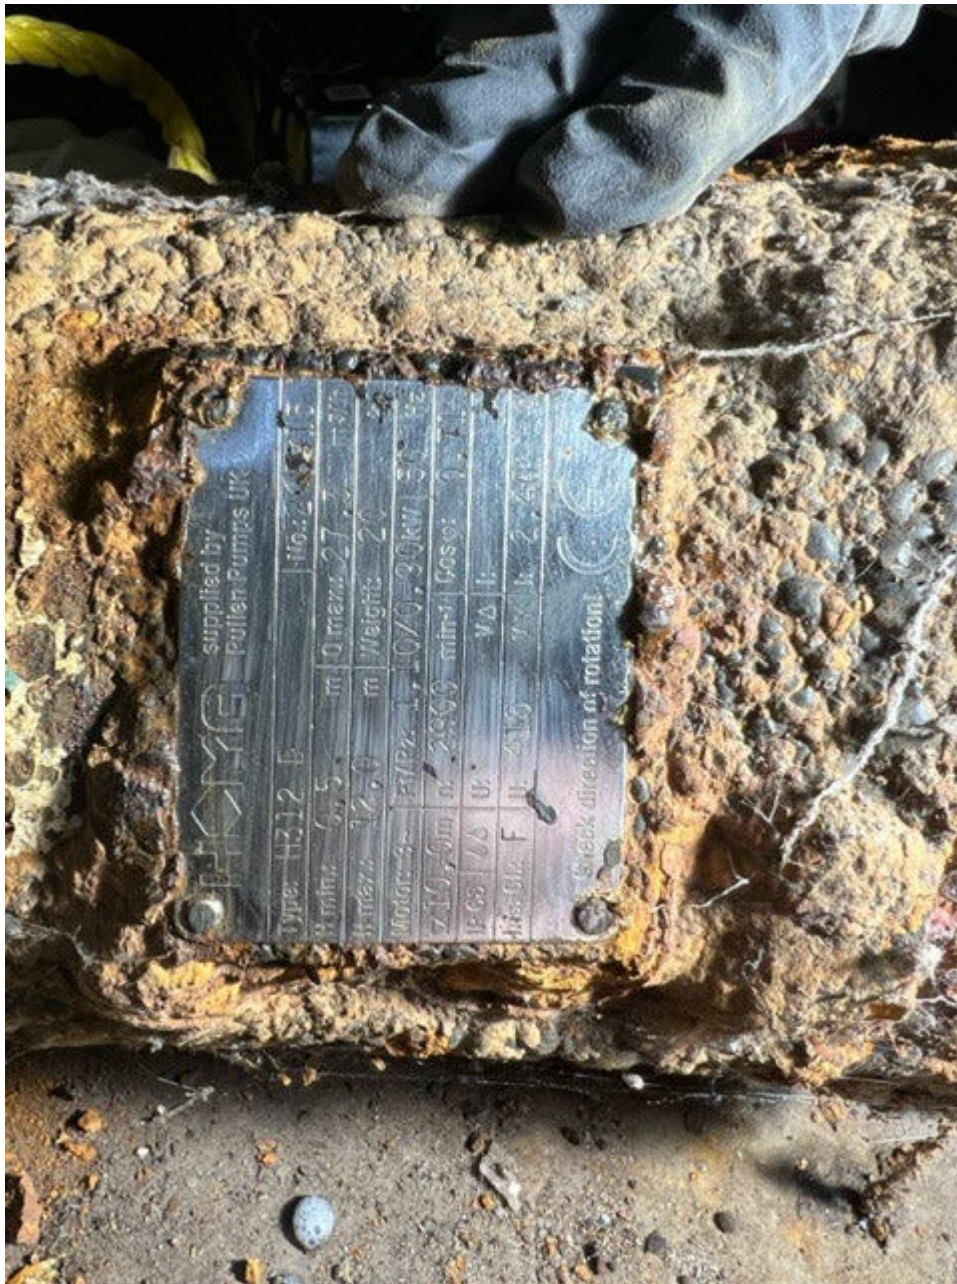
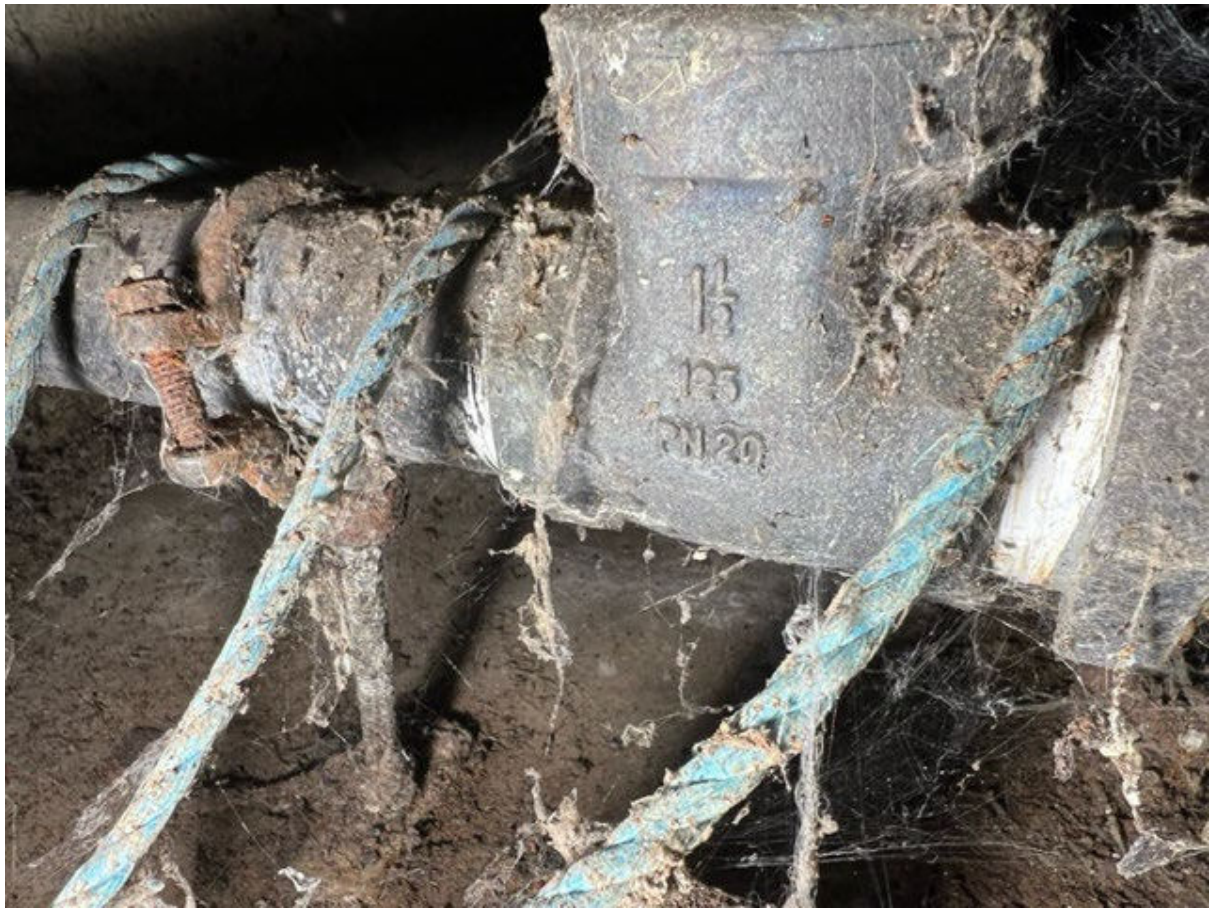
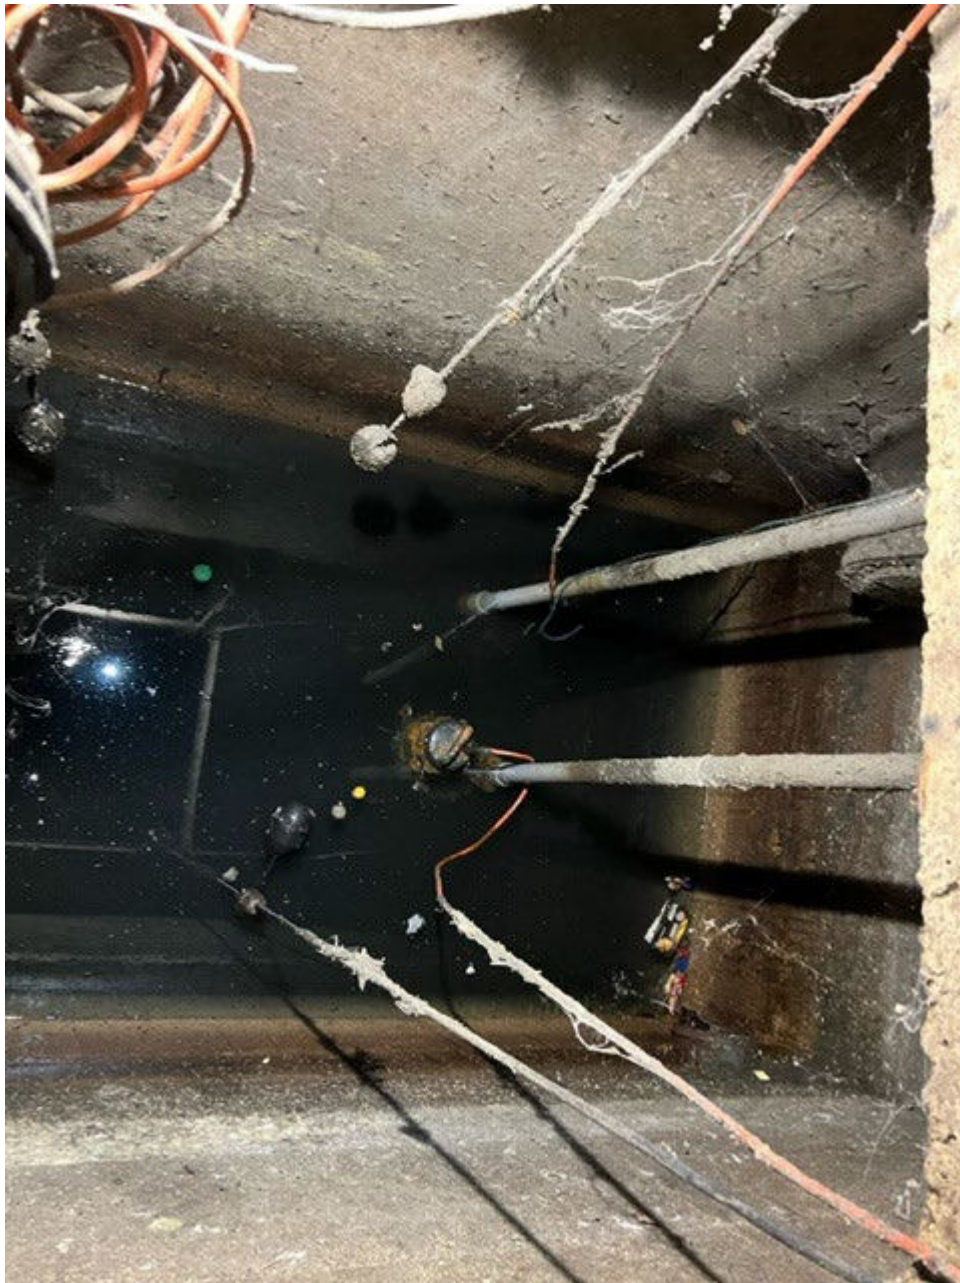
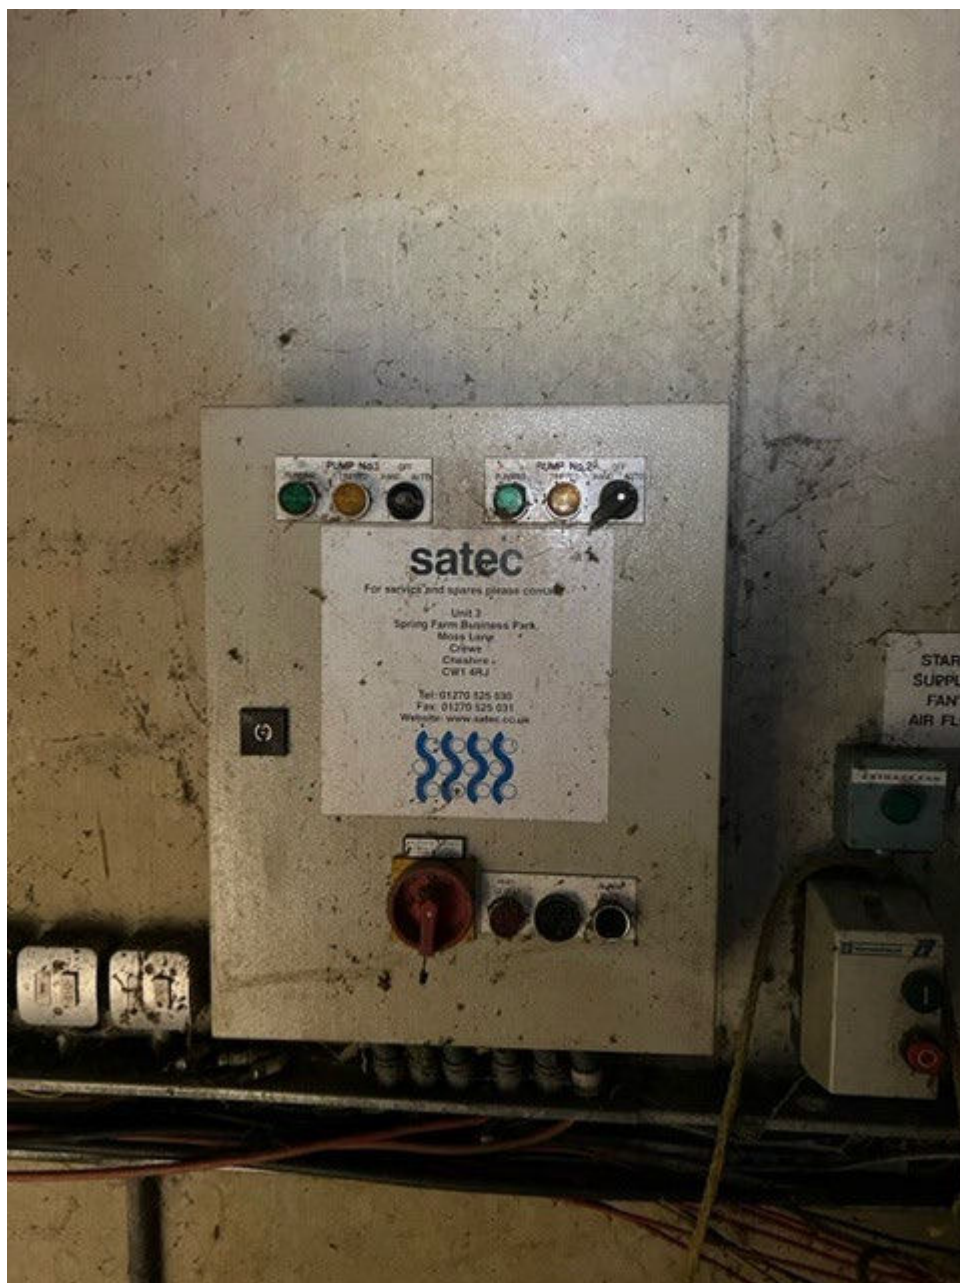
Storm Station – Switch Room

Switch Room Storm Station: This Station is in urgent need of a Full Refurb to bring it up to current spec. Also, the Cover Plate for the old pump station is broken and is very dangerous needs changing and making safe.
