## ARBORICULTURAL ASSESSMENT REPORT

**Risk Address:** 13 Weech Road, London, NW6 1DL

Survey Date: 22/06/2023

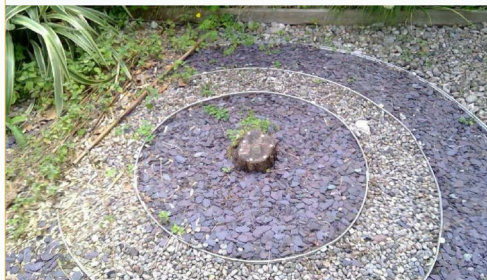
ST1 - Cherry

| Tree No | Common Name | Age Class | Condition | Height (m) | Crown Spread (m) | Stem diam. (mm) | Dist to bldg. (m) | Roots Implicated | Pruning history | Recommendation | Tree work constraints | Notes | Owner address | Owner |
|---|---|---|---|---|---|---|---|---|---|---|---|---|---|---|
| ST1 | Cherry | N/A | DD | 0 | 0 | 0 | 2.5 | N | Felled as per recommendations. | No work required. | | | 13 Weech Road<br>London<br>NW6 1DL | PH |
