Decay Detection Investigation

22 Frognall Way
London
NW3 6XE

March 2023

230227-DID-02

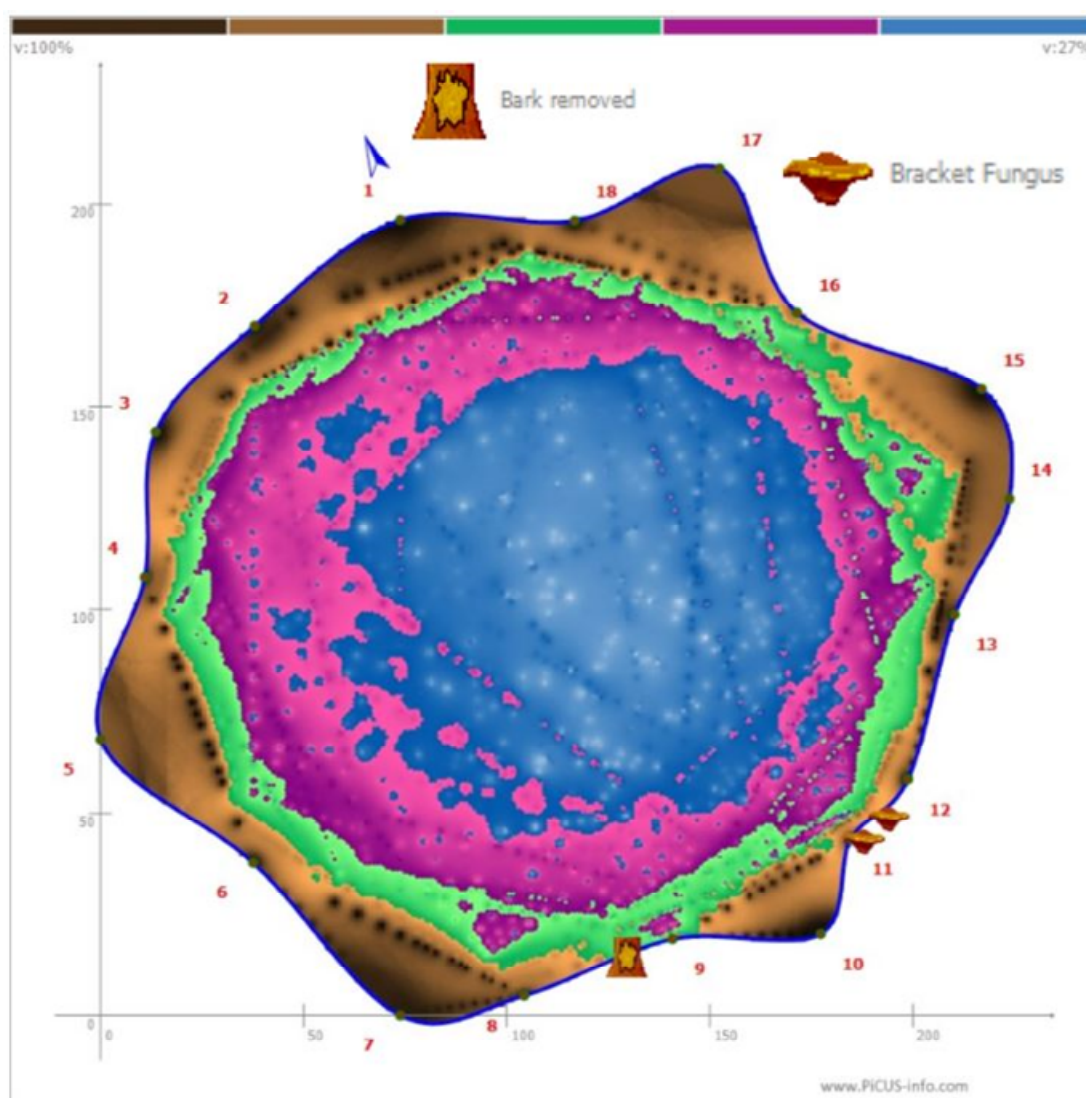
The above tomogram shows extensive internal decay (blue, pink) which continues to develop across the stem (green, yellow/light brown) with some sound wood (dark brown) remaining around the circumference

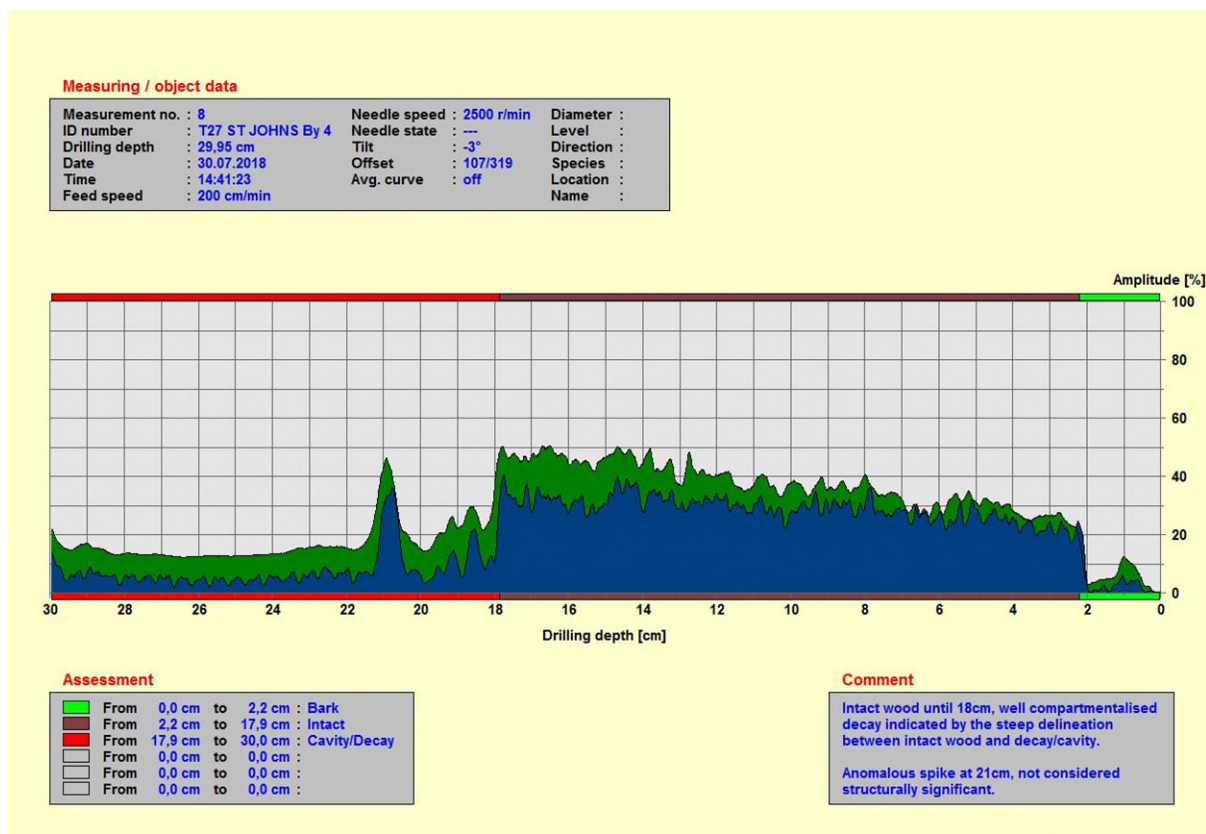
The above RESI PD graph (read from right to left) shows bark to 2cm, intact wood with high resistance until 18cm where resistance drops sharply, indicating well compartmentalised decay throughout the remainder of the graph.
