Asbestos Refurbishment / Demolition Survey Report

248-250 Camden Road
London
NW1 9HE

Survey Date: 18th November 2021

Report Number: 2118

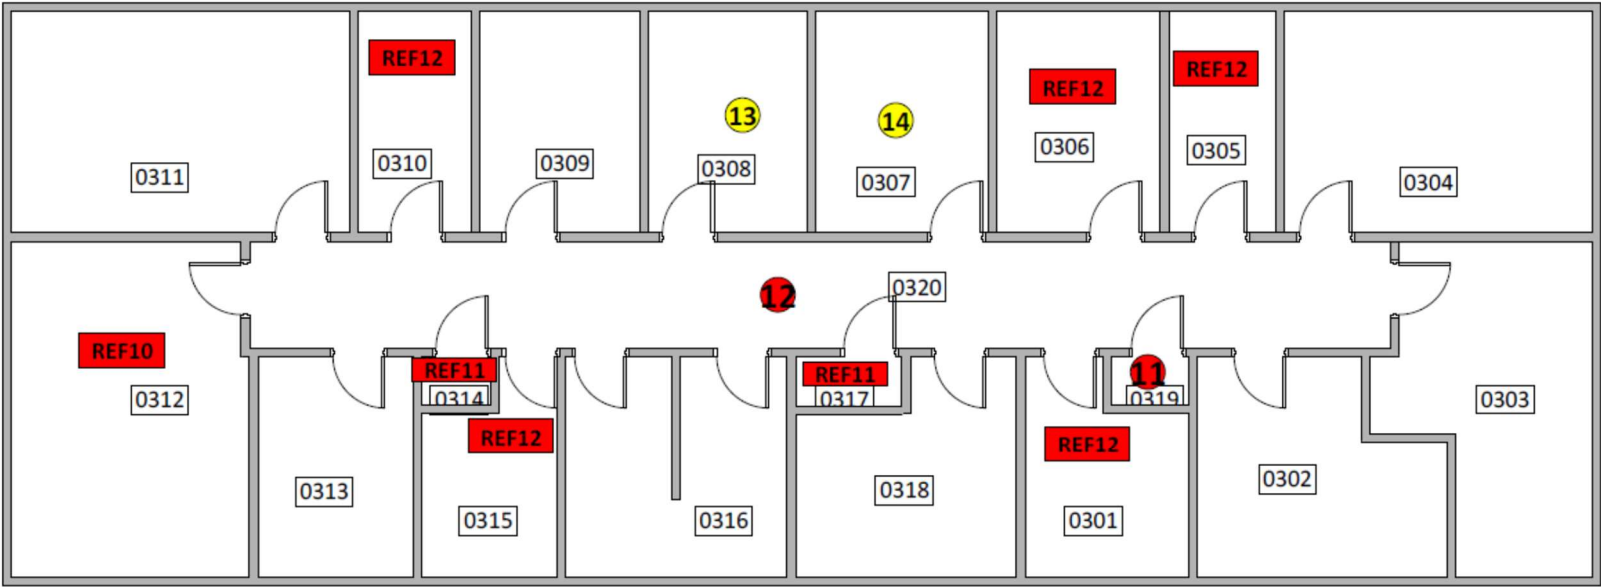
Area	Item	Sample Number	Extent	Asbestos Type	Action
THIRD FLOOR CONT...					
0313	None Detected				
0314	Floor Tiles & Bitumen Adhesive	REF11	1m ²	Chrysotile	Remove
0315	Bitumen Adhesive	REF12	2m ²	Chrysotile	Remove
0316	None Detected				
0317	Floor Tiles & Bitumen Adhesive	REF11	1m ²	Chrysotile	Remove
0318	None Detected				
0319	Floor Tiles & Bitumen Adhesive	11	1m ²	Chrysotile	Remove
0320	Bitumen Adhesive	12	20m ²	Chrysotile	Remove
