BS5837 Arboricultural Impact Assessment & Method Statement

34 Belsize Lane, Camden, London, NW3 5AE

Client: 34 Belsize Lane Limited

Job Reference: 04030Rv2

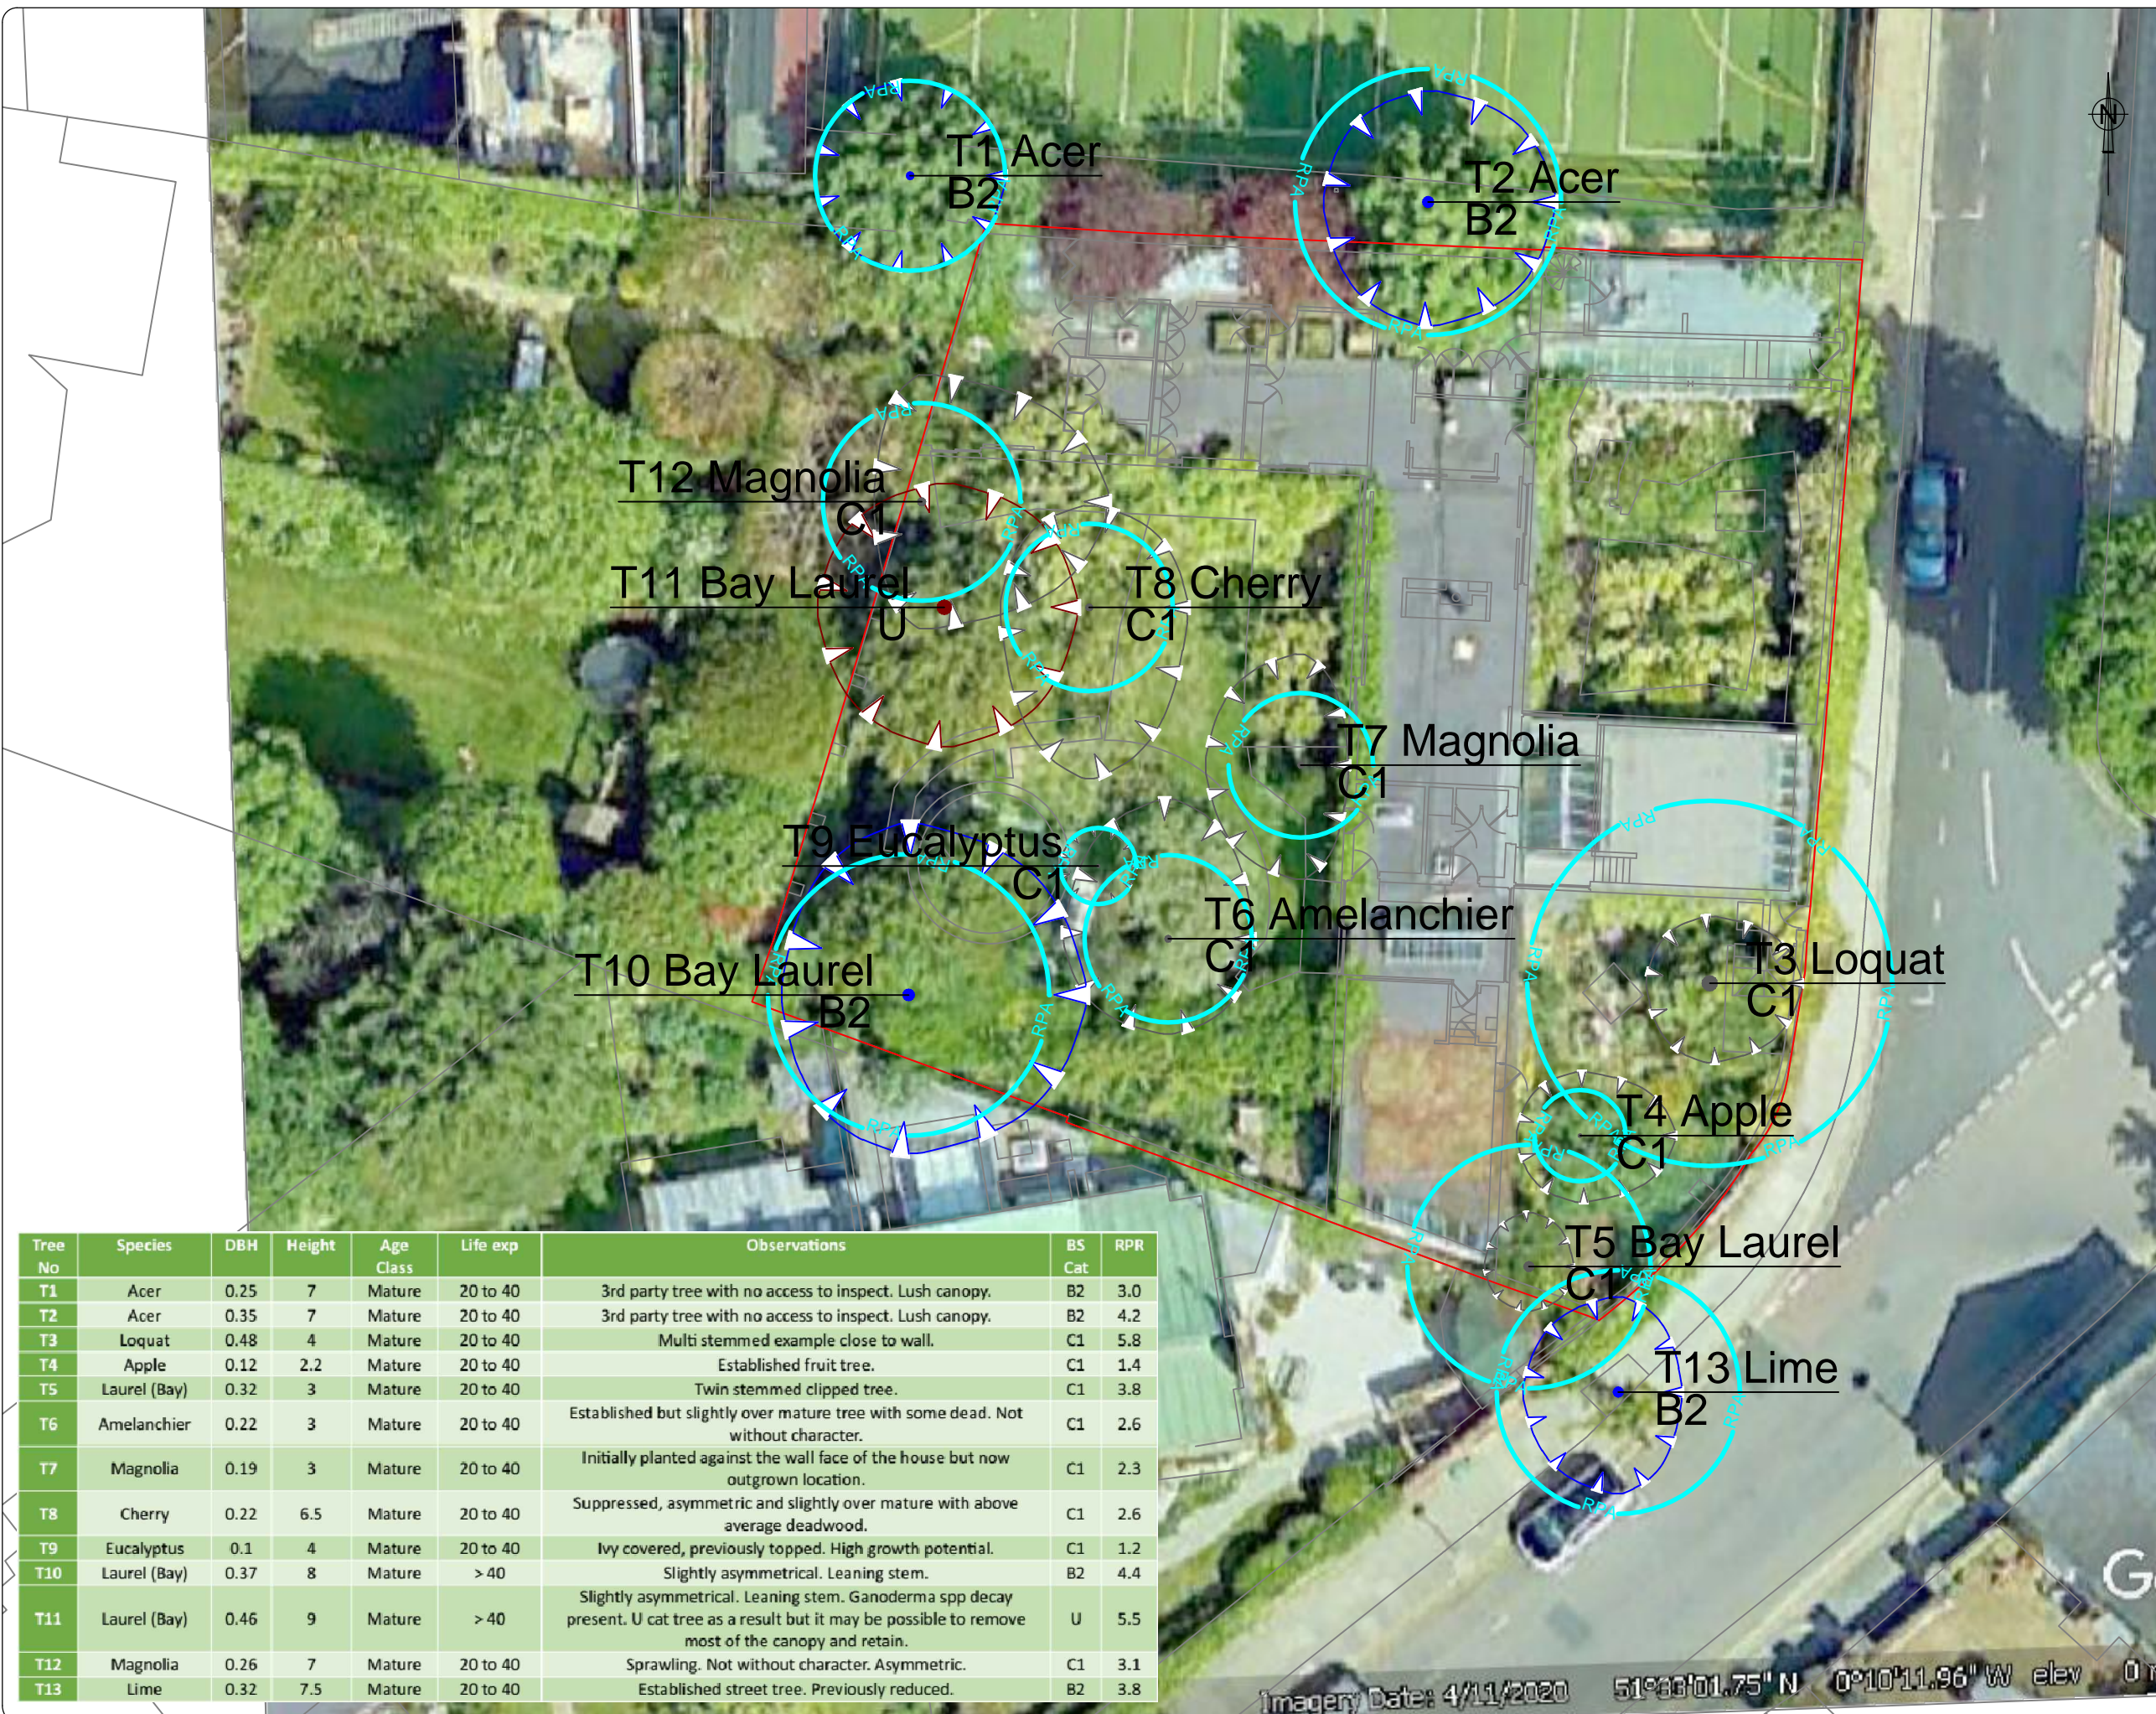
Job	04030R	Scale	1:200 @ A3	DRG NO		Revision	
Date	21/03/2024	Type	a	04030P_TCP_02		A

Tree No	Species	DBH	Height	Age Class	Life exp	Observations	BS Cat	RPR
T1	Acer	0.25	7	Mature	20 to 40	3rd party tree with no access to inspect. Lush canopy.	B2	3.0
T2	Acer	0.35	7	Mature	20 to 40	3rd party tree with no access to inspect. Lush canopy.	B2	4.2
T3	Loquat	0.48	4	Mature	20 to 40	Multi stemmed example close to wall.	C1	5.8
T4	Apple	0.12	2.2	Mature	20 to 40	Established fruit tree.	C1	1.4
T5	Laurel (Bay)	0.32	3	Mature	20 to 40	Twin stemmed clipped tree.	C1	3.8
T6	Amelanchier	0.22	3	Mature	20 to 40	Established but slightly over mature tree with some dead. Not without character.	C1	2.6
T7	Magnolia	0.19	3	Mature	20 to 40	Initially planted against the wall face of the house but now outgrown location.	C1	2.3
T8	Cherry	0.22	6.5	Mature	20 to 40	Suppressed, asymmetric and slightly over mature with above average deadwood.	C1	2.6
T9	Eucalyptus	0.1	4	Mature	20 to 40	Ivy covered, previously topped. High growth potential.	C1	1.2

T10	Laurel (Bay)	0.37	8	Mature	> 40	Slightly asymmetrical. Leaning stem.	B2	4.4
T11	Laurel (Bay)	0.46	9	Mature	> 40	Slightly asymmetrical. Leaning stem. Ganoderma spp decay present. U cat tree as a result but it may be possible to remove most of the canopy and retain.	U	5.5
T12	Magnolia	0.26	7	Mature	20 to 40	Sprawling. Not without character. Asymmetric.	C1	3.1
T13	Lime	0.32	7.5	Mature	20 to 40	Established street tree. Previously reduced.	B2	3.8
