## 34 Belsize Lane, NW3 Structural Report

2230268  
Issued for Information  
Revision P02  
22/03/24

### **34 Belsize Lane – Initial Site Visit Report**

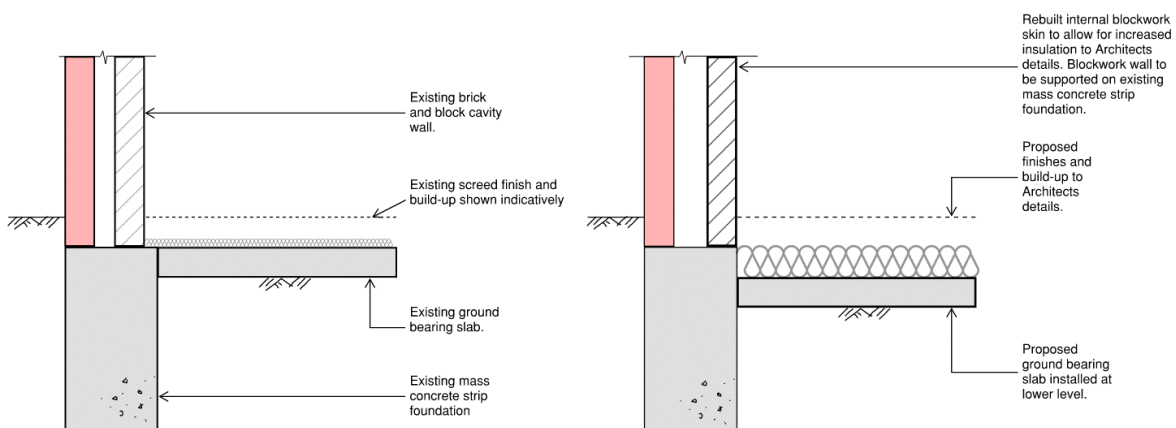
Typical Existing Perimeter Wall Detail

We understand that in order to modernise the thermal performance of the building a new ground floor slab is proposed to be replaced. The existing floors only have nominal polystyrene insulation and show signs of damp with poor conditions DPMs. There is underfloor heating which has failed after installation and will require replacement.

The existing slab will be carefully removed, whilst retaining the existing concrete foundations to perimeter and internal load bearing walls. The ground can then be excavated and a new reinforced concrete ground floor slab installed at the required level. This allows for load bearing walls to be retained in place while the slab is replaced.

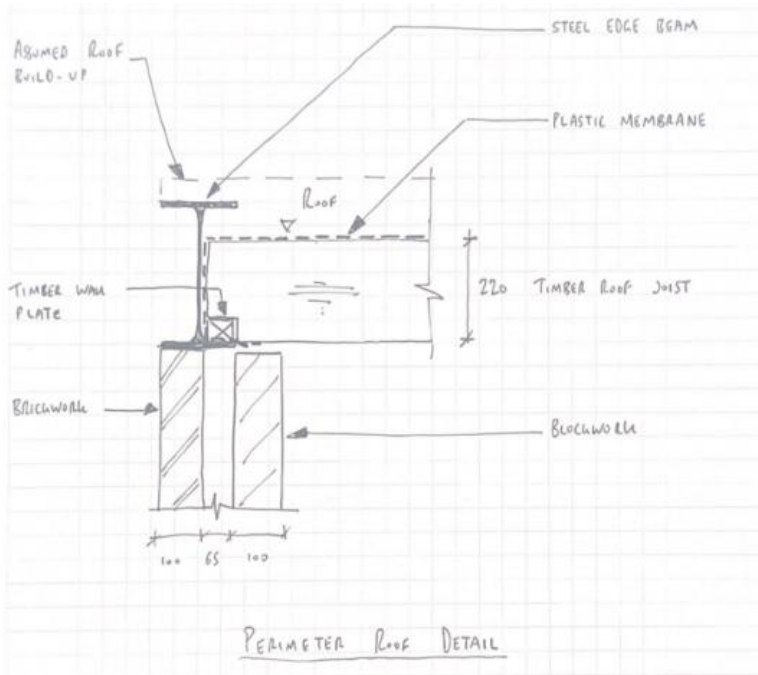
Figure 5: Existing roof detail

As part of the refurbishment, the Architect is proposing to improve the thermal performance of the building. The existing detail is proposed to be revised to reduce cold bridging and allow for insulation to be installed.

To achieve this the existing inner blockwork leaf of the cavity wall is proposed to be taken down and rebuilt, tied to the external brickwork. The roof joists will then be re-supported on the blockwork wall. The ring beam is proposed to be restrained by strapping back to the existing roof joists with a steel strap at 1.2m centres.

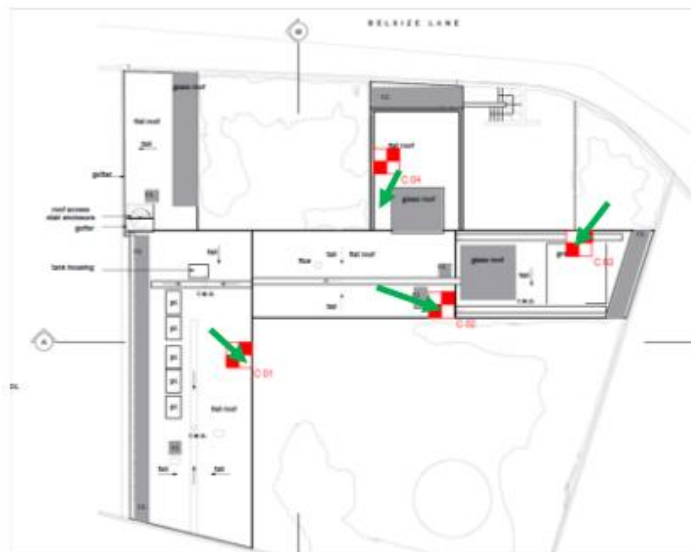
C01, C02 – Timber joists are 220mm x 60mm at 400mm c/c supported on a timber wall plate to the top of the brickwork outer leaf of the cavity wall. 'Super foil quilt' insulation present above timber joists. Joists generally appear to be in good condition along their length with some water staining at ends.
