50-52 MONMOUTH
STREET

DRAINAGE STRATEGY &
FLOOD RISK
ASSESSMENT

REPORT NO: 7930-FUR-ZZ-XX-RP-D-0901

Project Description: CCTV drainage condition survey

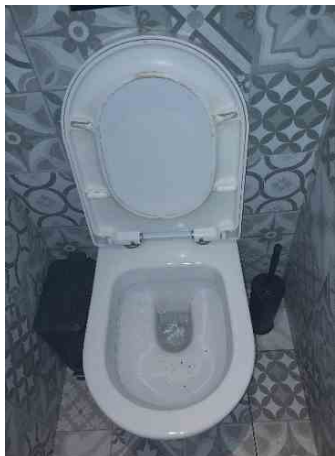
Female toilet unblocked

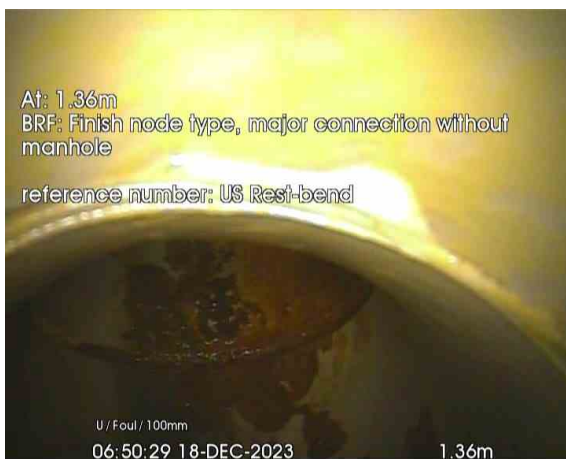
BR1X_529ad1da-56e0-4df2-b2b4-0fc0c54c73d5_20240108_111517_891.jpg, 00:00:52, 1.36 m
Finish node, major connection without manhole, reference: US, Rest-bend

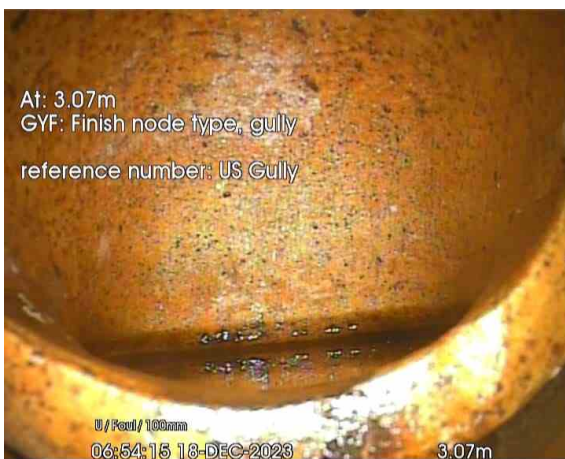
BR2X_e27c44b8-ba9c-4d40-9bde-be772f1ccc67_20240108_1
120128_367.jpg, 00:01:24, 3.07 m
Finish node, gully, reference: US, Gully

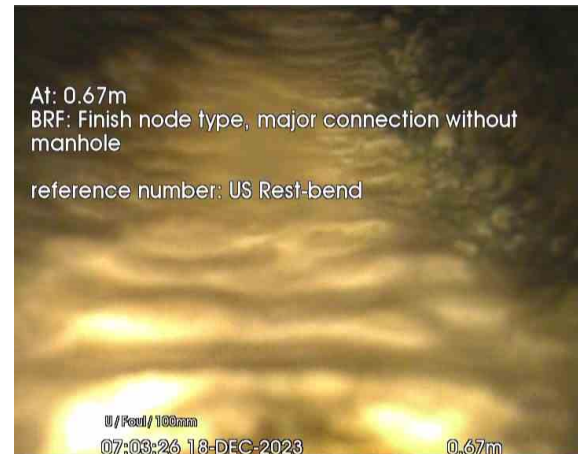
BR3X_50fe1519-7e59-4115-b1e9-d19affa9ae4_20240108_121952_667.jpg, 00:00:52, 0.67 m
Finish node, major connection without manhole, reference: US, Rest-bend

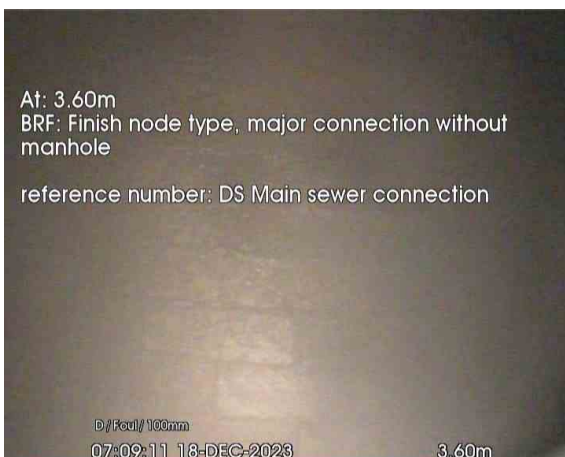
At: 3.60m
BRF: Finish node type, major connection without manhole

reference number: DS Main sewer connection

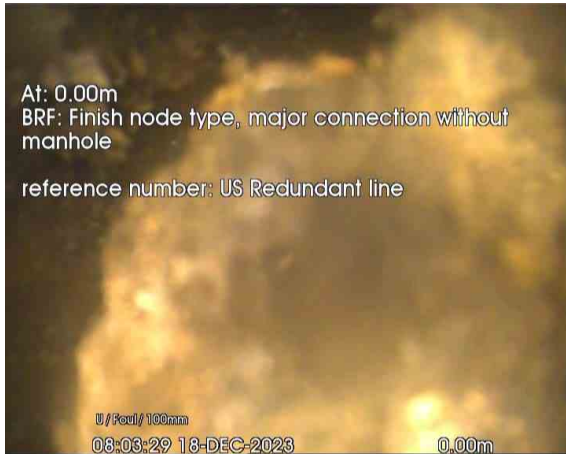
BR3X_7eca9340-759b-42cd-af44-16c491165e33_20240108_130726_569.jpg, 00:00:09, 0.00 m

Finish node, major connection without manhole, reference: US, Redundant line

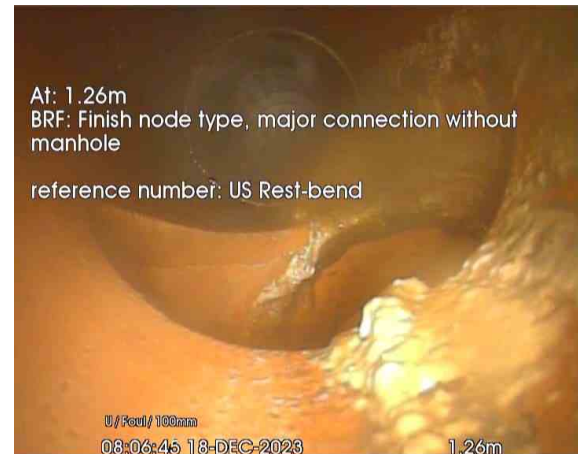
BR4X_b1b13176-b6ed-4f0a-bb39-93c66db45034_20240108_133508_265.jpg, 00:01:14, 1.26 m
Finish node, major connection without manhole, reference: US, Rest-bend
