CFBL WINDOW REPAIRS: DESIGN & ACCESS STATEMENT & HERITAGE IMPACT ASSESSMENT.

87 Holmes Road, Kentish Town, London NW5
3AX

LISTED BUILDING APPLICATION EXISTING WINDOW REPAIRS

Repairs to selected existing windows at CFBL & proposals for their repair in 2024.

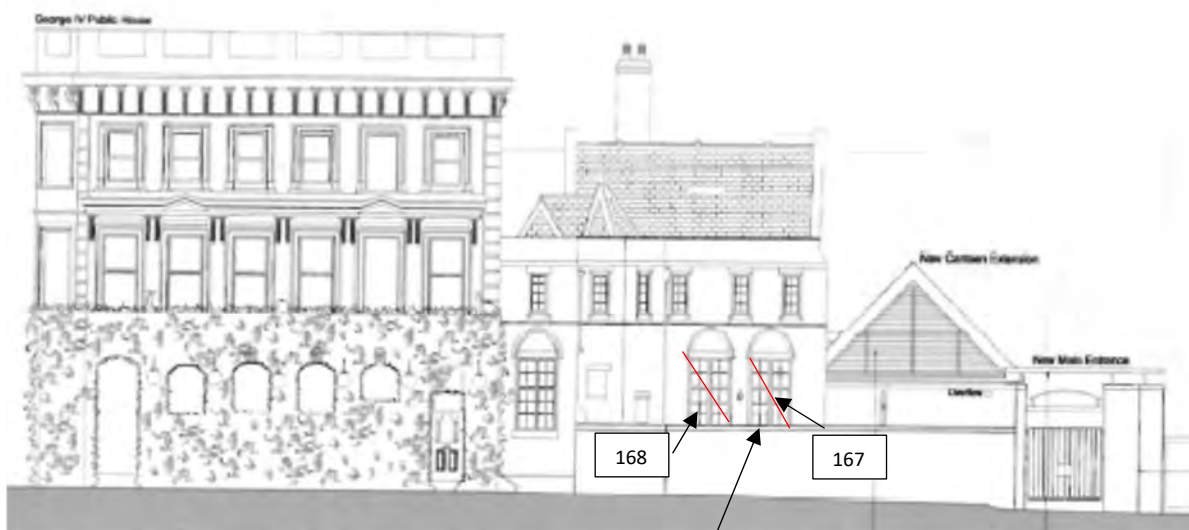
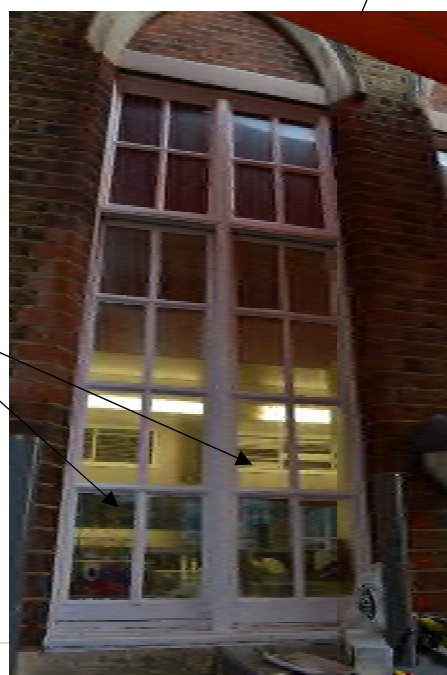
Kitchen Windows West
Elevation Willes Road

Bottom hung inward opening timber framed windows to the North on Holmes Road and East

Inward opening
lights
