Appendix 2: Structural Engineer Report and Drawings / Price & Myers

University of London Lansdowne Terrace & Guilford Street Townhouses

Structural Engineering
RIBA Stage 3 Report

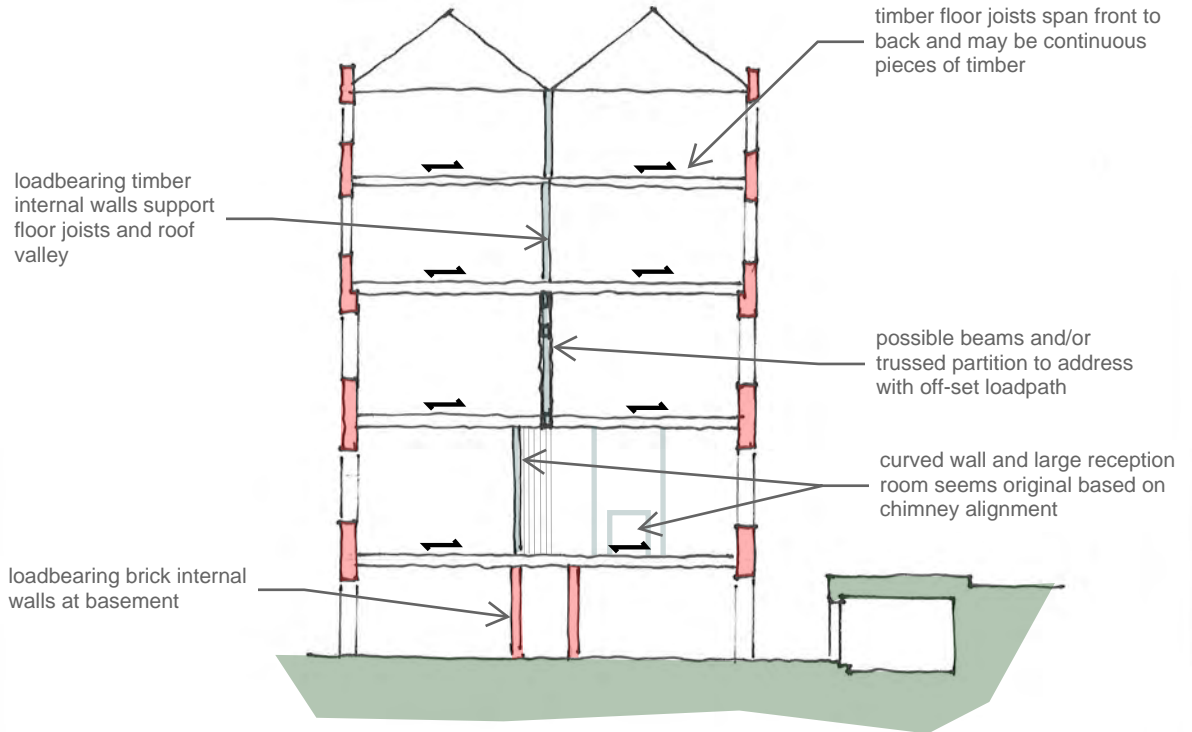
Possible Original Section

2-4 Lansdowne Terrace - Source of Internal Floor Distortion

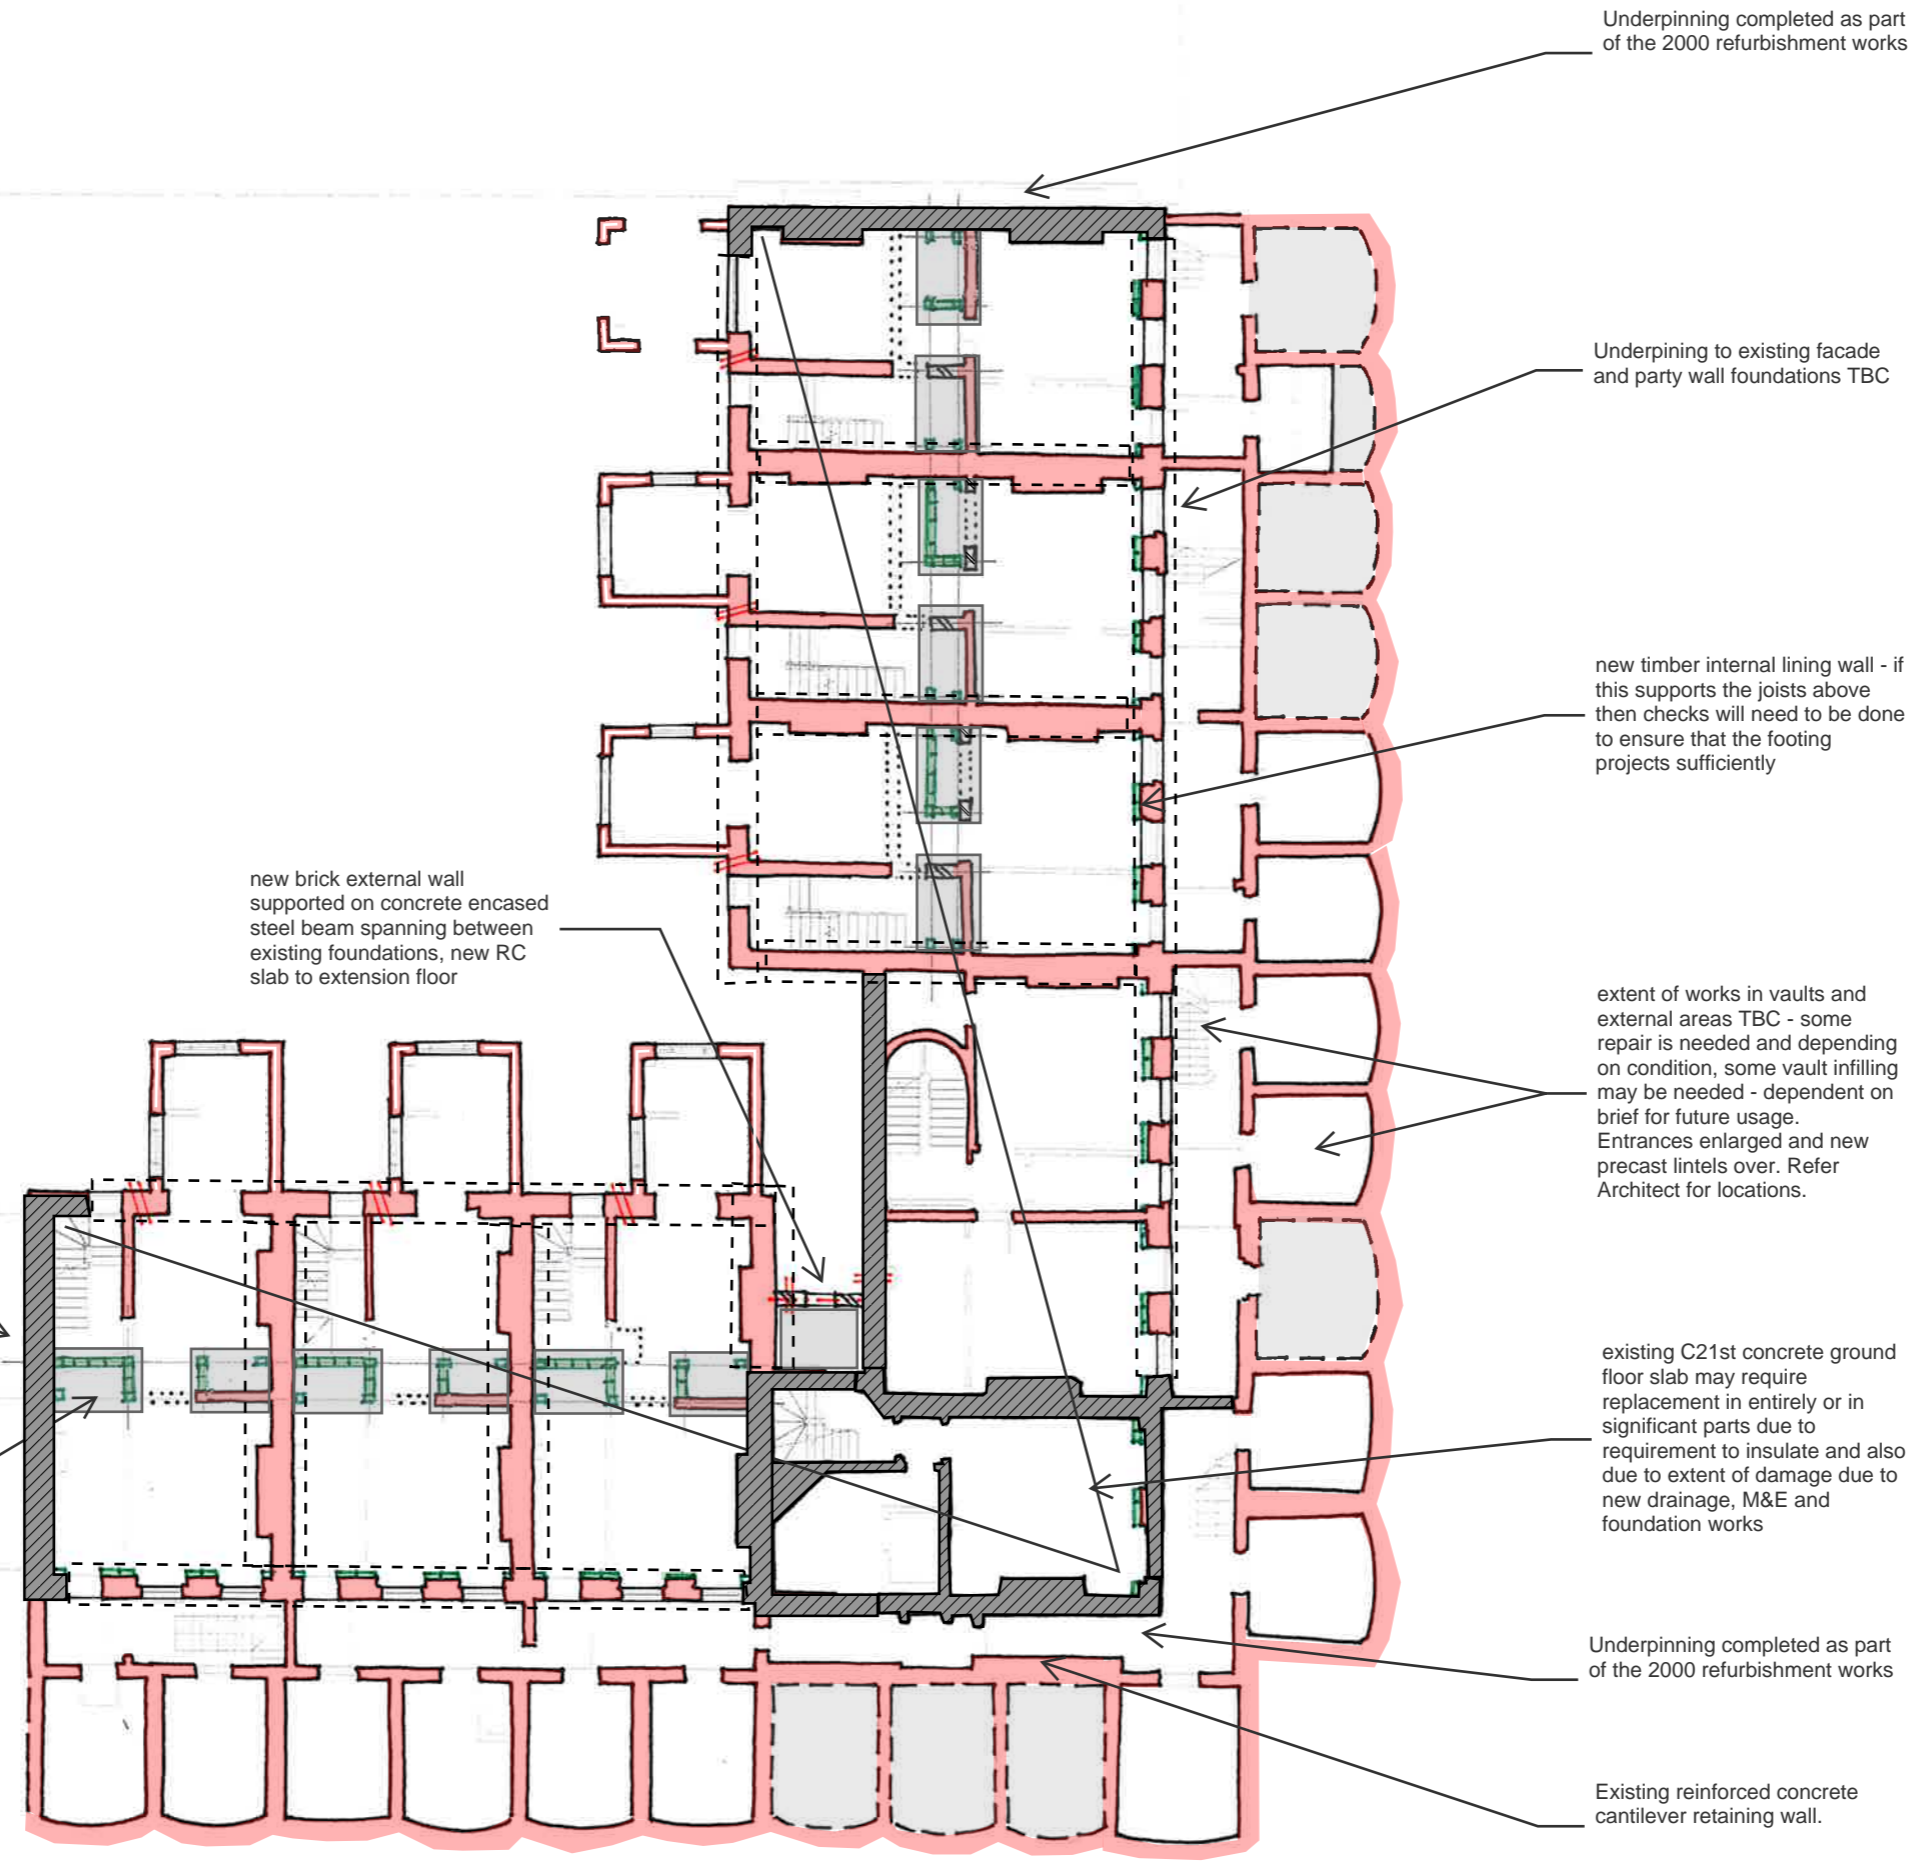
Historic underpinning

Underpinning completed as part of the 2000 refurbishment works

Underpinning to existing facade and party wall foundations TBC

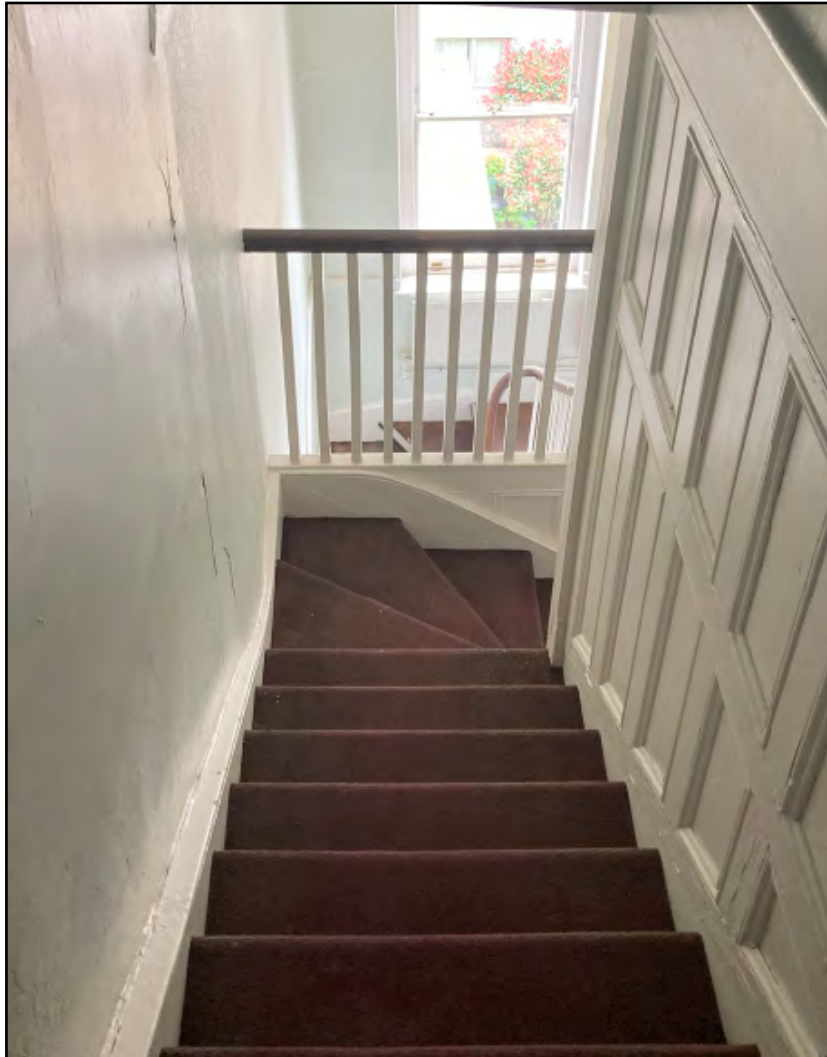
Type 2 stair

- Timber treads, risers and stringers
- Walls either side
- Handrail provided at some locations only

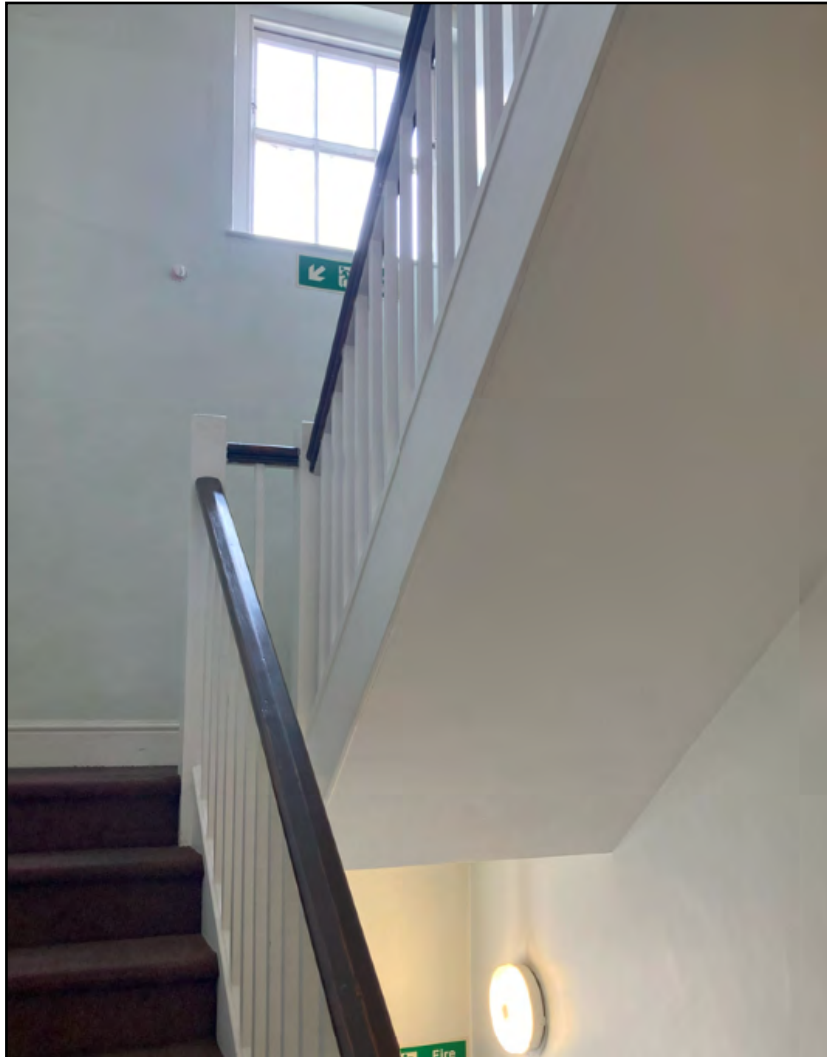
Type 4 stair

- Timber treads, risers and stringers
- Profiled 50mmx50mm timber handrail
- 25mmx25mm timber spindles at 120mm crs
- Pairs of 100mmx100mm newel posts at most landings
- Generally feels solid and in good condition
- Handrail height to be confirmed

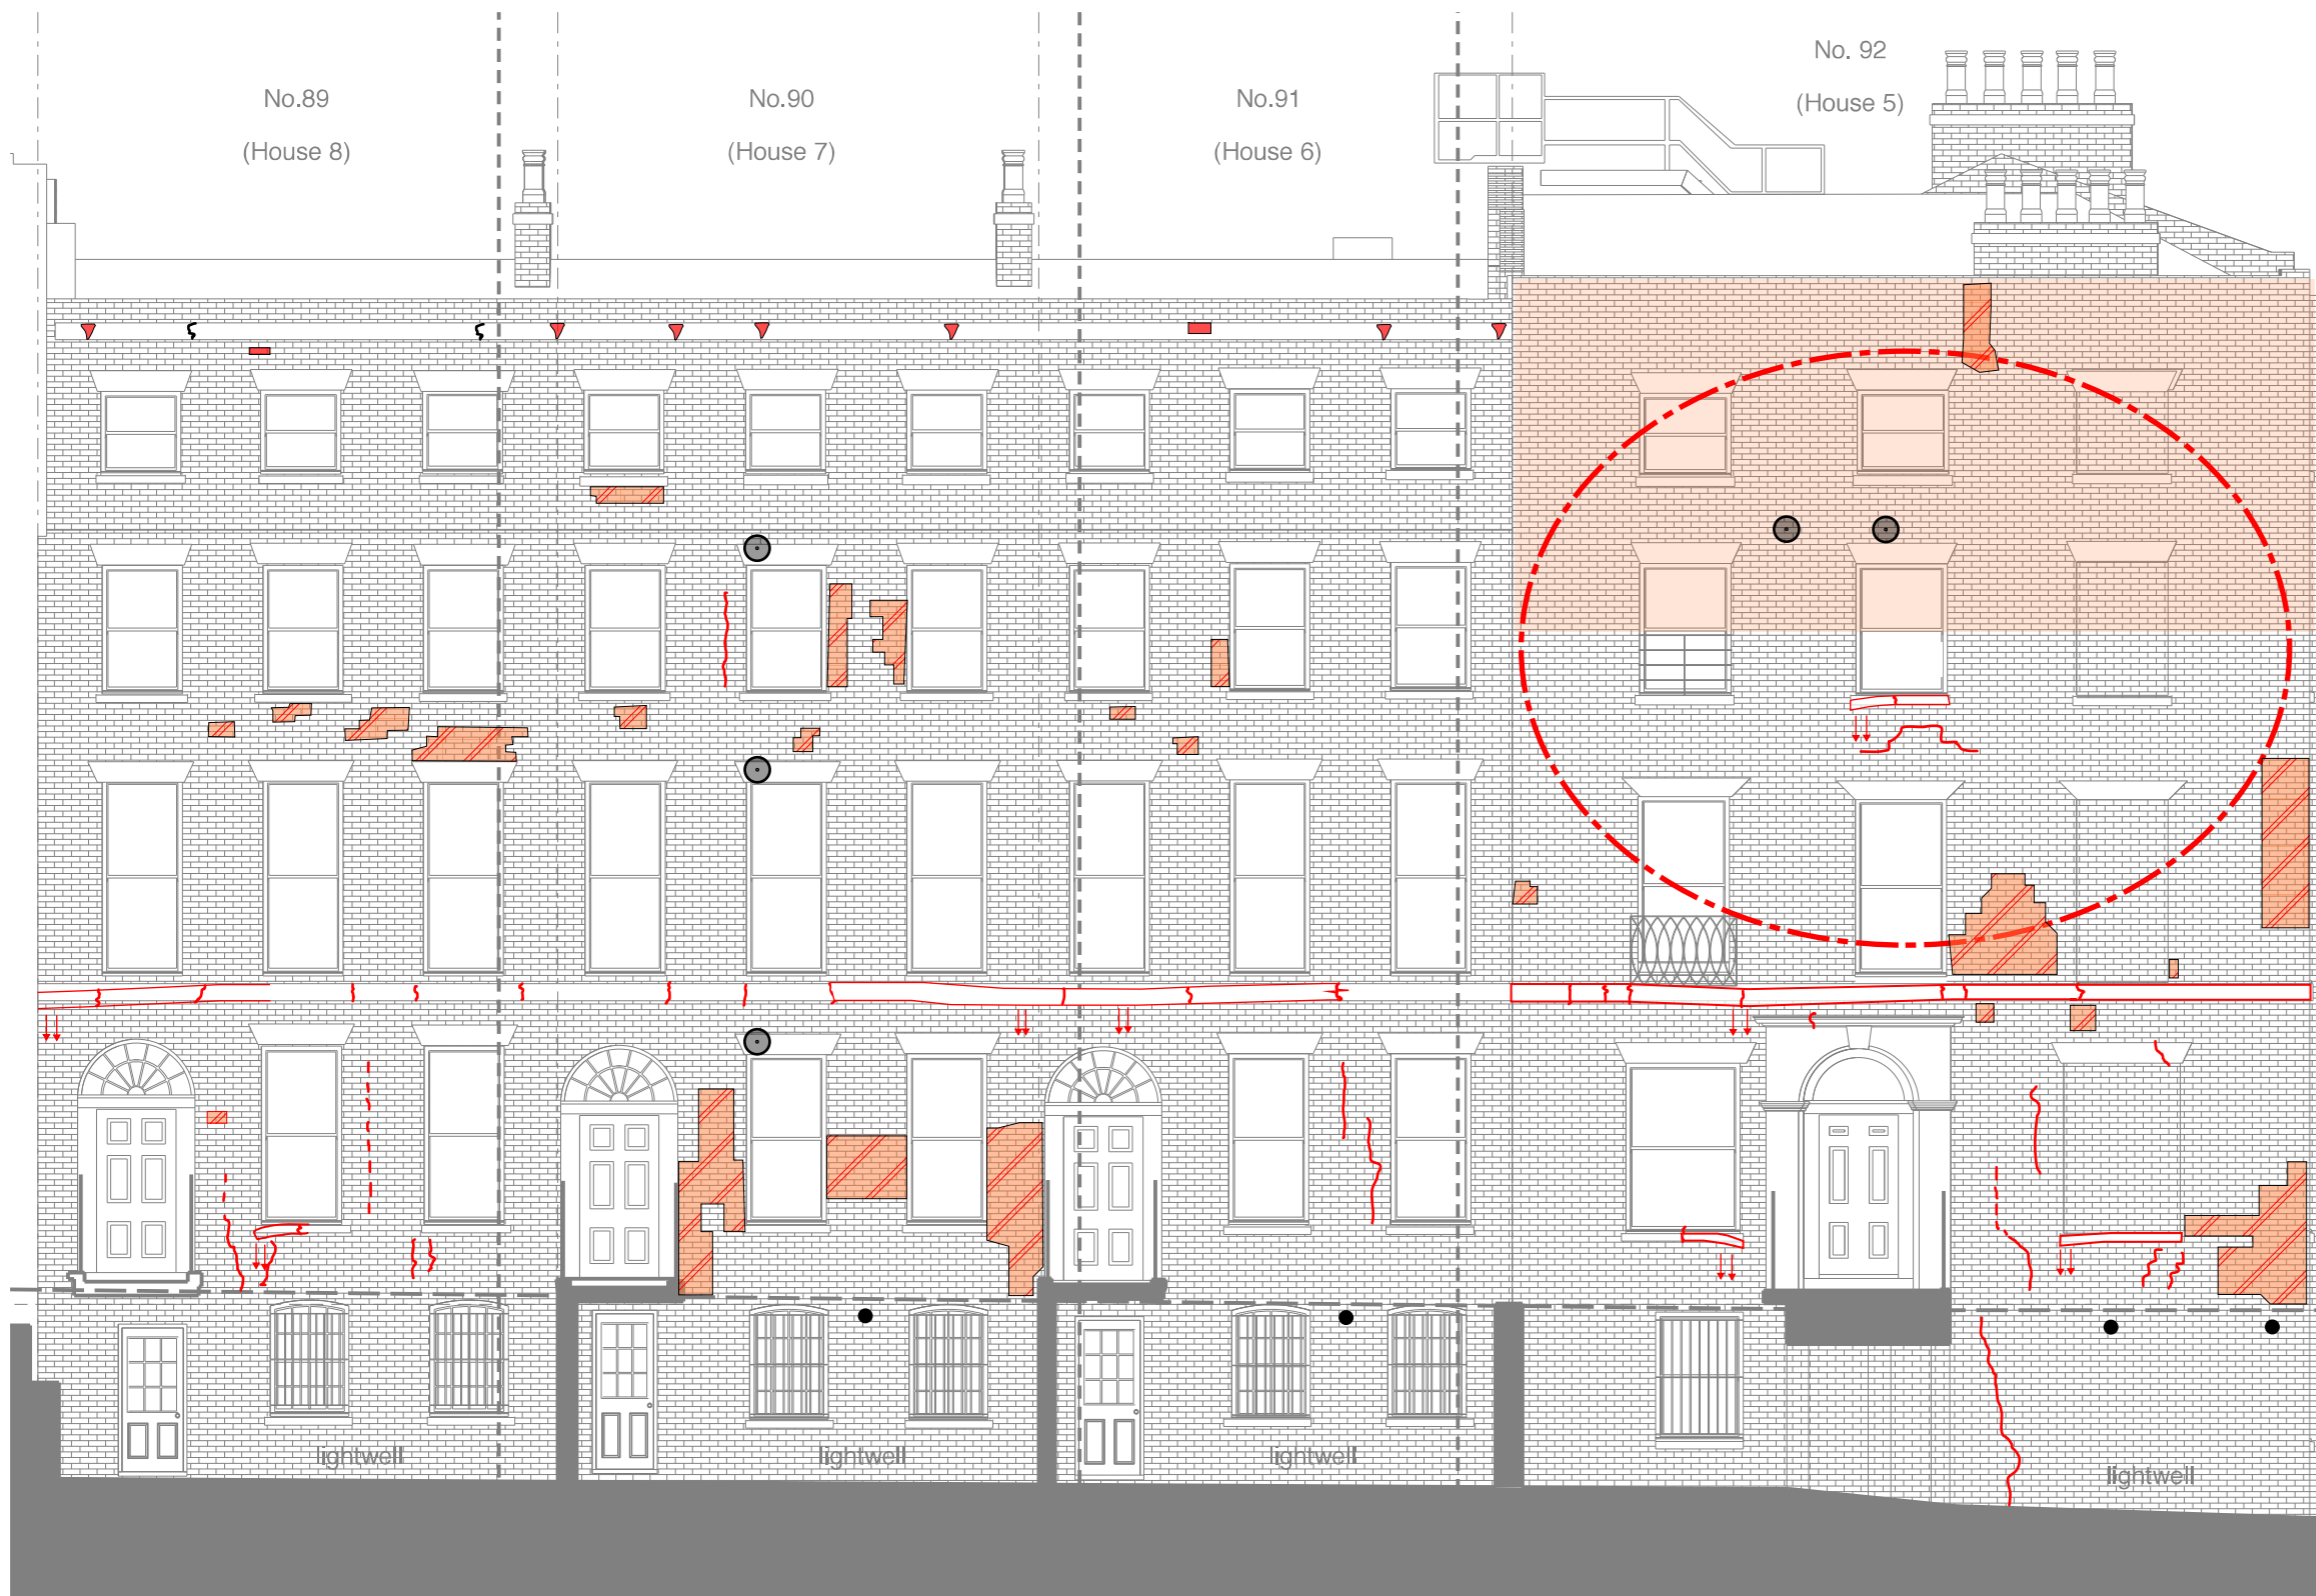
GUILFORD STREET GEORGIAN TERRACES FACADE CONDITION MAP

- 1) Lower Ground level facade has had a render applied which is possibly concealing further cracking to the facade.
- 2) Sections of the Ground level facade on Lansdowne terrace have had a render applied which is detailed to appear like brickwork and is delaminating. Refer SK12

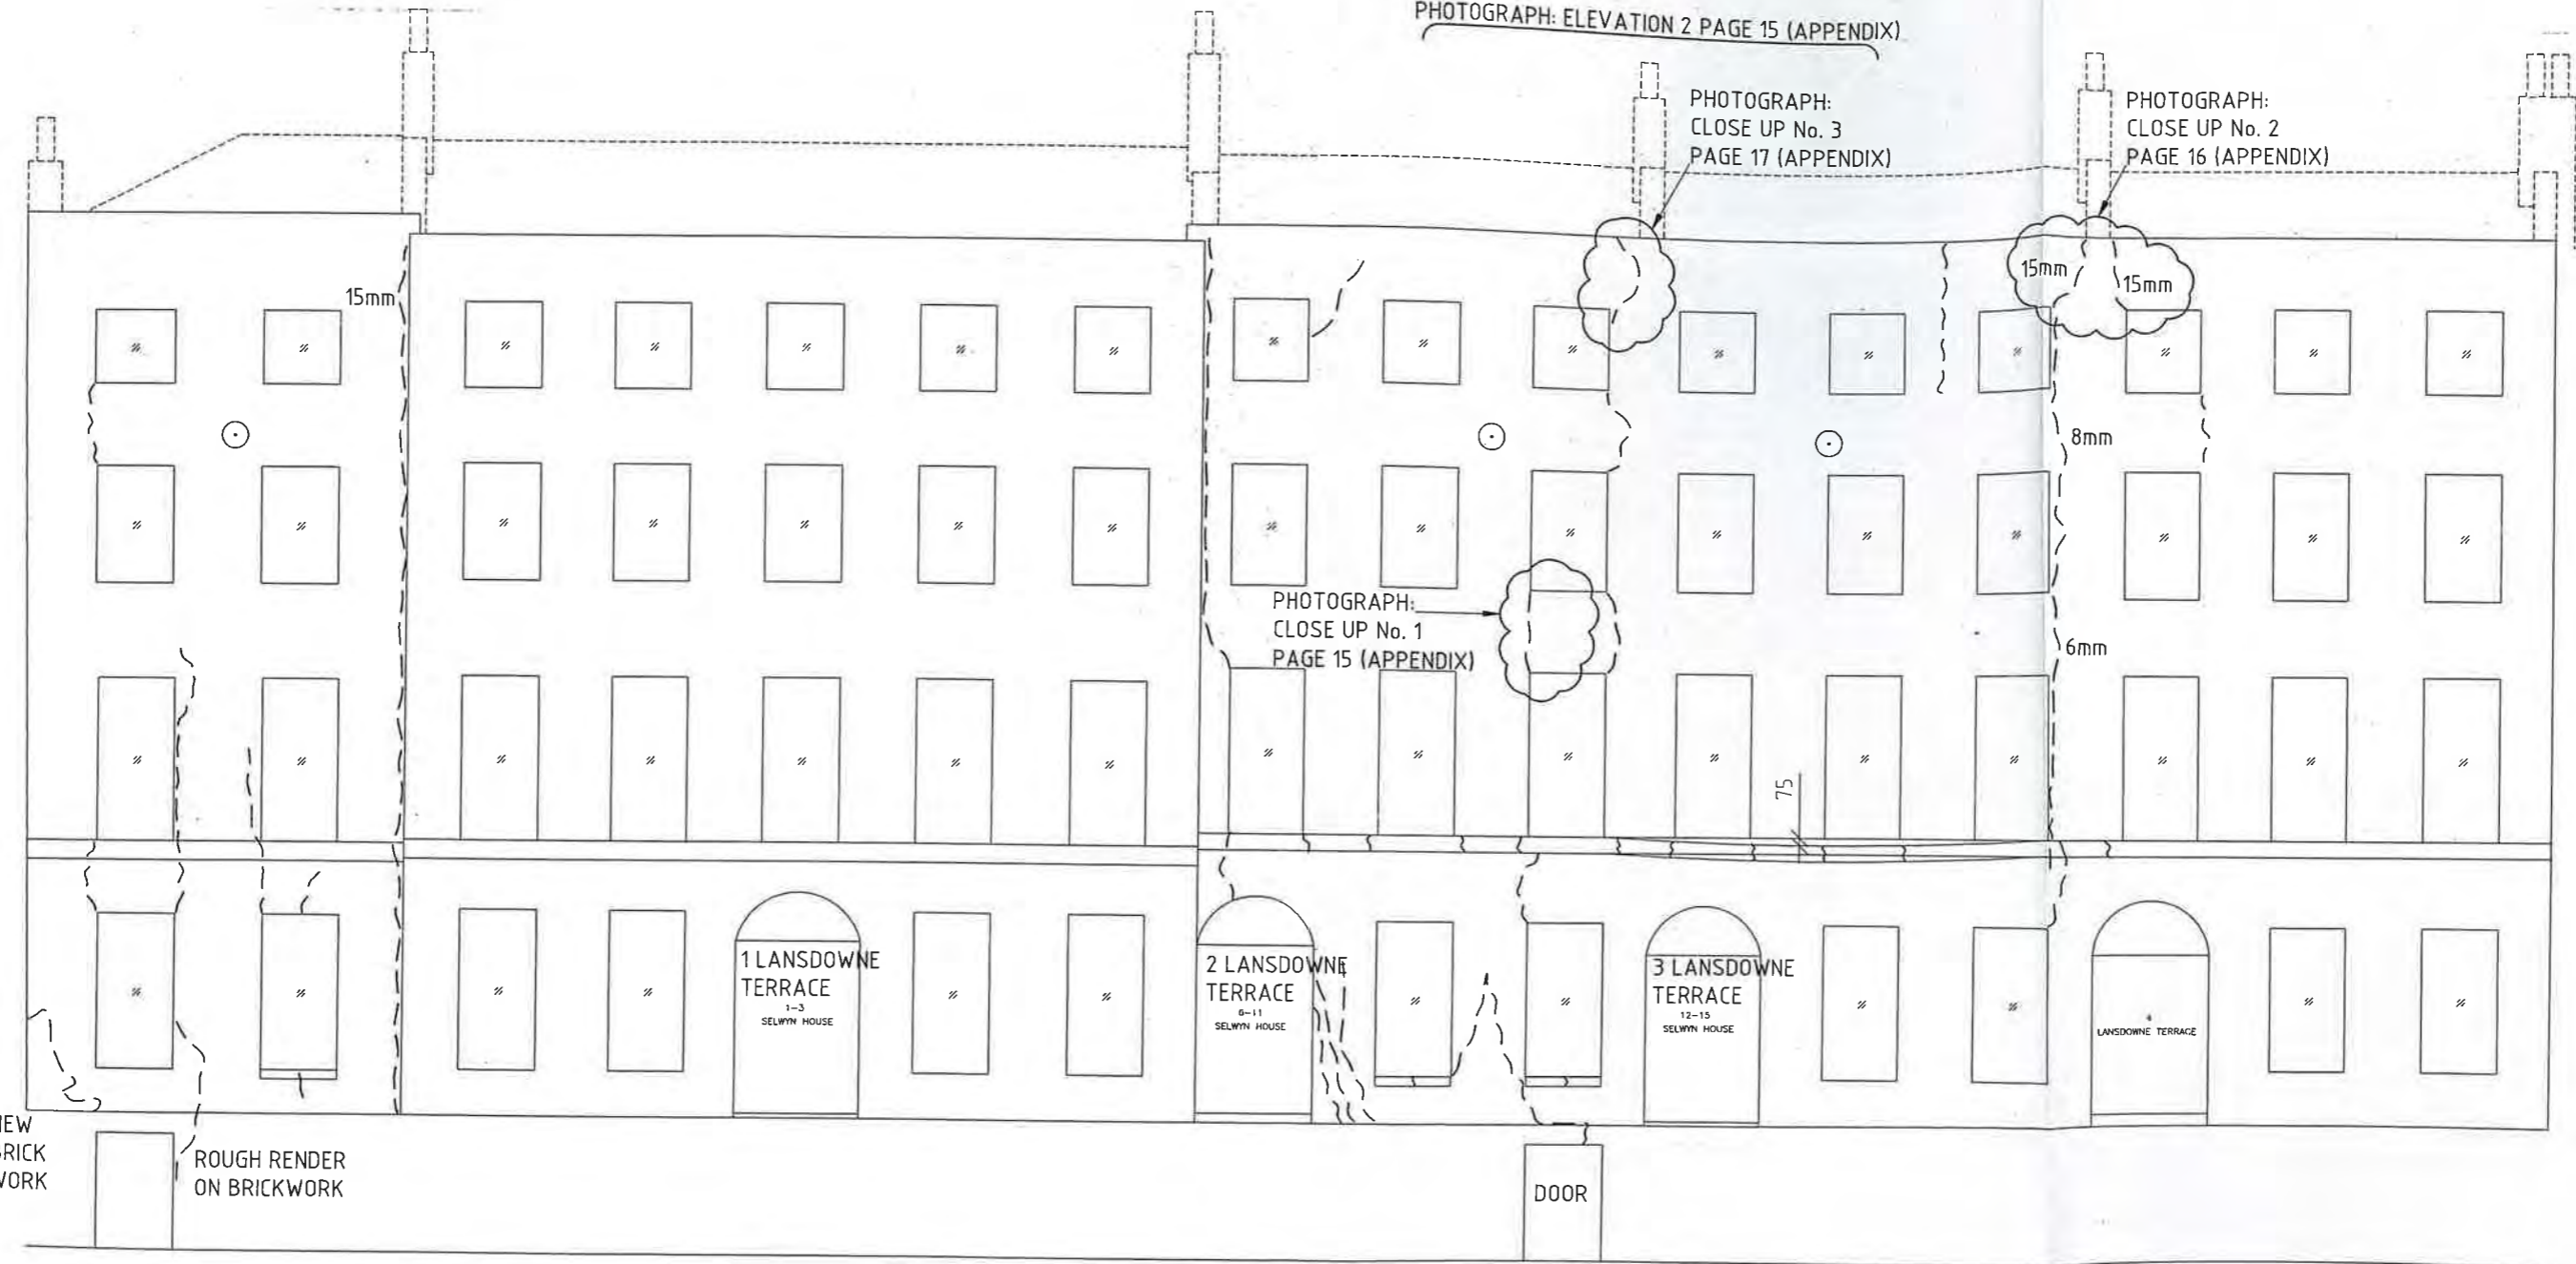
FRONT EXTERNAL ELEVATION LANSDOWNE TERRACE CRACK SURVEY

NEW BRICK WORK
ROUGH RENDER ON BRICKWORK
