## Arboricultural Consultancy for LV=

| Insured | | Address | 29 Edis Street, London, NW1 8LE | |

**Scope of Report:** To survey the property and determine significant vegetation contributing to subsidence damage, make recommendation for remedial action and assess initial mitigation and recovery prospects. The survey does not make an assessment for decay or hazard evaluation.

29 Edis Street, London, NW1 8LE  
Subsidence Management Services

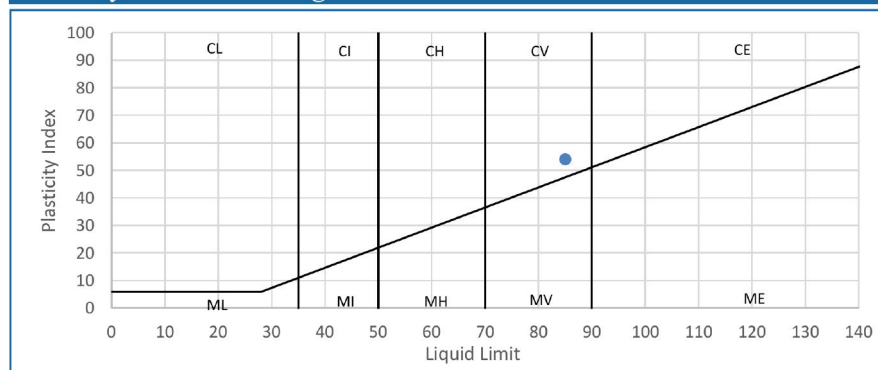
## Plasticity Chart for Casagrande Classification

| Lab Ref | Depth (m) | WC (%) | LL (%) | PL (%) | PI (%) | .425 mm (%) | mod. PI (%) | Av. Suc. (kPa) | Description |
|---|---|---|---|---|---|---|---|---|---|
| 6 | 3.2 | 30.8 | 85 | 31 | 54 | 94 | 51 | 608 | Stiff grey-brown silty CLAY with rare gravel. Gravel is fine |
| 7 | 3.7 | 29.9 | 85 | 31 | 54 | 94 | 51 | 557 | Stiff grey-brown silty CLAY with rare gravel. Gravel is fine |
