Landmark Trees

ARBORICULTURAL IMPACT ASSESSMENT REPORT FOR:

10a Oakhill Avenue

Ref: ADC/10aOA/AIA/05a

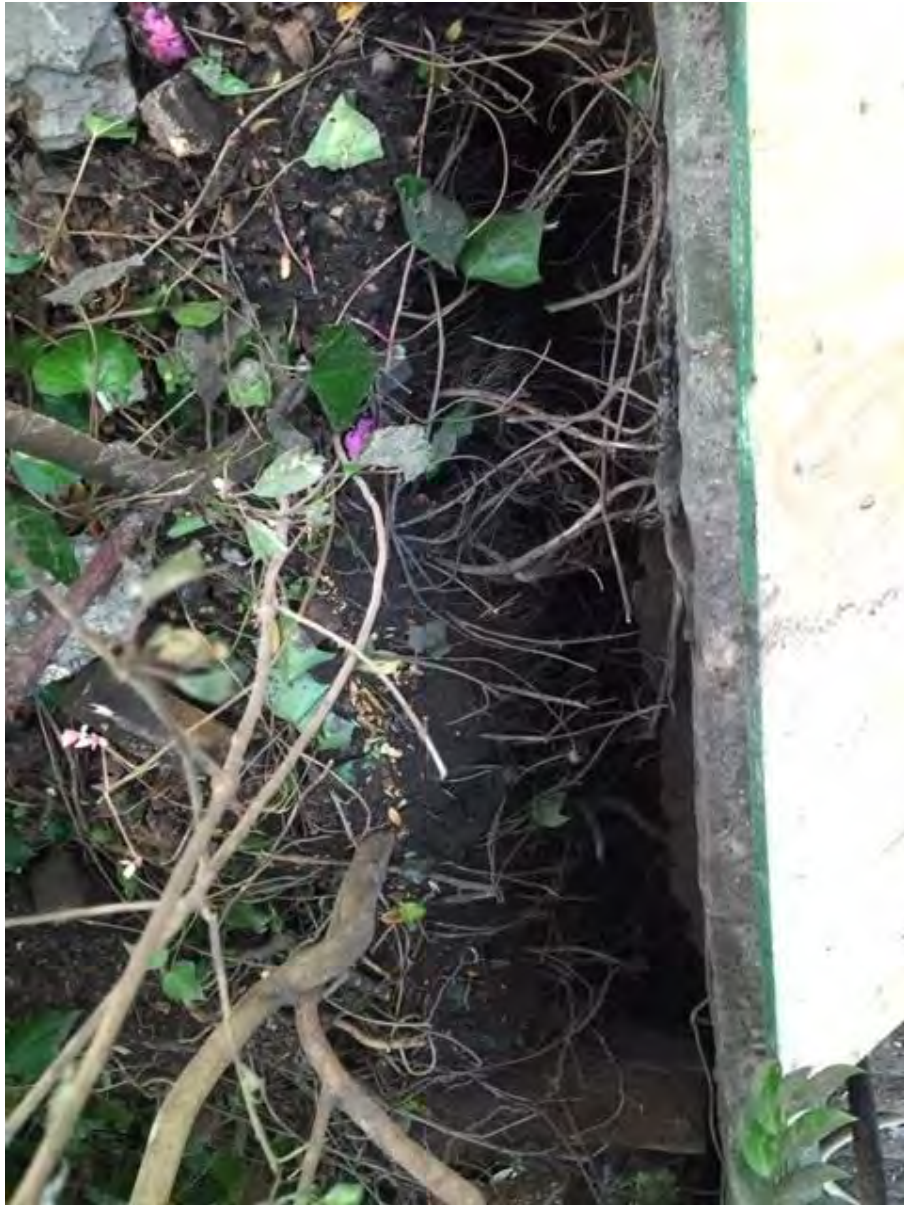
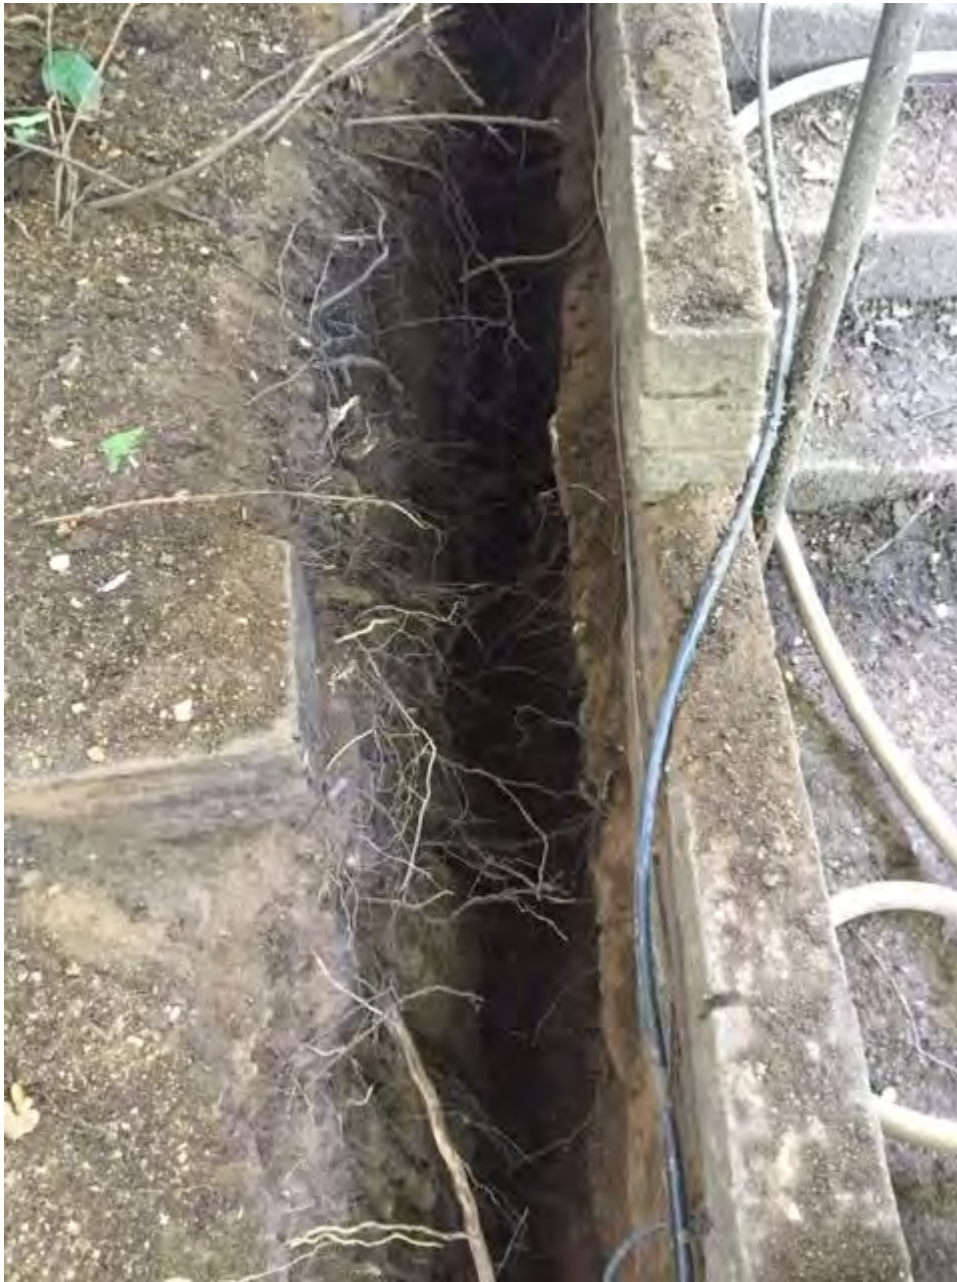
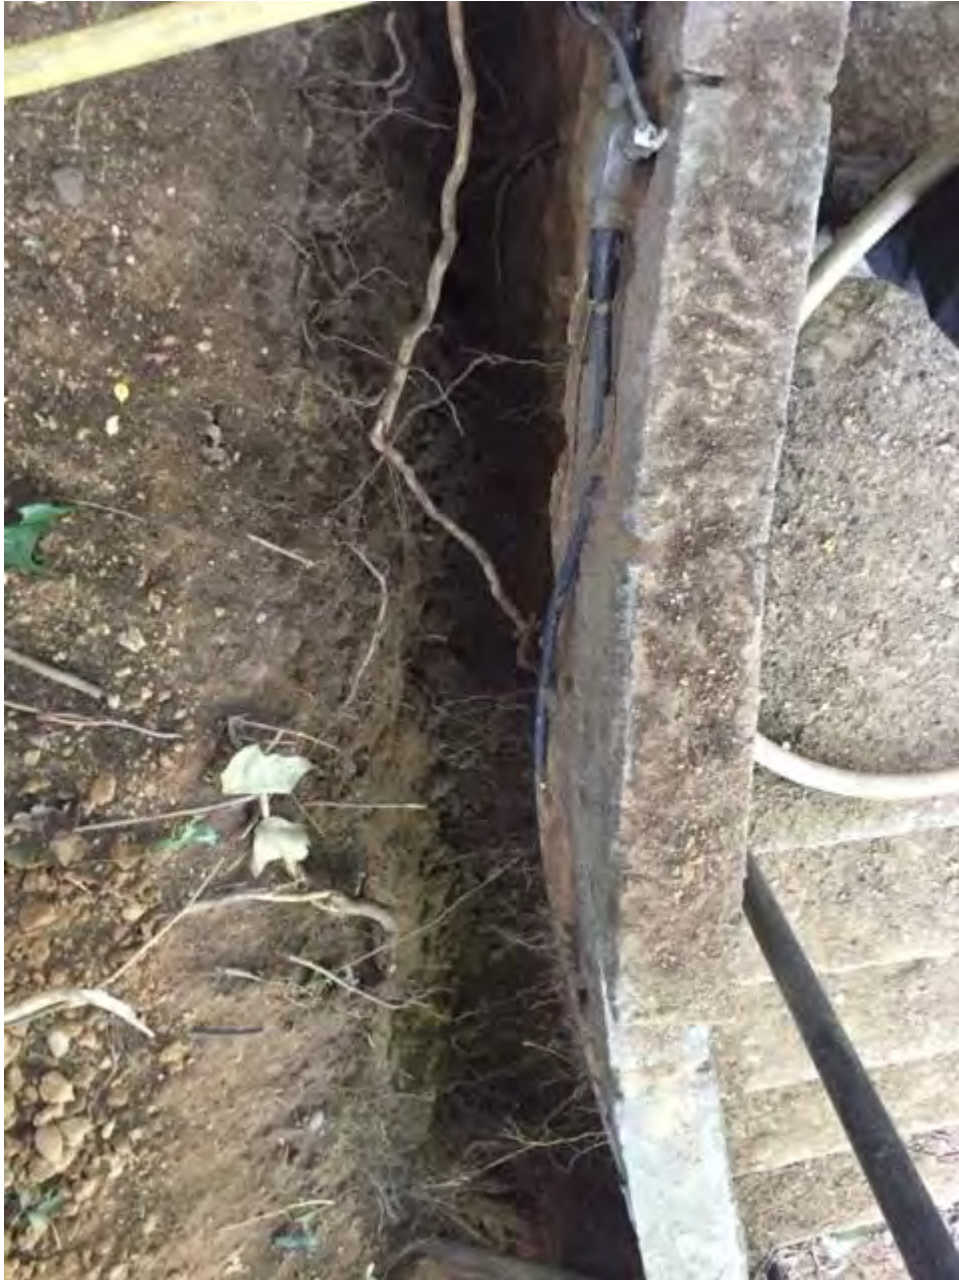
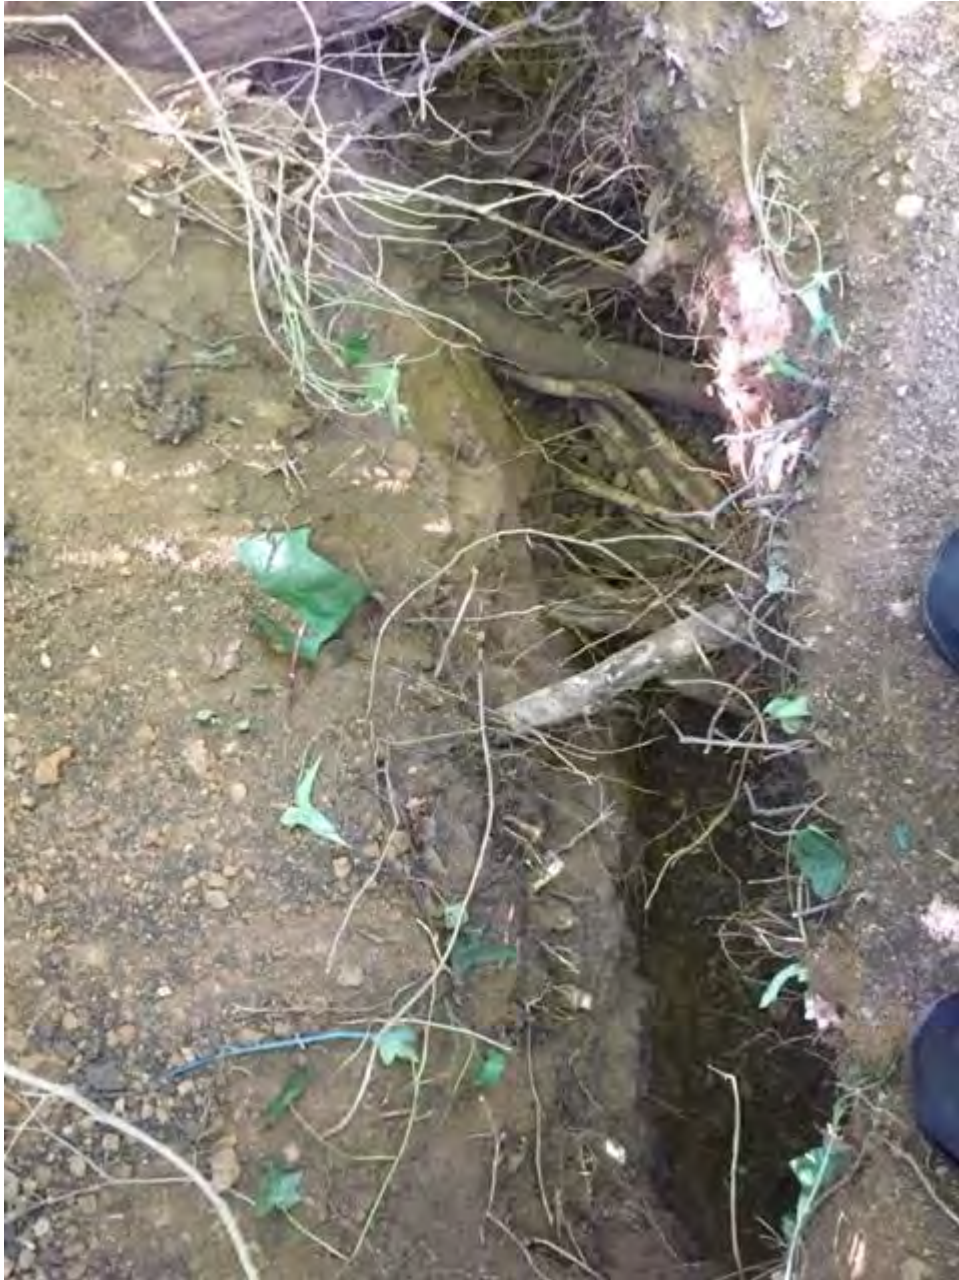
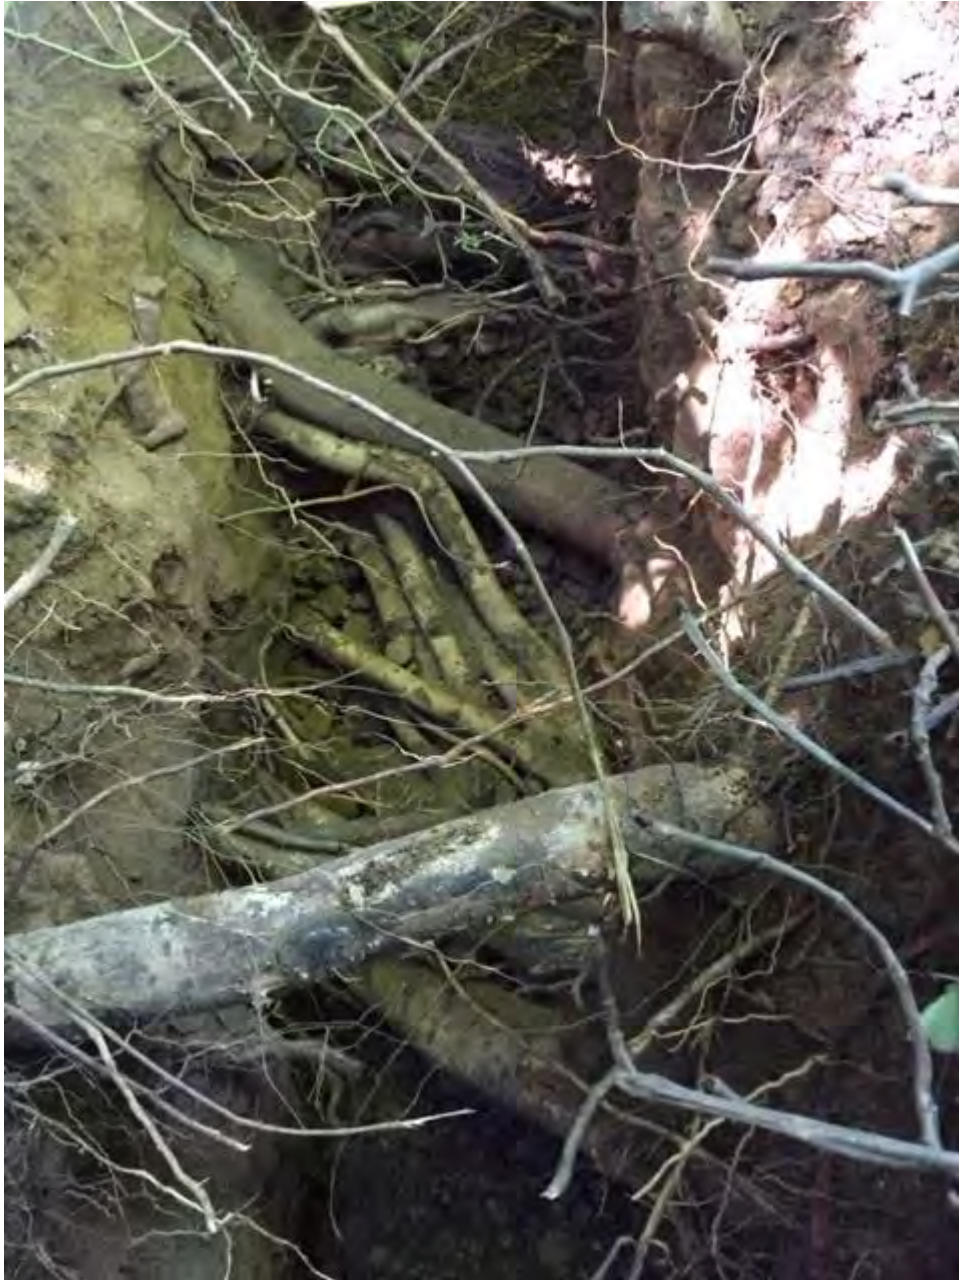
Root Excavation Report

There was a large concentration of roots though a 50cm length of the trench at the south end.
The centre of the trench was excavated deeper than the ends as this was the section closest to the oak. Once complete the Trial pits were covered with hardwood boards.
