Structural Report

**118 Malden Road
London
NW5 4BY**

Condition Report

24th May 2024

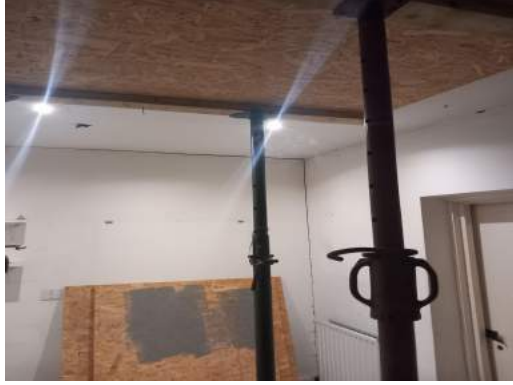
<p><u>Left side Photo</u> Section of damage ceiling with damp patches on ceiling</p> <p><u>Right side Photo</u> Boarded courtyard void with temp support</p>

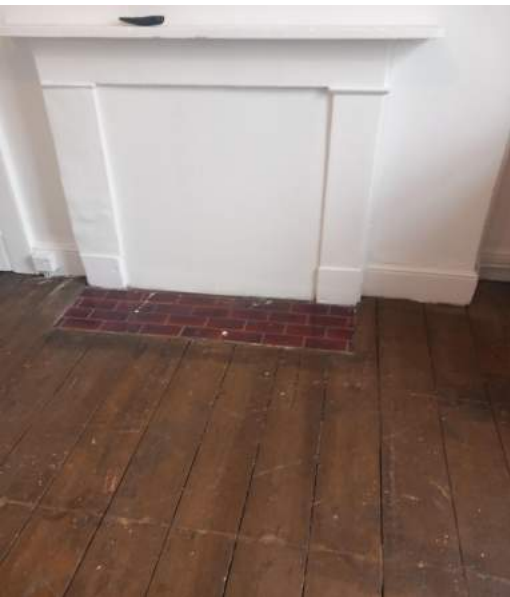
<p><u>Left side Photo</u> Bottom section of timber floor with signs of rot and vertical cracks on timber frame</p> <p><u>Right side Photo</u> signs of unevenness on the floor</p>

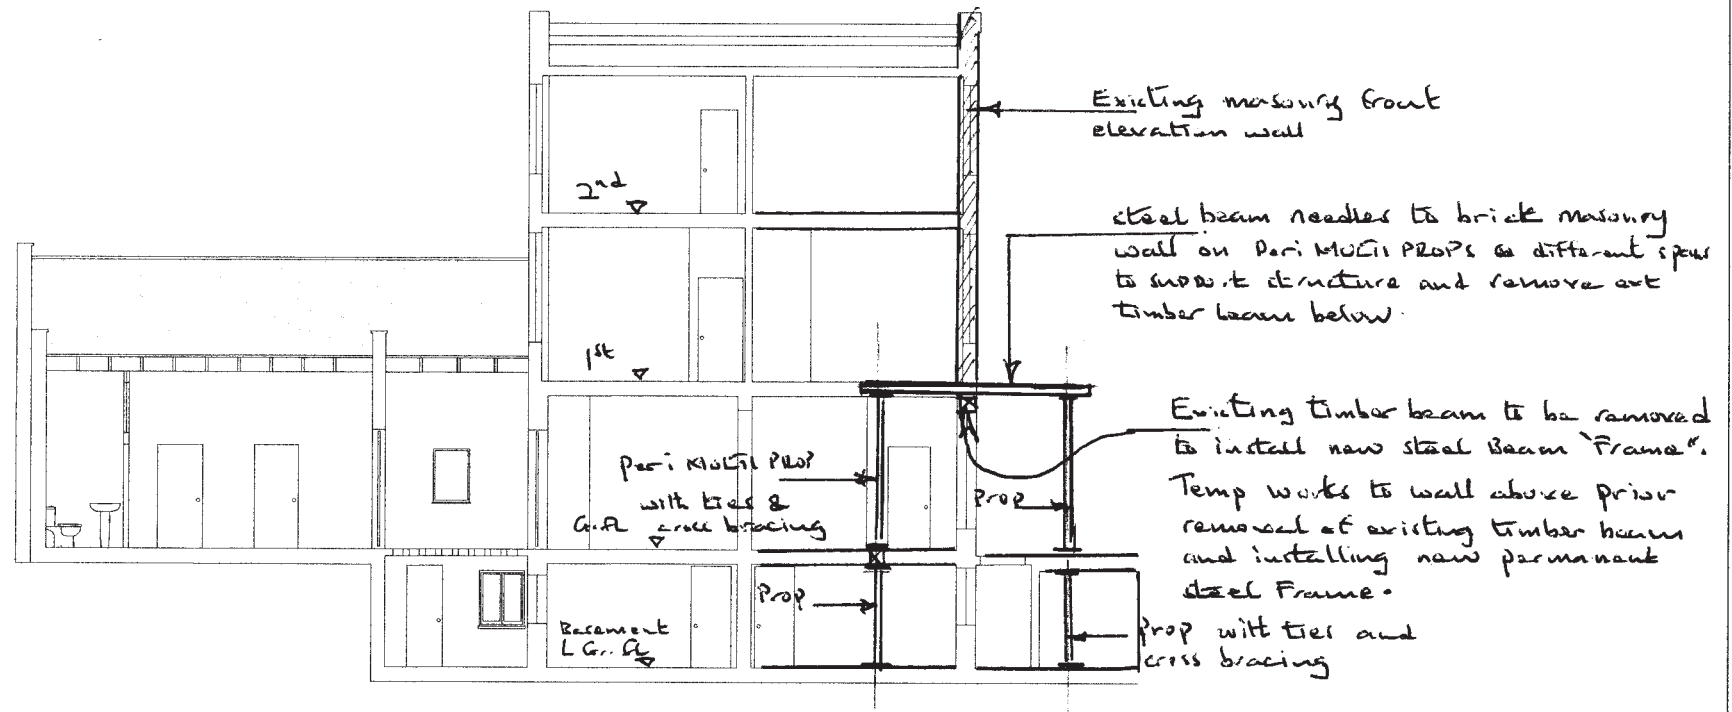
SK-01

Front Facade Temp works Proposal

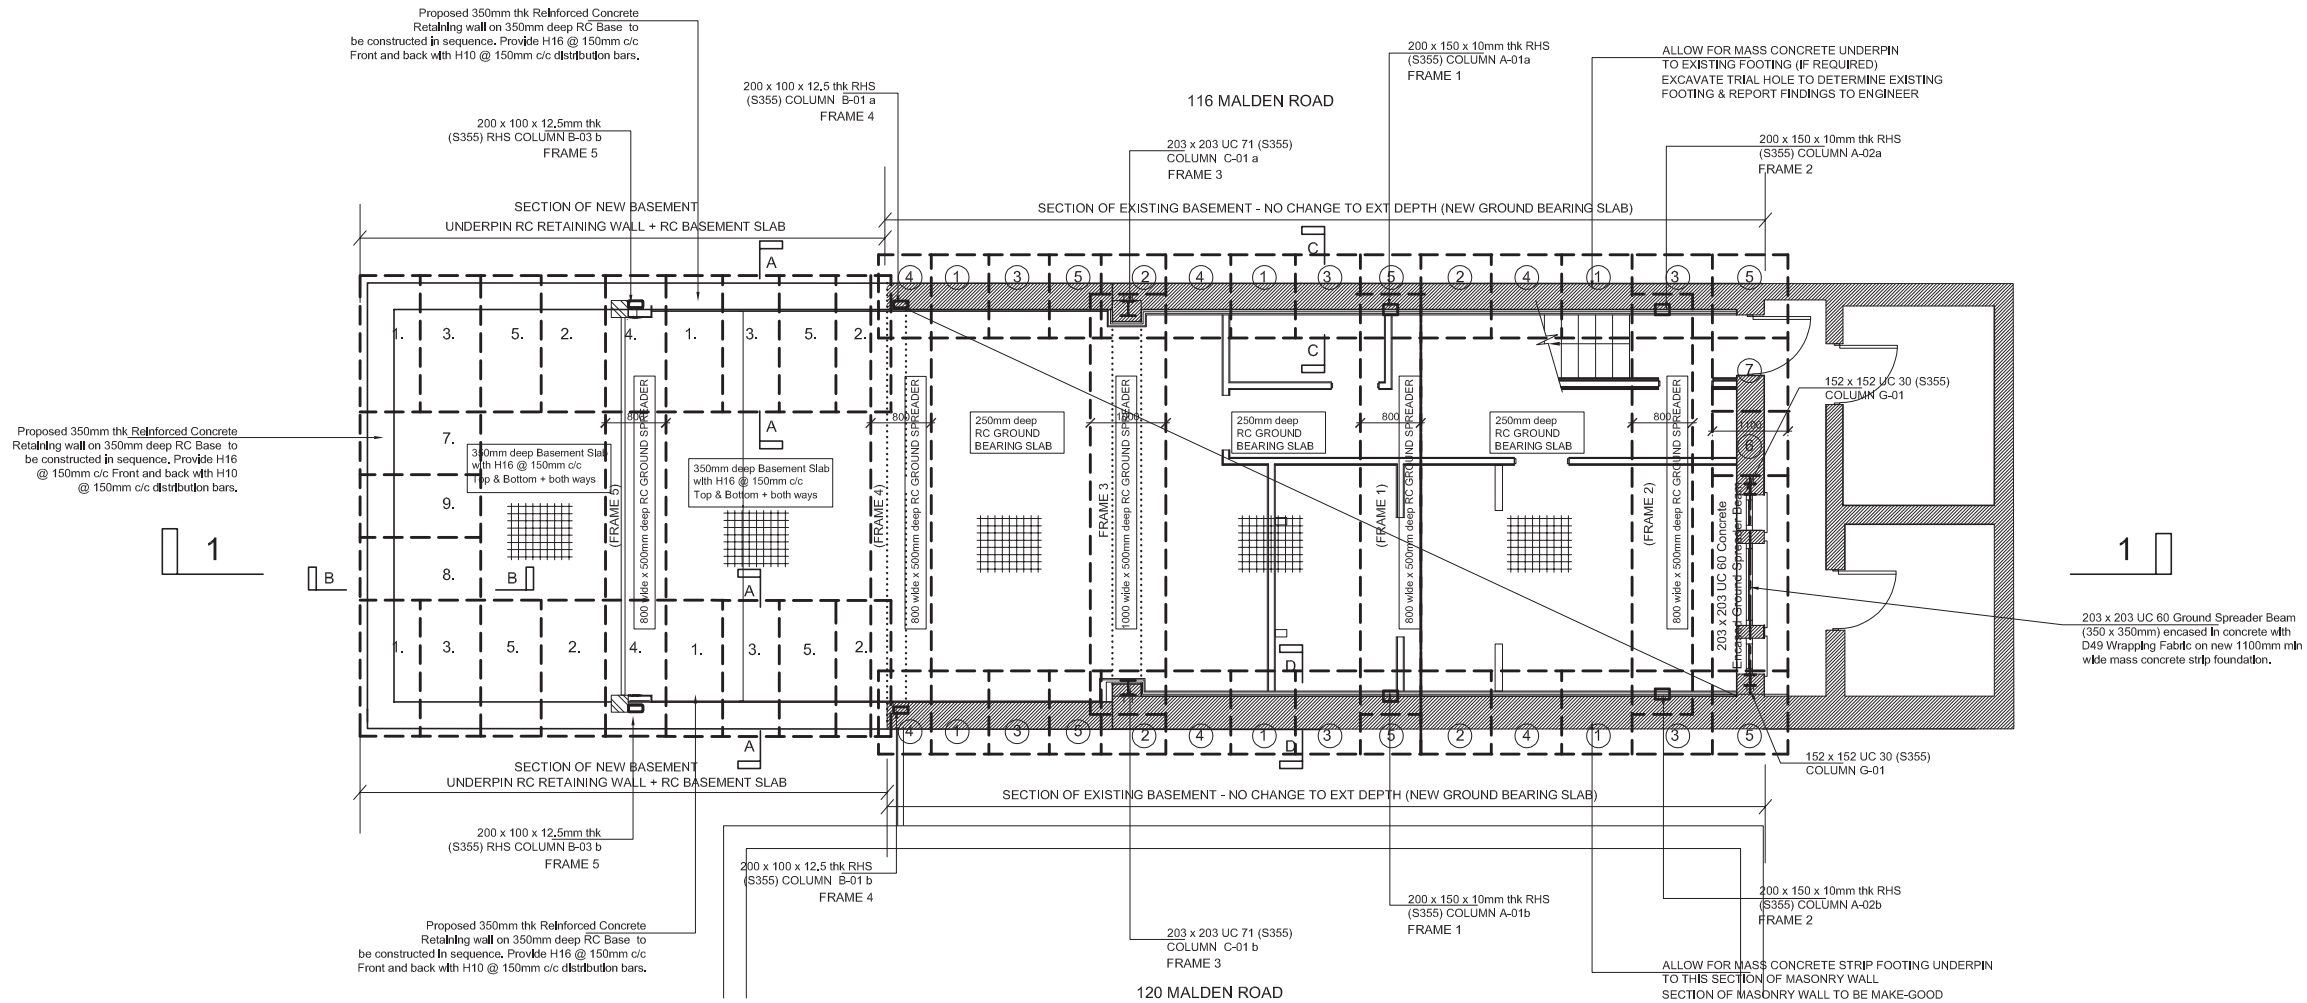
SK-02

Front Facade Temp Supports Proposal
