Revised Arboricultural Appraisal Report

Subsidence Damage Investigation at:

22a Harley Road
Hampstead
London
NW3 3BN

CLIENT: Crawford & Company
CLIENT REF: [REDACTED]
MWA REF: [REDACTED]
MWA CONSULTANT: Andy Clark
REPORT DATE: 06/12/2023

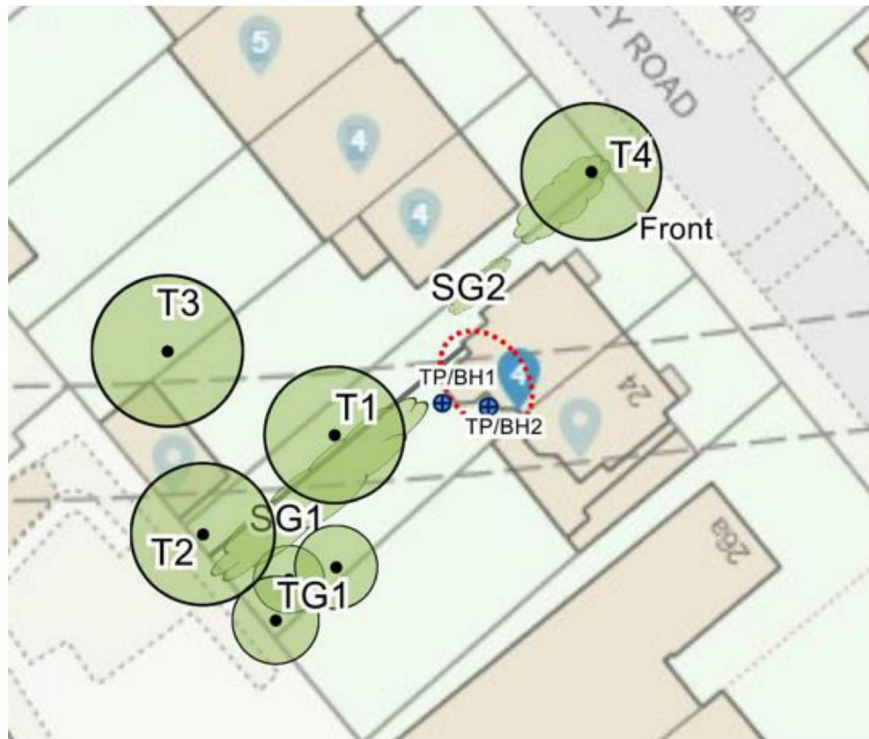
Site Plan

The origin of the Vitaceae spp. roots will be the grape of SG1 and are not considered significant to the current damage. The source of the Leguminosae spp. roots will be T2 False Acacia, the either Quercus spp. or [the related] Castanea spp. roots will emanate from T3 Oak, and the Ailanthus spp. roots will originate from T1 Tree of Heaven.

If an arboricultural solution is to be implemented to mitigate the influence of the implicated trees/vegetation we recommend that T1 Tree of Heaven and T2 False Acacia are removed at this stage. If movement persists the removal of the oak may become necessary.
