## Arboricultural Consultancy for LV=

| Insured | | Address | 29 Edis Street, London, NW1 8LE | | |

**Scope of Report:** To survey the property and determine significant vegetation contributing to subsidence damage, make recommendation for remedial action and assess initial mitigation and recovery prospects. The survey does not make an assessment for decay or hazard evaluation.

# GEOTECHNICAL

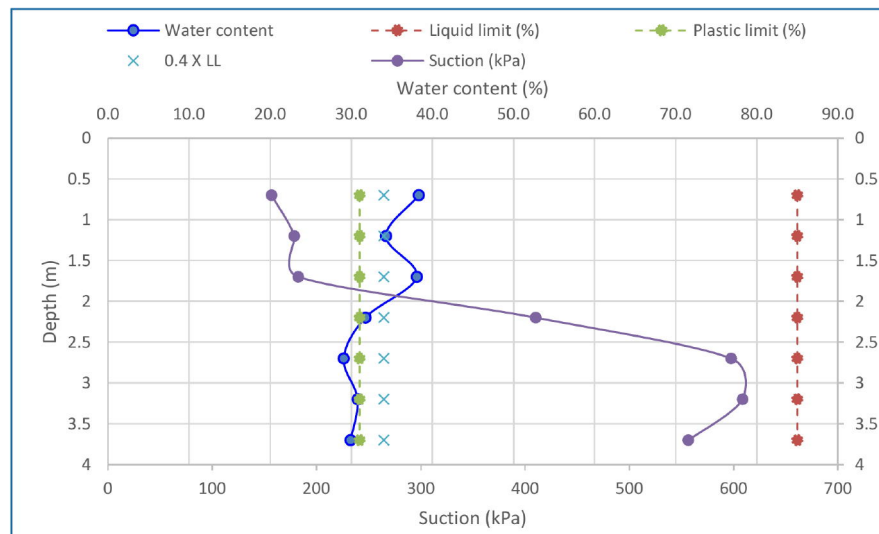
| Lab Ref | Depth (m) | WC (%) | LL (%) | PL (%) | PI (%) | .425 mm (%) | mod. PI (%) | Av. Suc. (kPa) | Description |
|---|---|---|---|---|---|---|---|---|---|
| 6 | 3.2 | 30.8 | 85 | 31 | 54 | 94 | 51 | 608 | Stiff grey-brown silty CLAY with rare gravel. Gravel is fine |
| 7 | 3.7 | 29.9 | 85 | 31 | 54 | 94 | 51 | 557 | Stiff grey-brown silty CLAY with rare gravel. Gravel is fine |
