## Parliament Hill Lido, Hampstead Heath, North East Boundary Wall

### Structural Assessment Report

**Ref:** 231038/E Painter

**Date:** 18 Dec 2023

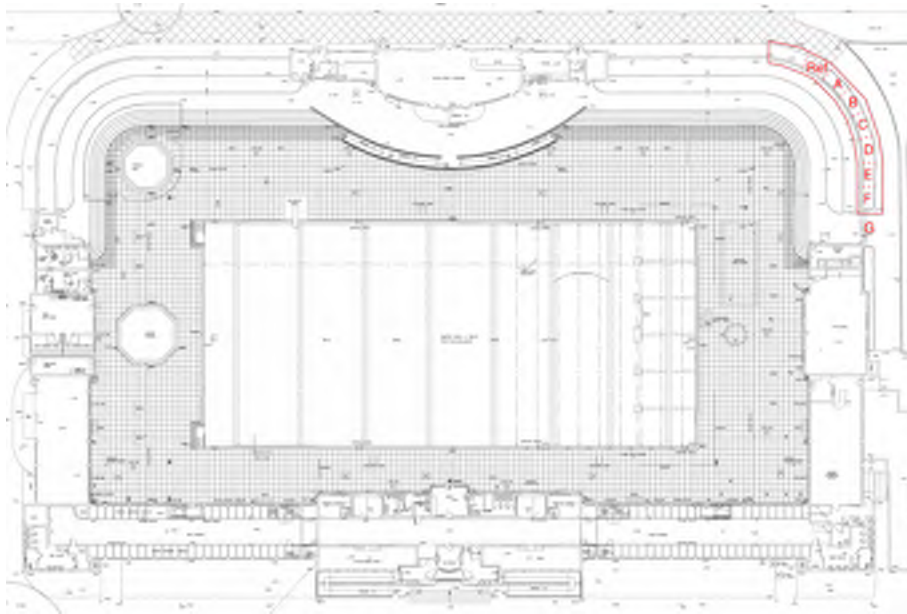
- 2.1 Figure 01 shows the location of the wall and the different zones referenced later in this document.

Figure 01 – Plan of the Lido showing area surveyed.
