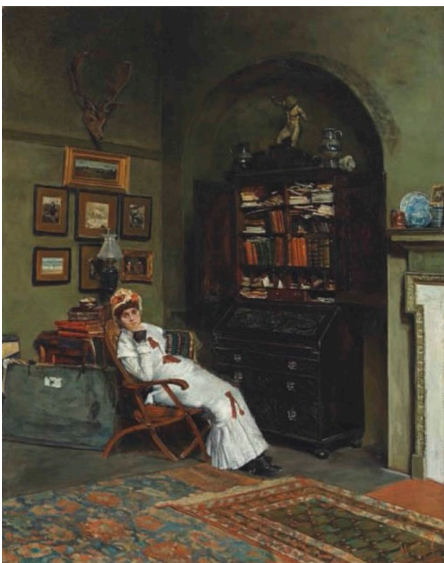
In The Painting Room the existing fireplace surround, corbel, mantel, hearth and size of the opening is not original. A painting by William Logsdail at 5 Primrose Hill Studios in 1883 (below) indicates a much grander fireplace and surround. The intention is to open the fireplace up to its original reveal size. Likewise the bricked up fireplace in the Models' "Retiring" room is to be unblocked and reinstated.

William Logsdail painting in 5 Primrose Hill Studios, 1883 with large fireplace surround.
