PROJECT ADDRESS: 38D DELANCEY STREET, LONDON NW1 7NH

DRAWING TITLE: EXISTING THIRD FLOOR PLAN SCALE: 1:50 at A3

DRAWING NO.: P0113_00A_103 REVISION: / DATE: 09/2024

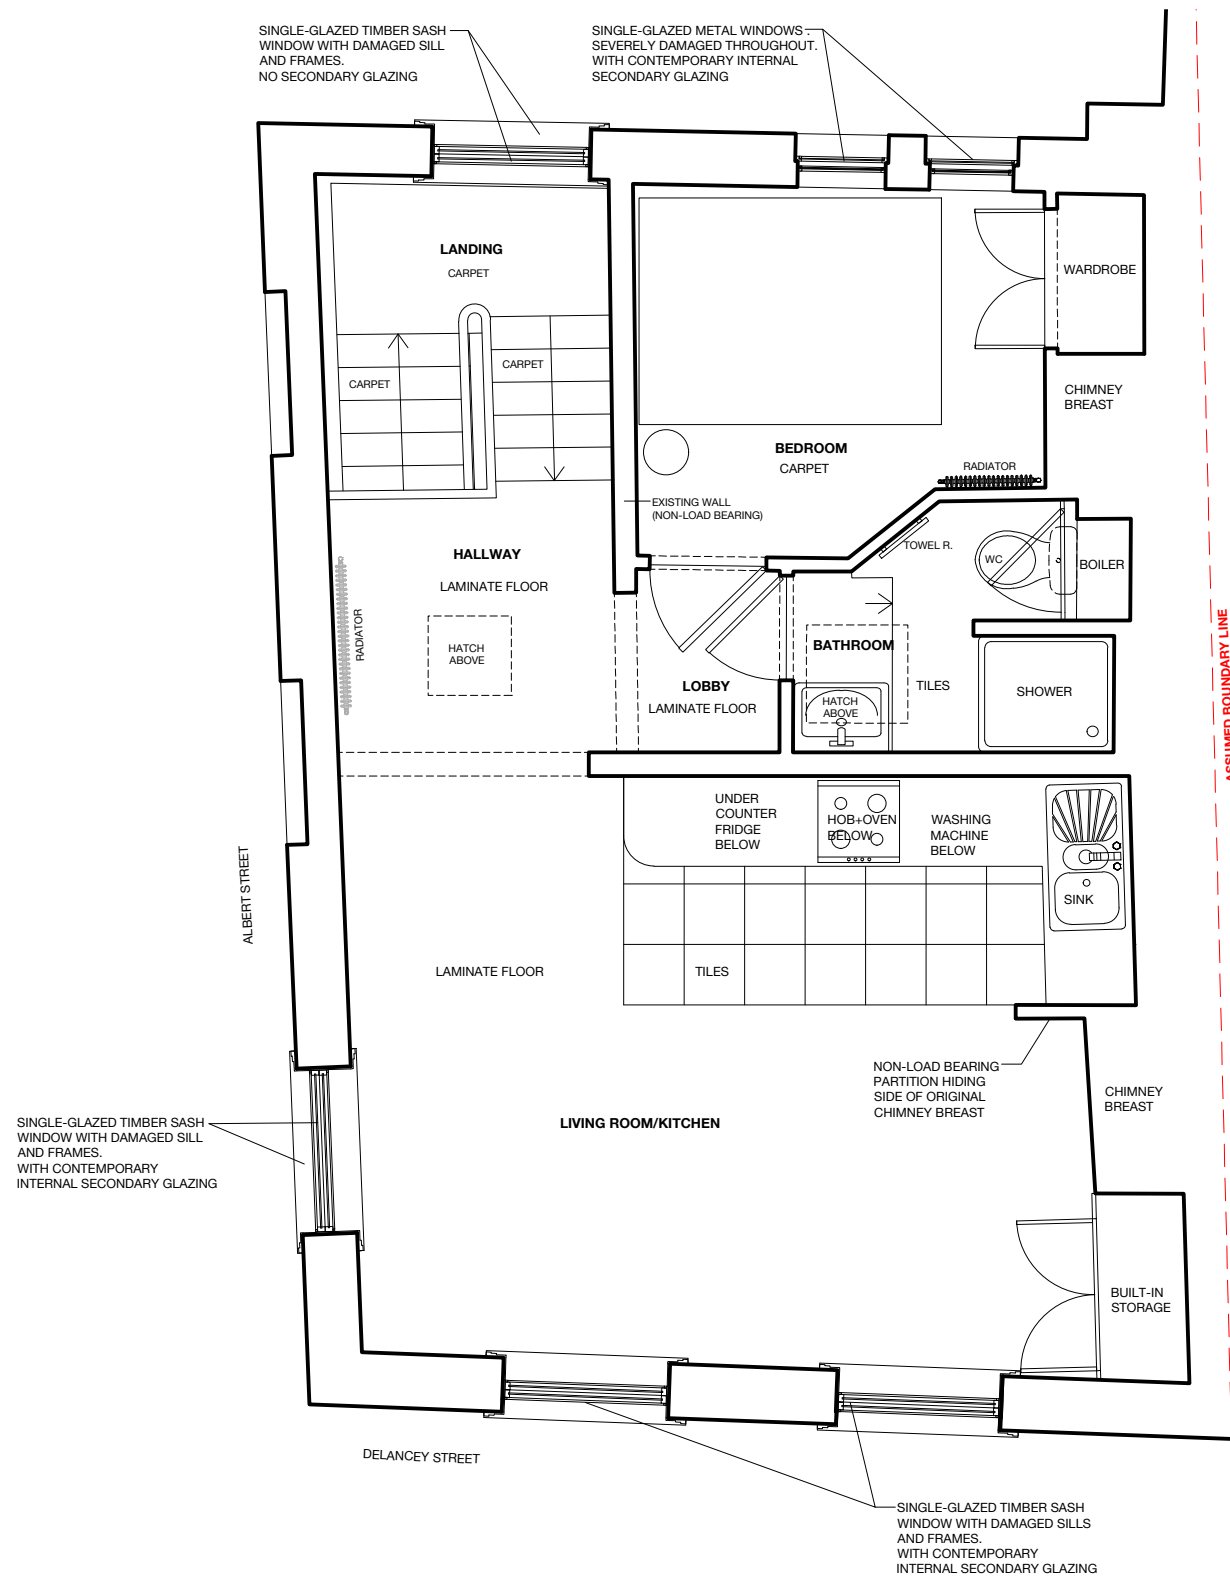
01 EXISTING THIRD FLOOR PLAN
00A-103 SCALE 1:50

SINGLE-GLAZED TIMBER SASH WINDOW WITH DAMAGED SILL AND FRAMES. WITH CONTEMPORARY INTERNAL SECONDARY GLAZING

SINGLE-GLAZED TIMBER SASH WINDOW WITH DAMAGED SILL AND FRAMES. NO SECONDARY GLAZING

SINGLE-GLAZED METAL WINDOWS SEVERELY DAMAGED THROUGHOUT. WITH CONTEMPORARY INTERNAL SECONDARY GLAZING

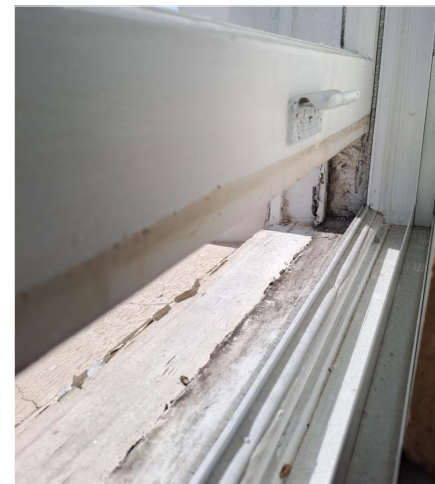
PHOTOGRAPH OF EXISTING SINGLE-GLAZED SASH WINDOWS IN LIVING ROOM, SHOWING ROTTEN SILL AND FRAME, AND CONTEMPORARY INTERNAL SECONDARY GLAZING

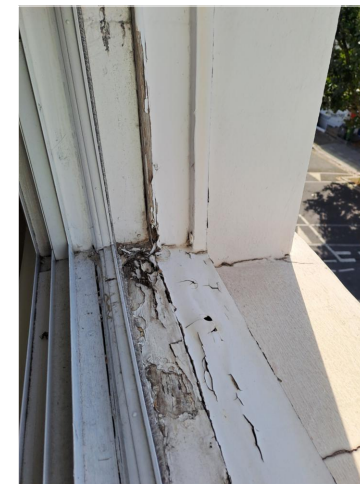
PHOTOGRAPH OF EXISTING SINGLE-GLAZED SASH WINDOWS ON STAIR LANDING IN BAD CONDITION AND WITHOUT SECONDARY GLAZING.
