5, BACON'S LANE, HIGHGATE, N6 6BL.

Condition & Feasibility Study (Options Appraisal)

Document No.: 5BL-PP-9020 (Rev A)

RATIONALE FOR DEMOLITION AND RE-BUILD

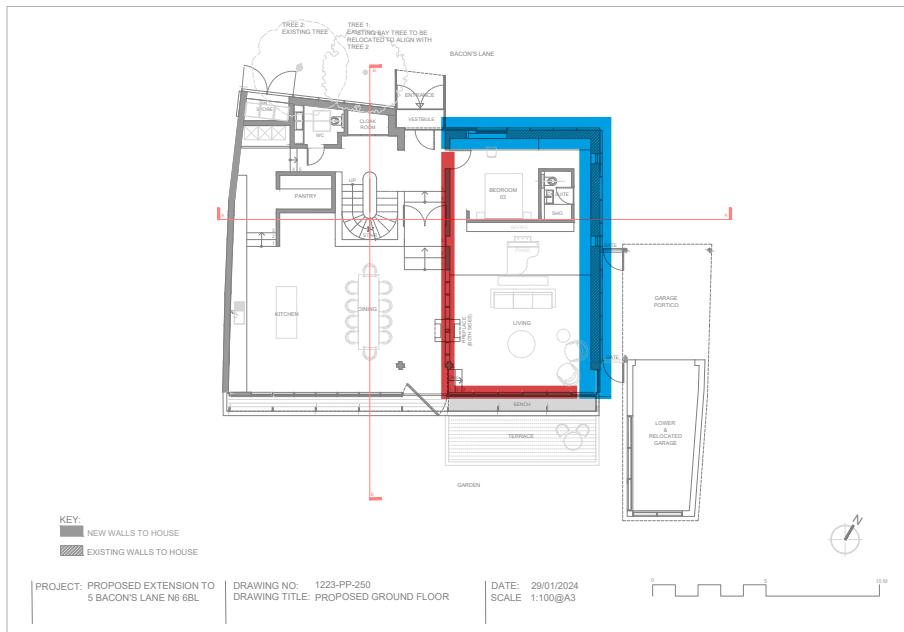
Extract of early Ground Level Plan, shared at Pre-Application Stage
Design sought to maximise retention of significant portion of the building envelope.
