# Arboricultural Appraisal Report

## Subsidence Damage Investigation at:

218 Finchley Road  
London  
NW3 6DH

CLIENT: Crawford & Company  
CLIENT REF: [REDACTED]  
MWA REF: [REDACTED]  
MWA CONSULTANT: Andy Clark  
REPORT DATE: 21/11/2023

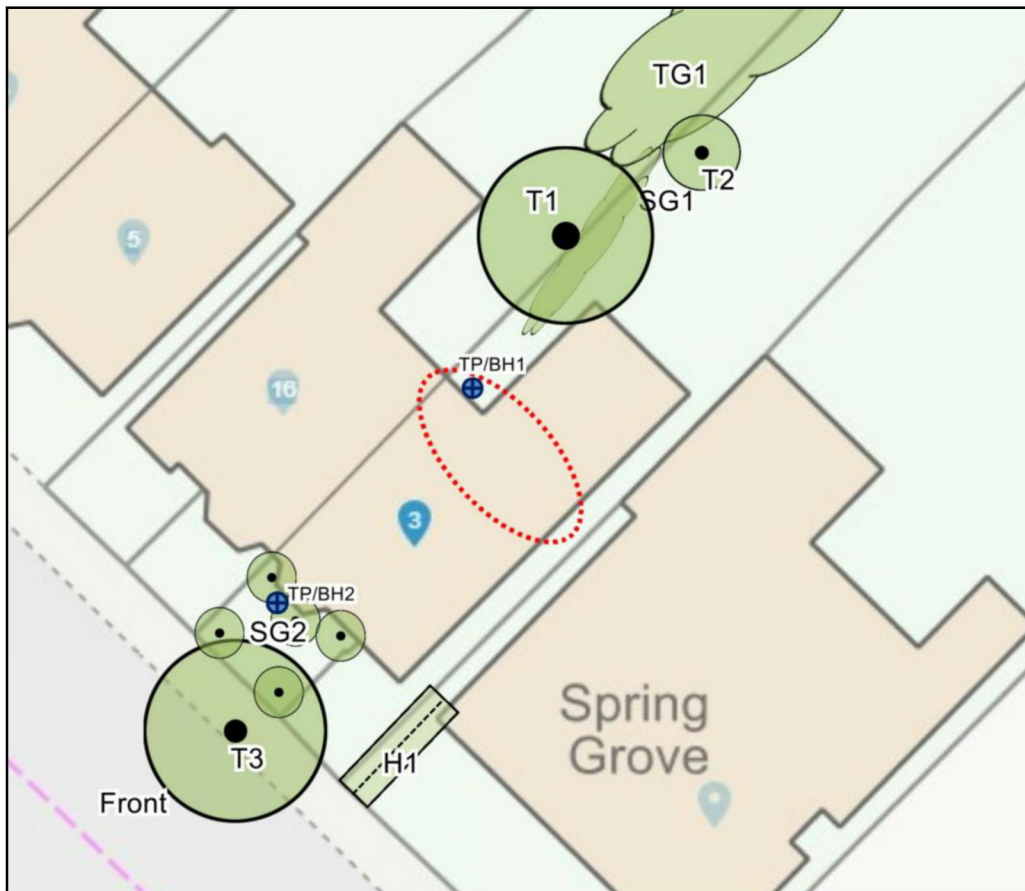
## Site Plan

Roots were observed to a depth of 1.1m bgl in TP/BH1, and recovered samples have been positively identified (using anatomical analysis) as Salicaceae spp.; the origin of which will be T1 Poplar confirming its influence on the soils below the foundations at the rear of the building.

Level monitoring is in progress, with initial readings also showing movement to the front of the building. We are not aware of any damage affecting the property frontage, however readings suggest that T3 London Plane may be responsible.

If an arboricultural solution is to be implemented to mitigate the influence of the implicated trees/vegetation we recommend that T1 Poplar is removed in the first instance. If movement persists, or if further evidence comes to light which confirms the involvement of T3 London Plane the management of this tree may need to be reviewed.
