# Site Investigation Report

Auger were commissioned by Allianz to undertake a site investigation and CCTV inspection of the underground drainage within the area of concern (AOC) at the property.

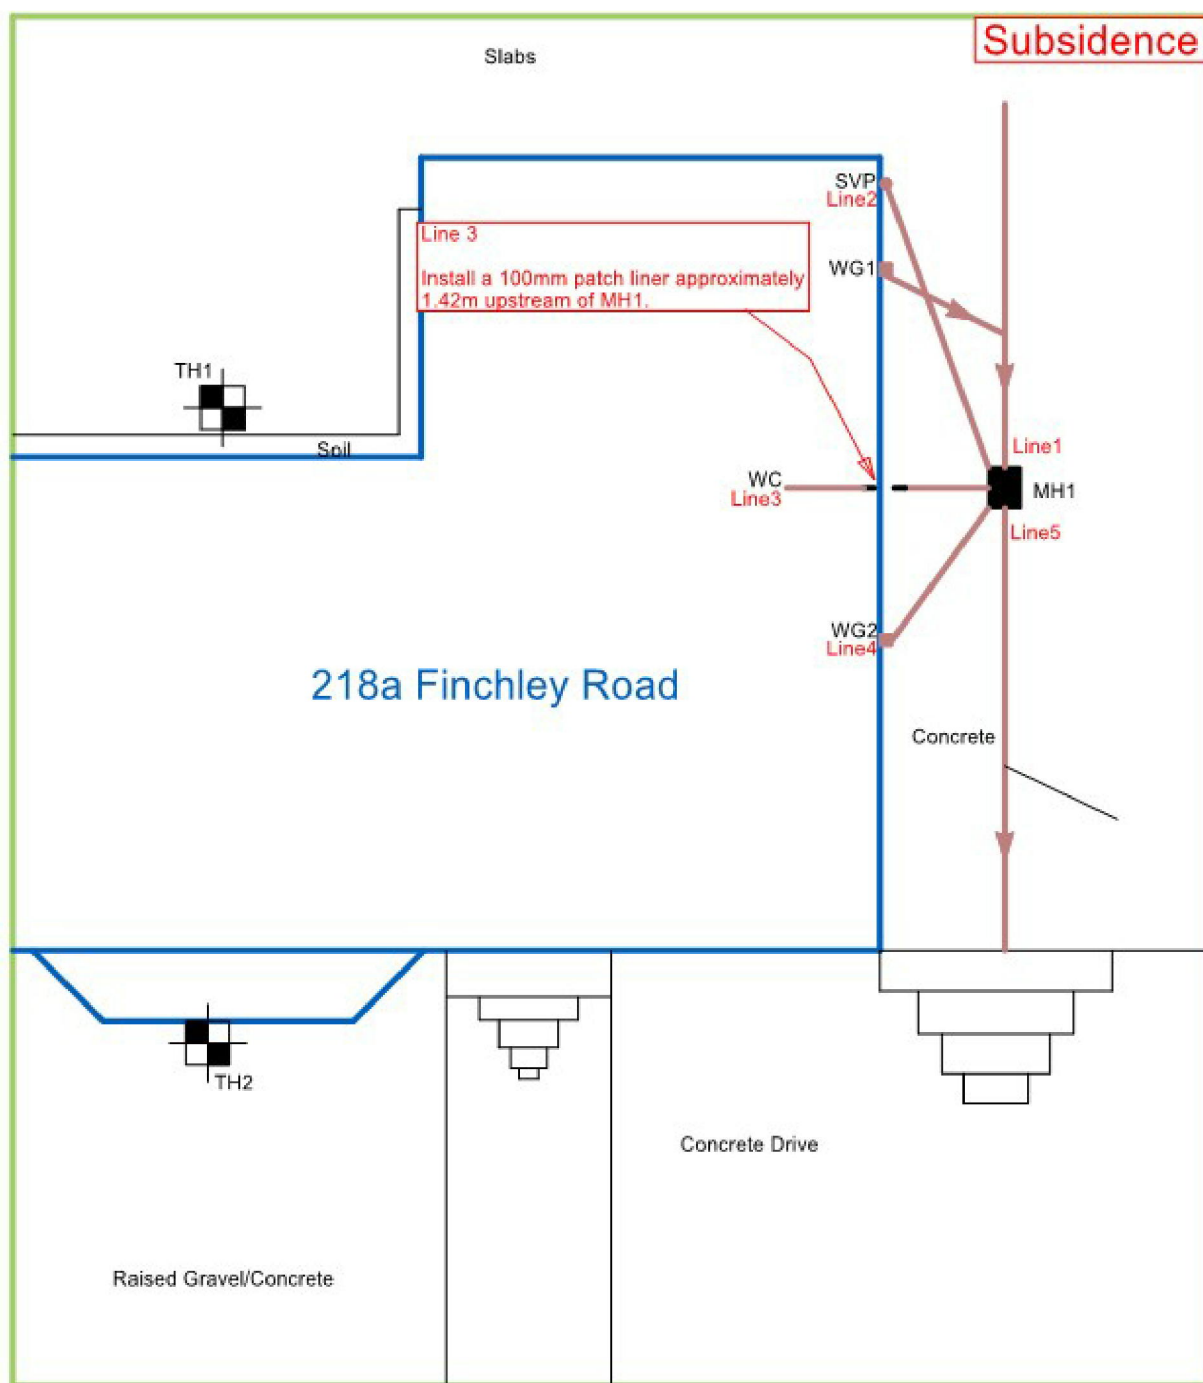
Our survey of line 3 revealed a minor crack at 1.42m.

The above mentioned defects to the below ground drainage system have been caused by ground movement.

Install a 100mm patch liner approximately 1.42m upstream of MH1.
