## 2.1 Introduction & Purpose

This document sets out the findings of the Condition & Feasibility Study for the existing building at The Courtyard Building, to respond to the requirements set out in the London Borough of Camden (LBC) Energy Efficiency & Adaptability Camden Planning Guidance (EEA CPG) Chapter 9. This document is provided in response to a request from LBC’s sustainability officer at the sustainability pre-app to provide further evidence of our workflows and analysis of the existing building ahead of the application for the new proposal for the site. Much of this work had taken place ahead of any decision to alter the existing building on site.

**Existing Facades – Thermal Analysis, Condensation Risk Analysis,  
Corrosion Risk & Vented Cavity Study**

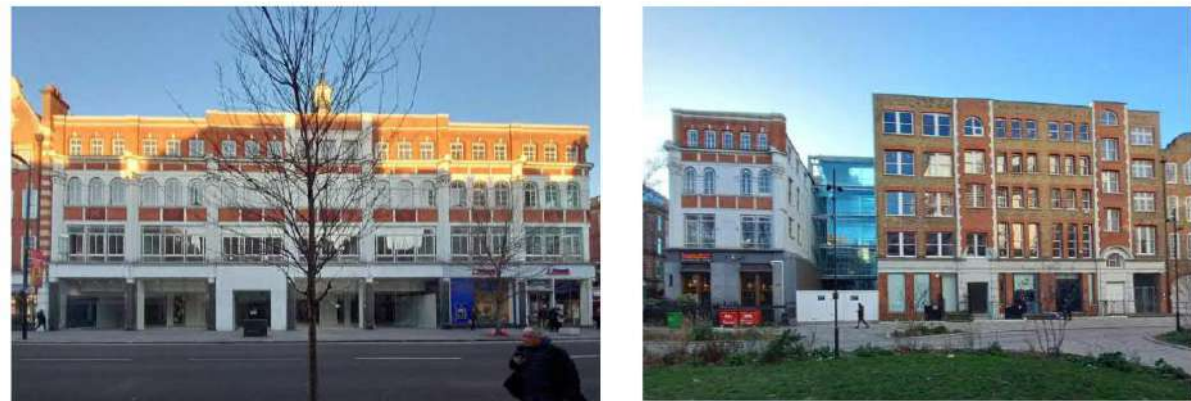
**Figure 2.3.1:** images of the existing buildings on site.

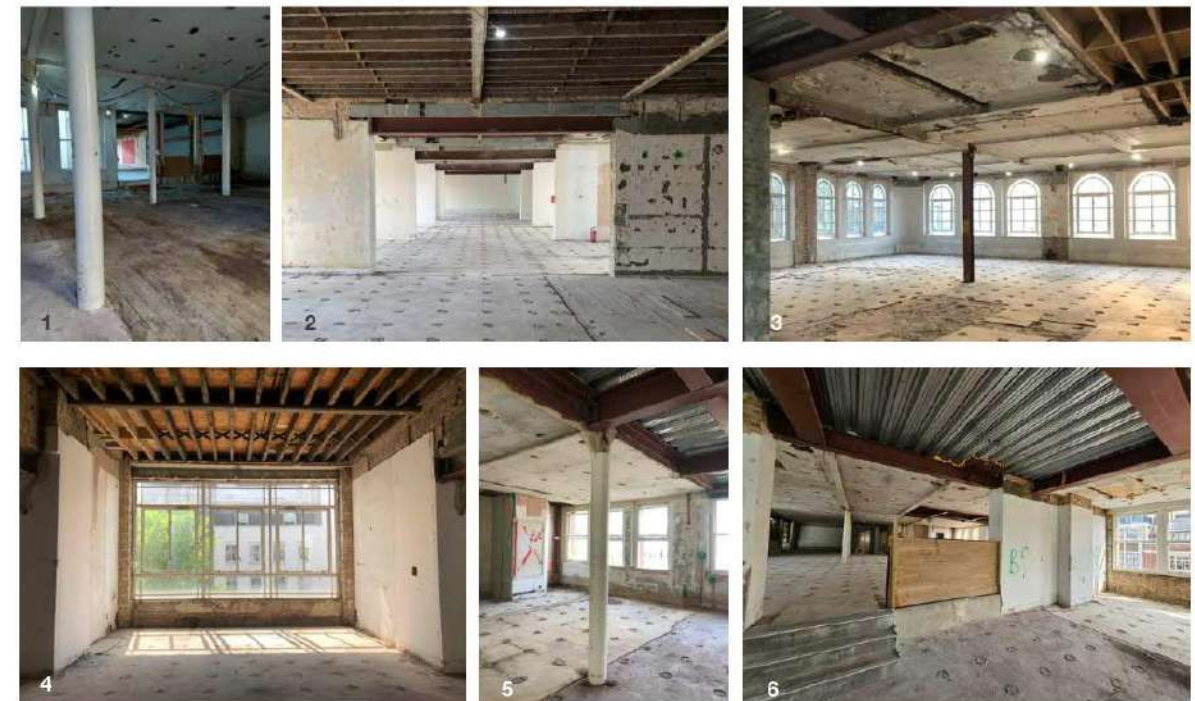
**Figure 2.3.2:** example images from across the site of typical floorplates showing the extent of retained materials after the strip out undertaken by the previous building owner.

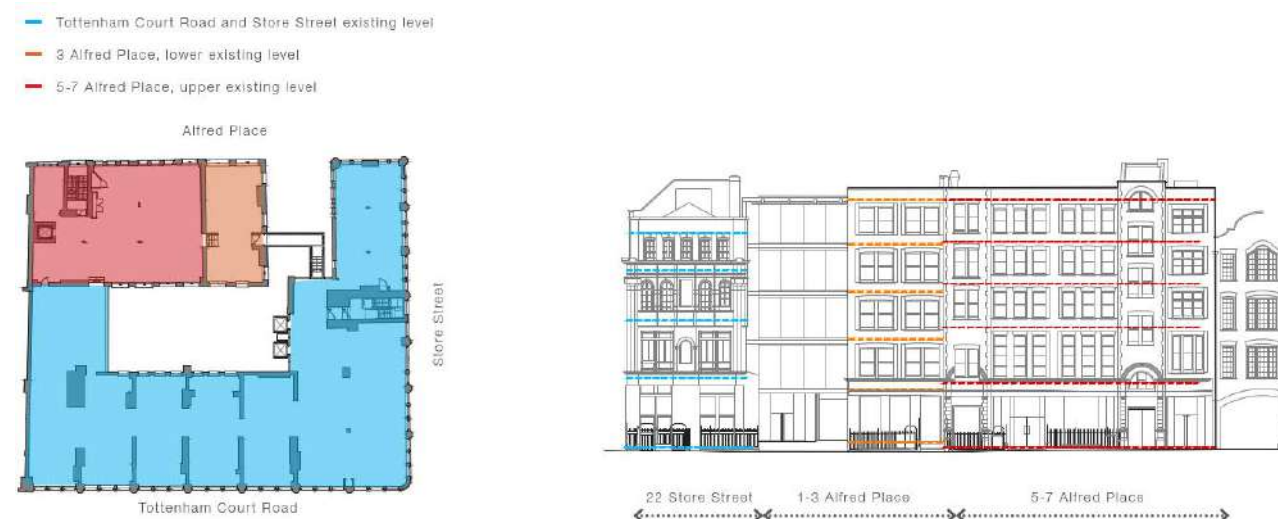
- 1-3 and 5-7 Alfred Place are on significantly different floor levels - connected to rest of site by the 1990s extension. Presents internal accessibility issues (see drawings and images in Figure 3.1.1).

**Figure 3.1.1:** drawings and site images to demonstrate the differences in levels within the existing buildings on site.
