**Clarifications and  
Responses on Demolition  
Justification including Pre-  
Redevelopment Audit and  
Retention options appraisal**

October 2023

This document relates to planning application 2023/2510/P and has been compiled in response to feedback from the GLA Stage 1, LB Camden officers and their 3rd Party technical reviewers. In particular the queries relate to how the proposals address the requirements of specific policies;

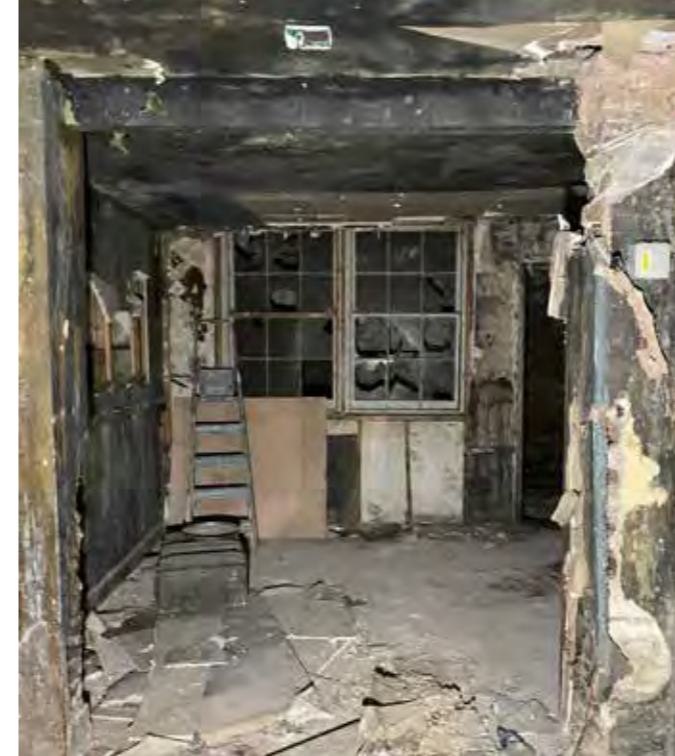
Modern joist supporting opening to front and back of basement. Boarded up fireplace possibly concealing range. Concrete screed.

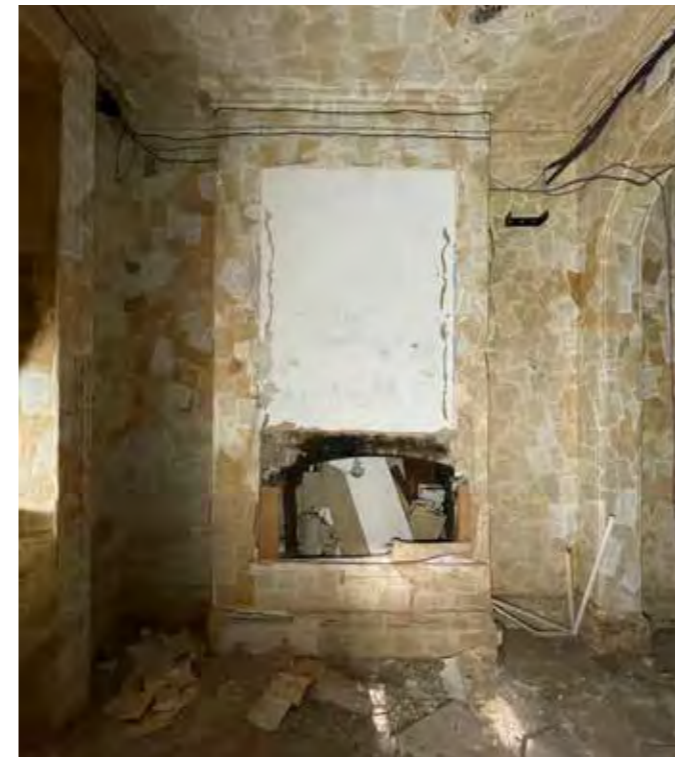
Partially infilled fireplace opening. Cornice and architraves of early phases.

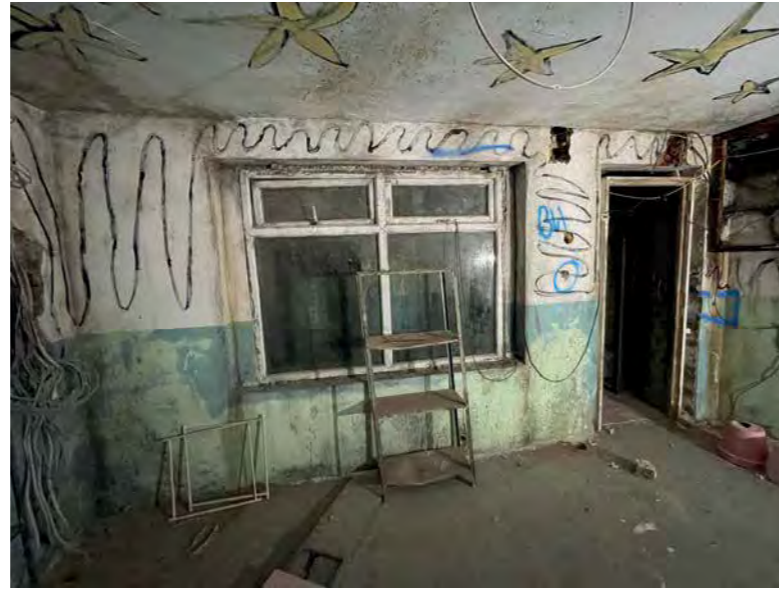
Front room. Note modern uPVC window

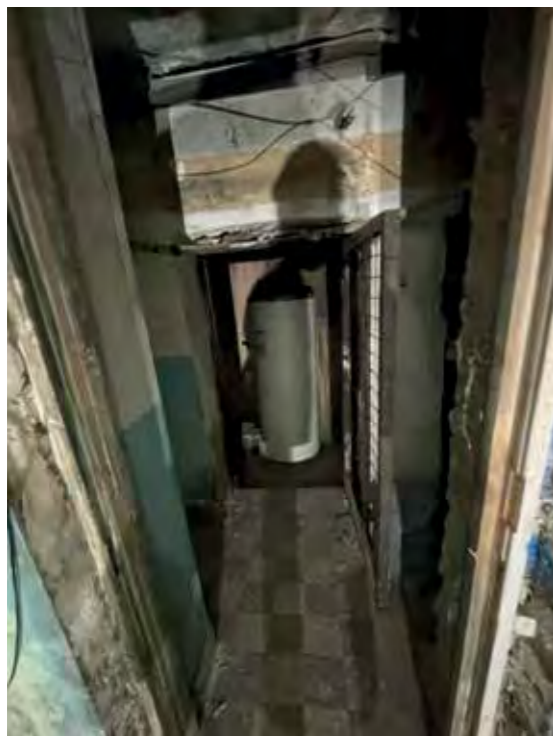
Coal vault in 11. Note tank

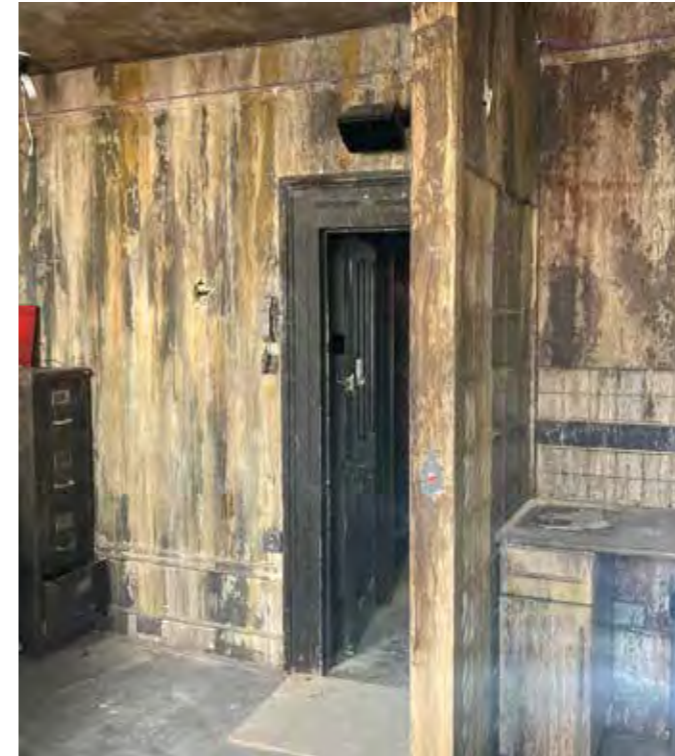
Historic skirting and picture rail. Doorcase with later modifications. Modern kitchenette. (35 NOST.)

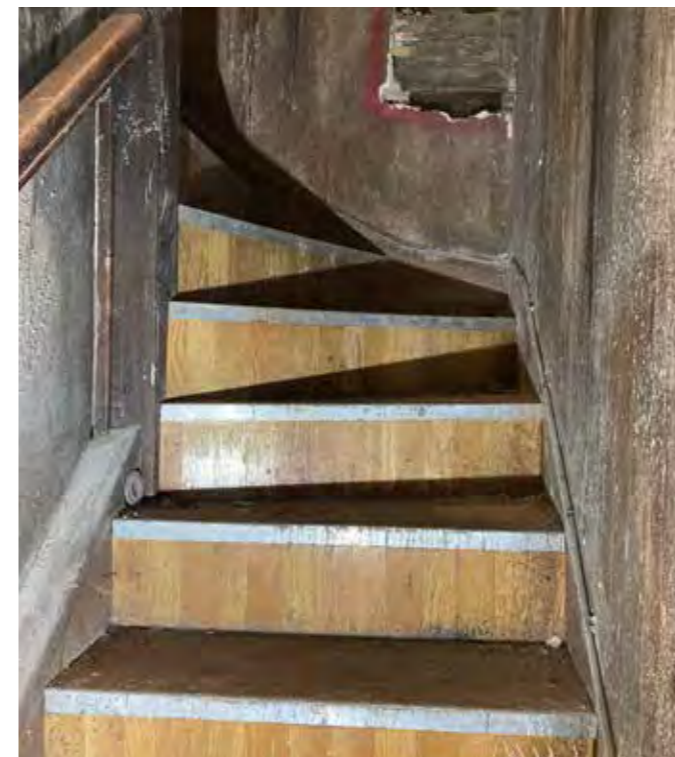
Modernised and substantially rebuilt staircase. (37 NOST.)

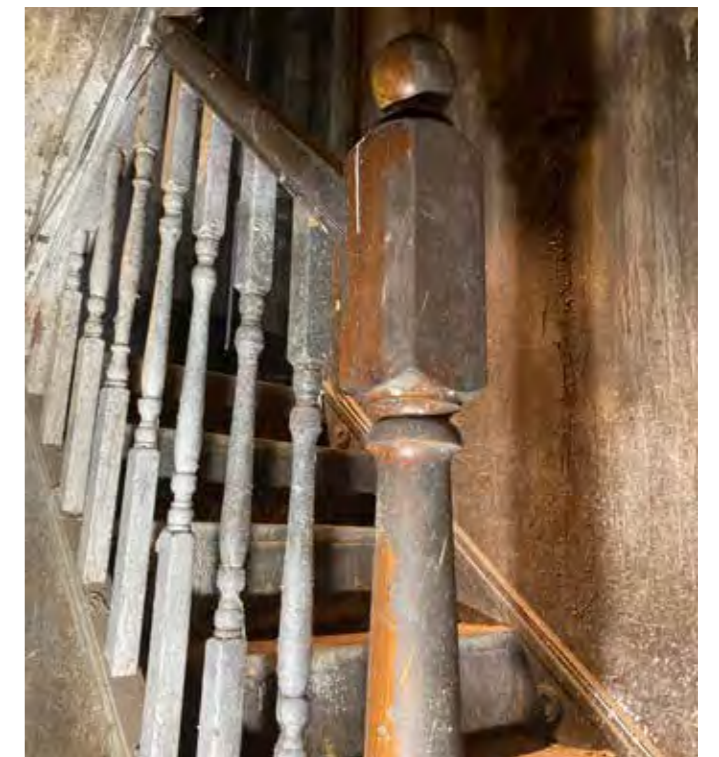
Modern balustrading, treads, risers and stringers cladding. (35 NOST.)

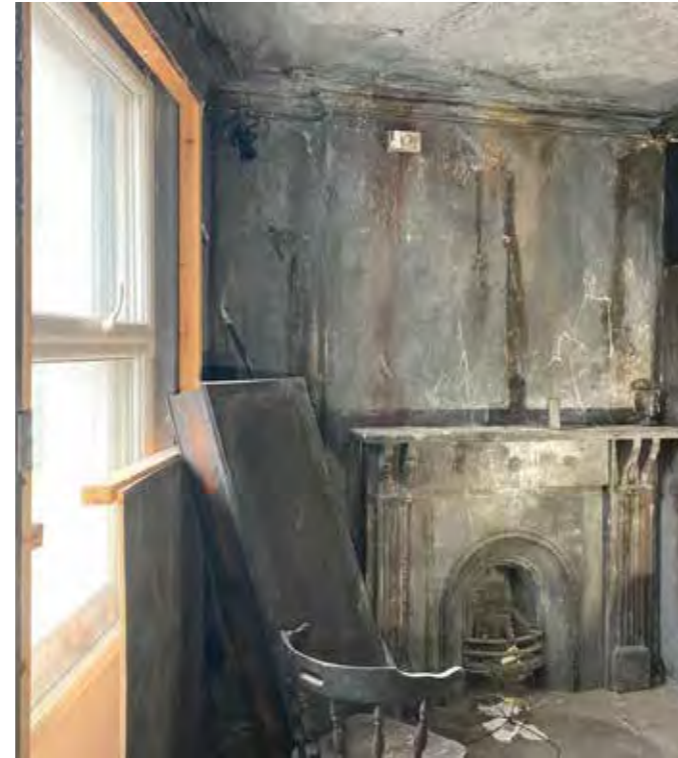
Fireplace to front room: one of the few remaining historic features within 35 and 37 New Oxford Street (35 NOST.)

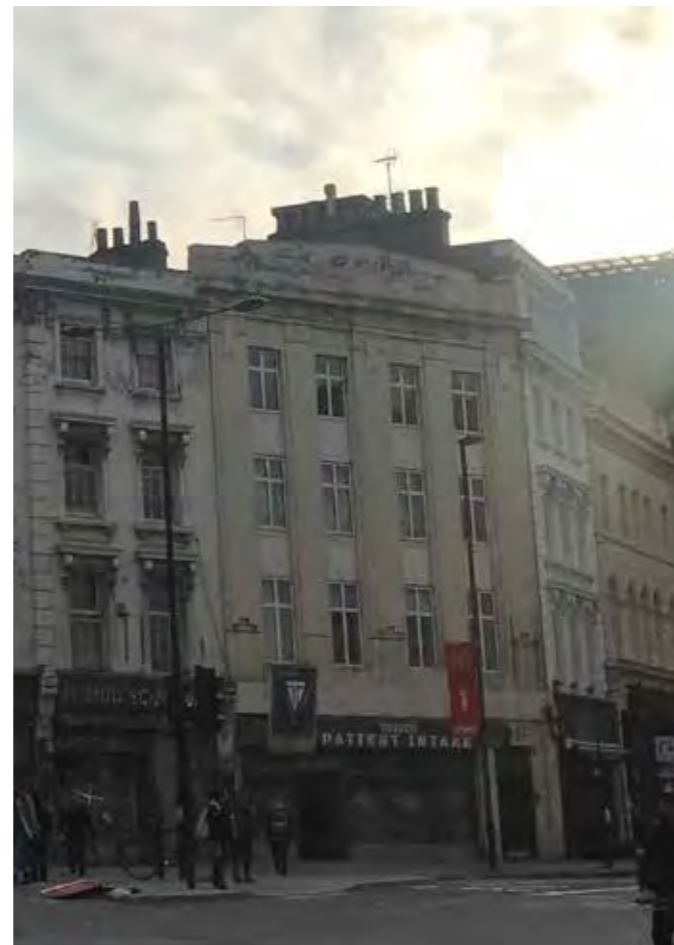
Existing Facade Overview
