New Square No.6 1:50
Rear South Elevation PROPOSED

Drawn	Rev	Notes
JW		For List B / Faculty and Tender
Job No	Job	Client
0400	LINCOLN'S INN - NEW SQUARE	
Drawn	Drawn	Drawn
234	NS6 Rear Elevation PROPOSED	
Scale	This document is copyright and the property of Chartery Conservation Architects Ltd. Any copies of this drawing made by any method must also include a copy of this sheet.	
1:50 at A1	©Chartery Conservation Architects Ltd

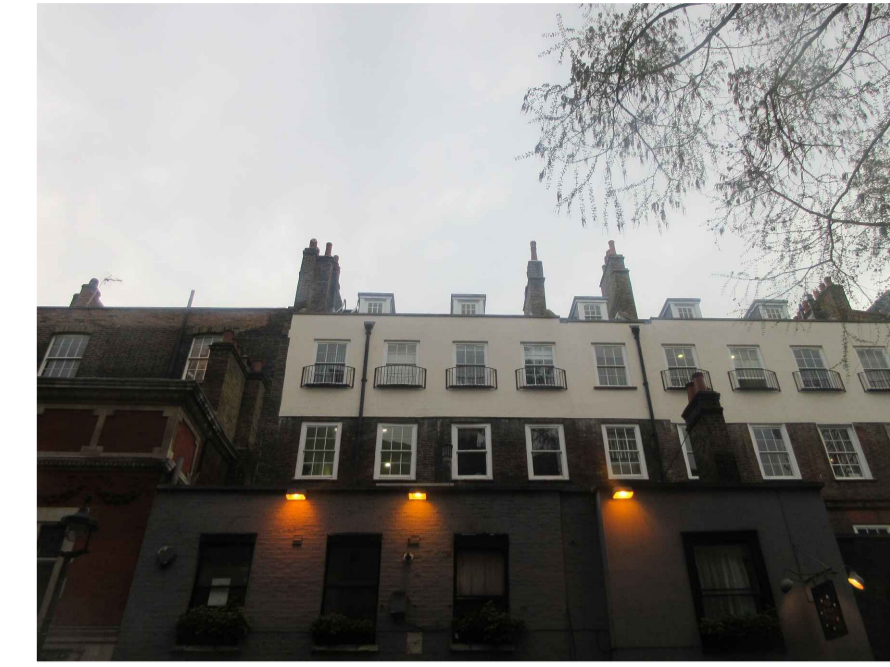
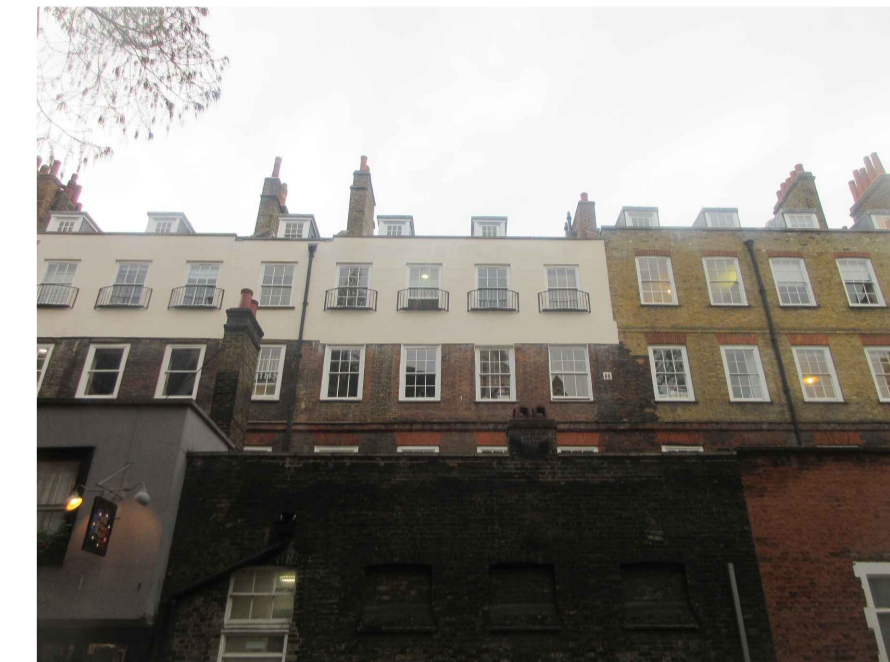
The stability of mortar repairs to brick window heads to be checked. Where loose or failing, new rubbed bricks installed. The stability of the gauged brickwork needs to be checked to all 2nd floor windows (west end)

Brickwork is to be repointed where missing or failing. Cement mortars where failing will be replaced with a hydraulic lime mortar (NHL 2.0). Mortar mix to be agreed. Badly damaged or mortar repaired bricks are to be cut out and replaced with salvaged bricks sourced to match the existing. Assume 10% repointing unless described otherwise. All masonry lightly Thermatech cleaned. Air bricks cleaned of paint to maximise ventilation and then redecorated.

Gauged brick string courses
Thermatech cleaned and badly decayed bricks, inappropriate cement mortar repairs, unstable areas and cement pointing removed.
Replacement new gauged bricks installed with lime putty pointing.

New lead drip in Code 5 lengths not exceeding 1200mm

Existing lead drip renewed in Code 5 lengths not exceeding 1200mm.

New mortar fillet - NHL 5.0.

All cast-iron and lead downpipes and cast iron soil pipes require redecoration. Colour: Black to match the existing.

Shutters to be overhauled and repaired with scarf repairs. Racked shutters to be dismantled and reglued. All joinery to be thoroughly prepared and redecorated. New lead cover flashing to top rail.

Fractured and badly decayed gauged brickwork or mortar repairs to window heads to be cut out and replaced on a brick-by-brick basis. Washed out joints repointed with a non-hydraulic lime putty.

Stone window cills Thermatech cleaned and where necessary poulticed to remove extensive deposits. Mortar repairs to localised damage. All windows overhauled with scarf joinery repairs to decayed sections. Putty replaced where missing, detaching or cracked. All joinery redecorated. Draught-proofing seals and strips surface fixed to the existing windows.

New stone cills or indent repairs to stone cills.

New tiled cills.

All railings to Areas, bridges and steps to be rubbed down and repainted. Decayed ends opened up, painted and releaded. Localised damaged stonework to the bridge and plinths require a combination of pieced-in or mortar repairs. Open joints between paving slabs and steps to be repointed (NHL 5.0).

Basement Areas - Paving lifted and relaid to falls to existing channels and gully positions. New stone sourced to match existing when badly fractured or missing.

Basement Area walls - Decayed bricks and cement mortar repairs are to be repaired with salvaged bricks to match the originals. Wall surfaces cleaned of loose paint and relime washed. Scarf repairs to existing doors and redecoration.

Tile repair to cill

Missing glazing bars reinstated

Brick string course cleaned, decayed bricks cut out, mortar repairs cut and new gauged bricks inserted. New lead drip installed over existing tile drip course. Tiles replaced where damaged
