New Square No.9 1:50

Front East Elevation PROPOSED

| Drawn | Rev | Notes |
|---|---|---|
| 0400 | LINCOLN'S INN - NEW SQUARE | |
| 243 | NS9 Front Elevation PROPOSED | |

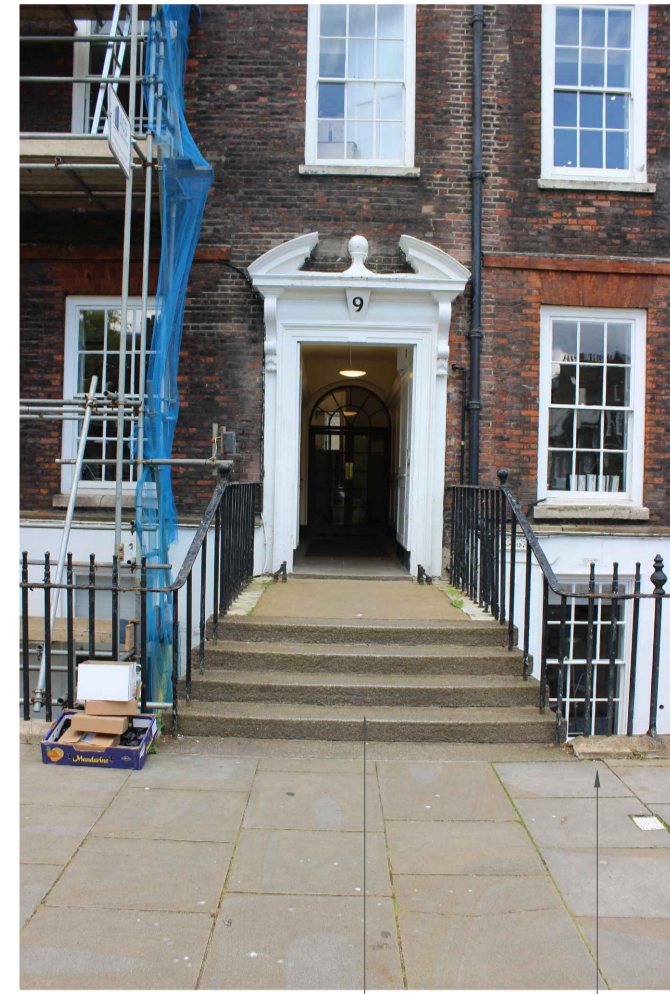
Nº9

Open joints need repointing (NHL 5.0)

Railing repairs and redecoration. Pieced-in stone repair to damaged stone

Basement steps
Open joints need repointing

Brickwork is to be repointed where missing or falling. Cement mortars where failing will be replaced with a hydraulic lime mortar (NHL 2.0). Mortar mix to be agreed. Badly damaged or mortar repaired bricks are to be cut out and replaced with salvaged bricks sourced to match the existing. Assume 10% repointing unless described otherwise. All masonry lightly Thermatech cleaned. Air bricks cleaned of paint to maximise ventilation and then redecorated.

Gauged brick string courses Thermatech cleaned and badly decayed bricks, inappropriate cement mortar repairs, unstable areas and cement pointing removed. Replacement new gauged bricks installed with lime putty pointing.

Fractured and badly decayed gauged brickwork or mortar repairs to window heads to be cut out and replaced on a brick-by-brick basis. Washed out joints repointed with a non-hydraulic lime putty.

Stone window cills Thermatech cleaned and where necessary poulticed to remove extensive deposits. Mortar repairs to localised damage. All windows overhauled with scarf joinery repairs to decayed sections. Putty replaced where missing, detaching or cracked. All joinery redecorated. Draught-proofing seals and strips surface fixed to the existing windows.

All railings to Areas, bridges and steps to be rubbed down and repainted. Decayed ends opened up, painted and releaded. Localised damaged stonework to the bridge and plinths require a combination of pieced-in or mortar repairs. Open joints between paving slabs and steps to be repointed (NHL 5.0).

Basement Areas - Paving lifted and relaid to falls to existing channels and gully positions. New stone sourced to match existing when badly fractured or missing.

Basement Area walls - Decayed bricks and cement mortar repairs are to be repaired with salvaged bricks to match the originals. Wall surfaces cleaned of loose paint and relimewashed. Scarf repairs to existing doors and redecoration.
