New Square No.11 1:50  
Front East Elevation PROPOSED

Drawn	Rev	Notes
JW		For List B / Faculty and Tender
0400		LINCOLN'S INN - NEW SQUARE
247		NS11 Front Elevation PROPOSED

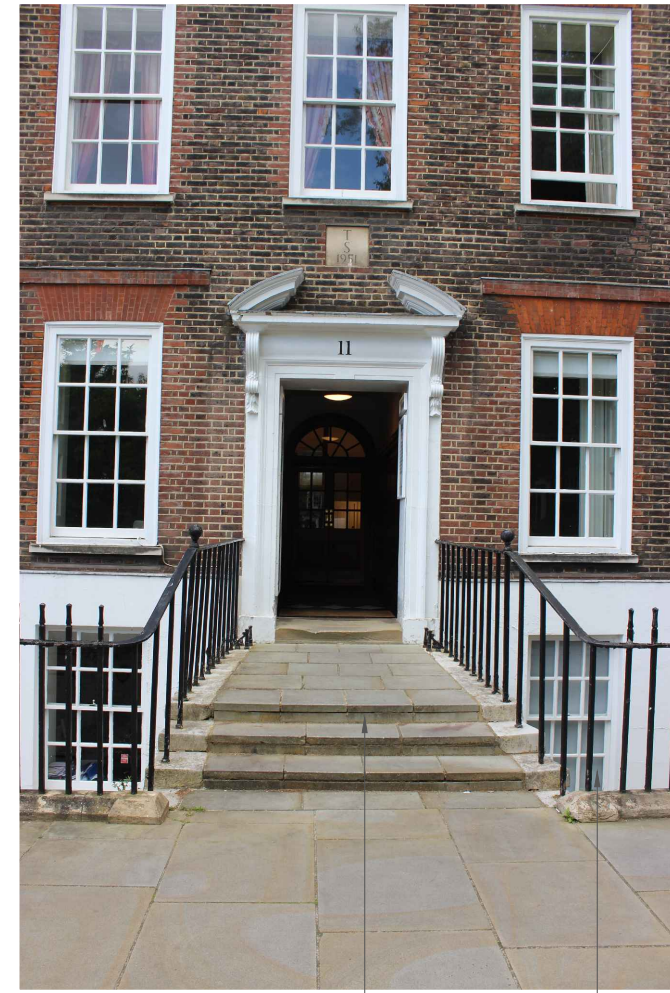
Nº11

Open joints need repointing (NHL 5.0)

Railing repairs and redecoration. Pieced-in stone repair to damaged stone

New access ladder to replace existing see drawing no: BSS-14237-003-NSL015 & NSL016

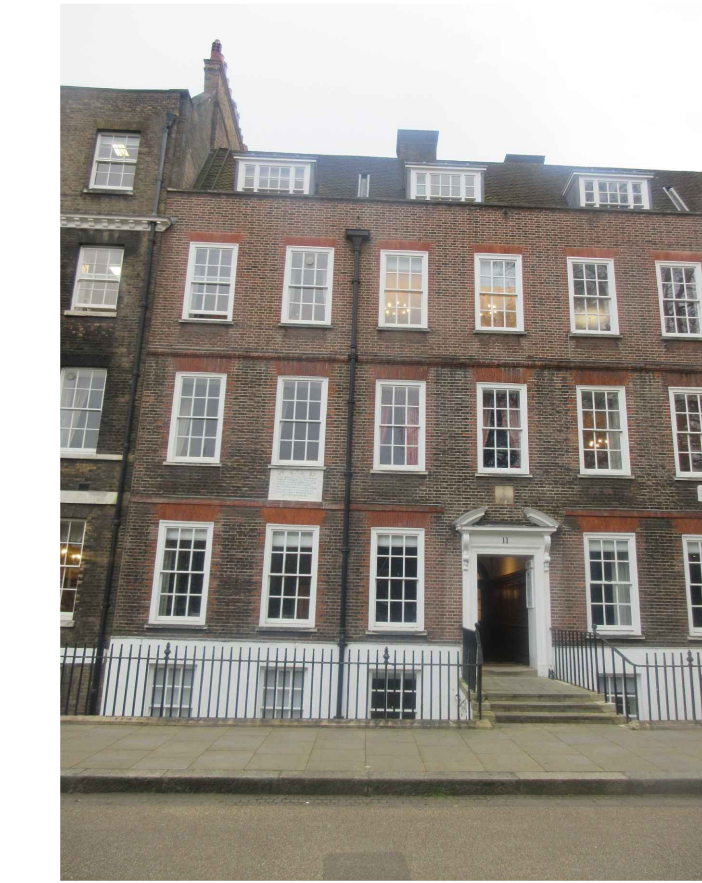
NS11A-1F-119

Downpipe condition needs checking
